TECHNICAL SERVICE BULLETIN

ISSUE DATE:	09/29/2023
REVISION DATE:	12/13/2023
SERVICE BULLETIN SUBJECT:	BuSCoM 2.0 800vRR DuoPower Software Update
VINs or MODELS AFFECTED:	Service Specified Buses
COMPLETE BY:	Earliest Service Opportunity
SERVICE BULLETIN #:	SC-23-136
Labor Operation Code:	PP65Z

BuSCoM 2.0 800vRR DuoPower Software Update

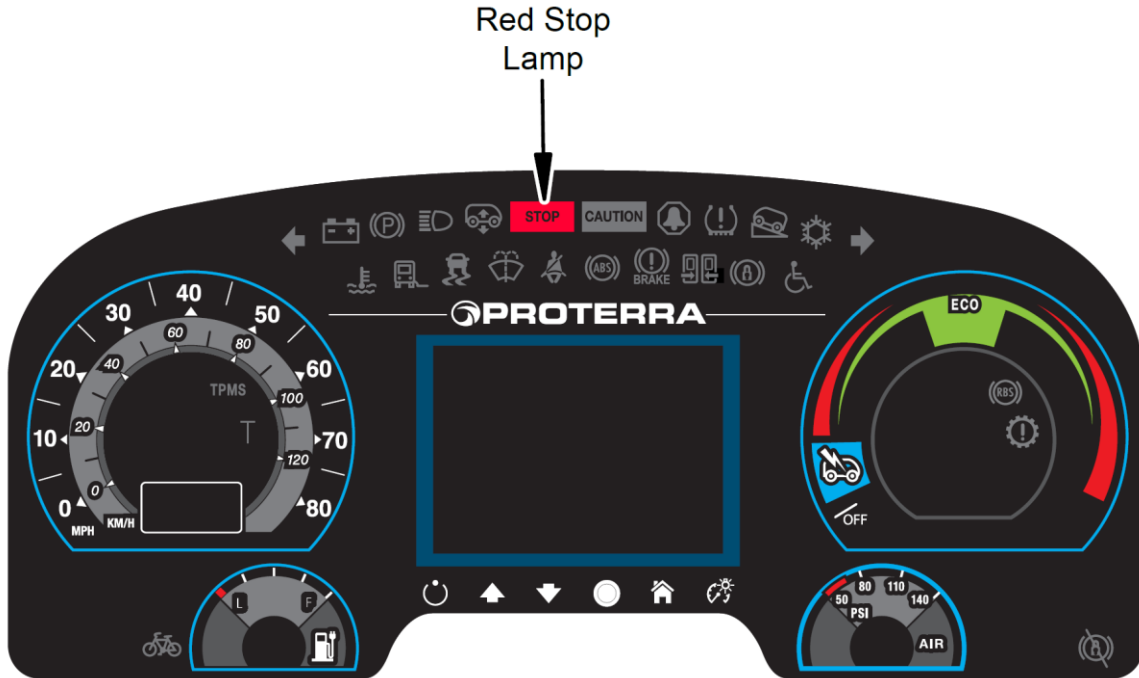
Figure 1 – Red Stop Lamp on Original Dash

Critical battery faults which indicate the potential for a thermal event will result in a Fast Flash Red Stop Lamp in the vehicle dash that blinks at a rate of two times per second, and an audible alarm that pulses twice per second (collectively, the “Critical Battery Fault Warnings”). *Critical Battery Fault Warnings indicate a critical battery failure which could result in a thermal event.* When the Critical Battery Fault Warnings are active, please immediately follow the procedures set forth in the Operator/Driver Guidelines section below, as well as the instructions in any applicable sections of the Proterra Driver’s manual.

If the Critical Battery Fault Warnings are active as described in Section 3.2 (but there is no smoke, burning smell, abnormal popping or whistling noises, flame, etc.), the vehicle should be promptly parked in a safe outdoor location at least 20 feet away from other objects such as buildings, trees and other vehicles, and at least 100 feet away from highly flammable items such as gas stations or propane tanks. Once the vehicle has been moved to a safe location, the operator and passengers may exit the vehicle and the vehicle should be removed from service.
