MAS003433 RU 24-27

# Rapid Update 576

## MC20 - Door striker reinforcement

DATE: September 4, 2024

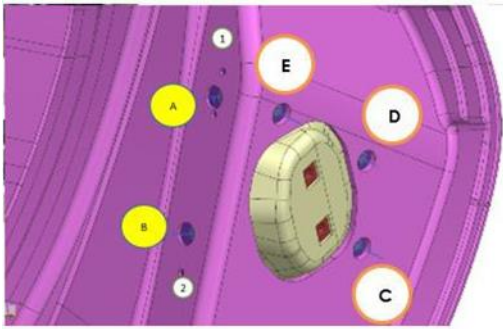
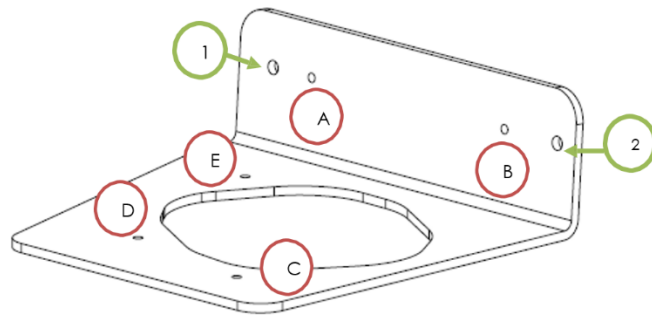
The rework consists of installing 5 rivets to reinforce the joint between the striker and the door.

1 and 2: Gasket reference holes to Center/align the template on the door

A - E: Holes to be made on the car for inserting rivets

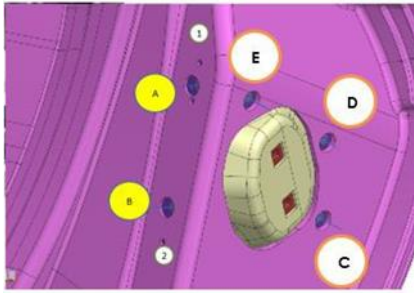
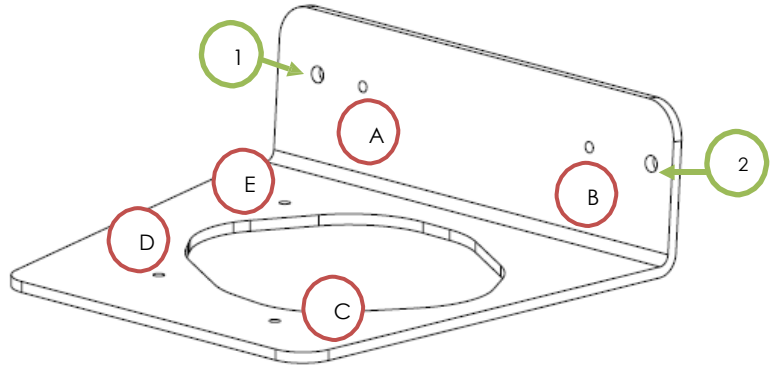
1 and 2: Gasket reference holes to Center the template on the door

A - E: Holes to be made on the car for inserting rivets

8. Repeat the same operations also for points C, D, and E shown in the figure below.
