Service Bulletin

Bulletin No.: 24-NA-145

Subject: Malfunction Indicator Lamp (MIL) Illuminated - DTC P219A Set as Current or History

Brand:	Model:	Model Year:		VIN:		Engine:	Transmission:
		from	to	from	to		
Buick	Enclave	2024	2025			2.5 LK0	
Chevrolet	Traverse						
GMC	Acadia

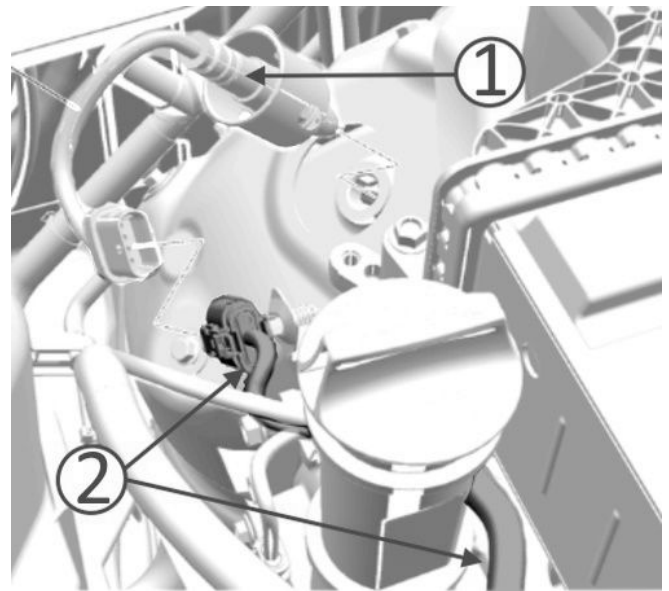
6709693

Note: The wiring from the PCM X3 connector cavity 48 routes to cavity 3 and cavity 49 routes to cavity 4 in the HO2S connector.
