Rear Camera Foggy Or Missing Image

DATE: September 9, 2024

MODELS: M161 Levante (All MY).

SECTION: 08.71 – 1 CAMERA

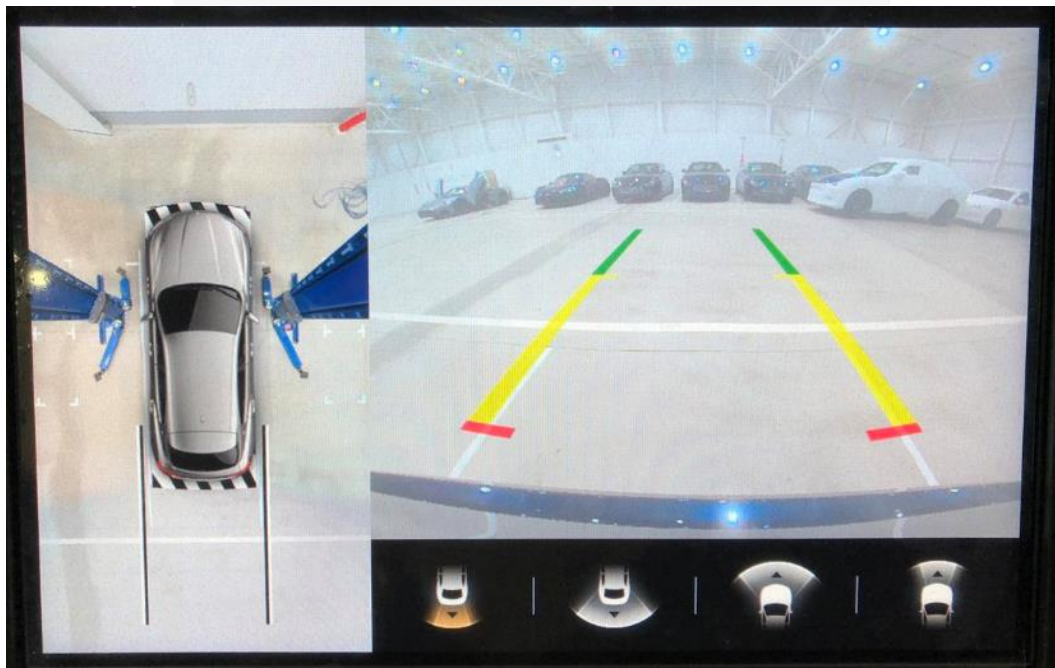
ISSUE: Rear camera malfunction (opaque / distorted or absent image - ref. Picture 1)

Picture 1 – example of opaque or foggy images from the rear camera

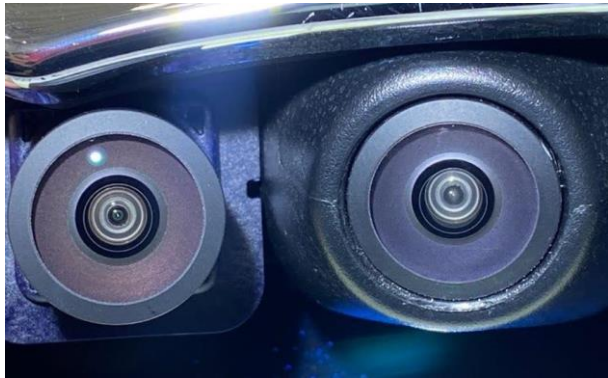
Picture 2 – OK

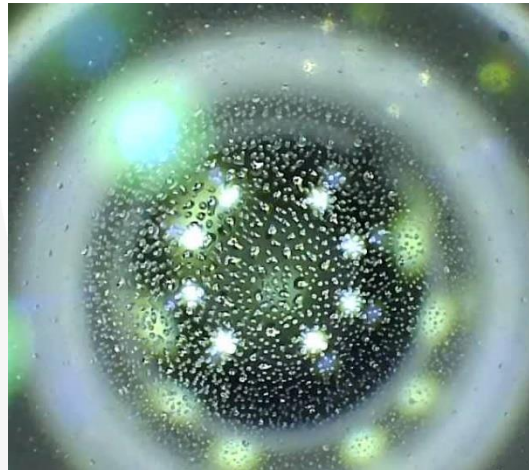
After a full analysis, it was found that the anomaly is linked to water infiltration into the rear camera. Below are some examples:

Picture 3 – water infiltration - NOT OK

In case of confirmed water infiltration in the rear camera, we suggest to replace it along with the lower spoiler gasket, now separately available (Component #69 in table 09.15 -1).
