TO: Mercedes-Benz Dealer Principals, General Managers, Sales Managers, Service Managers, Parts Managers	FROM: Gregory Gunther, Senior Manager, Vehicle Compliance and Analysis, Engineering Services
RE: Service Campaign Launch Notification Replace Electrical Fuse in Vehicle Interior MY24 GLB (247 platform)	DATE: September 13, 2024

Campaign No. 2024090001, September 2024

SUBJECT: **Model GLB (247 platform)**
Model Year 2024

Replace Electrical Fuse in Vehicle Interior

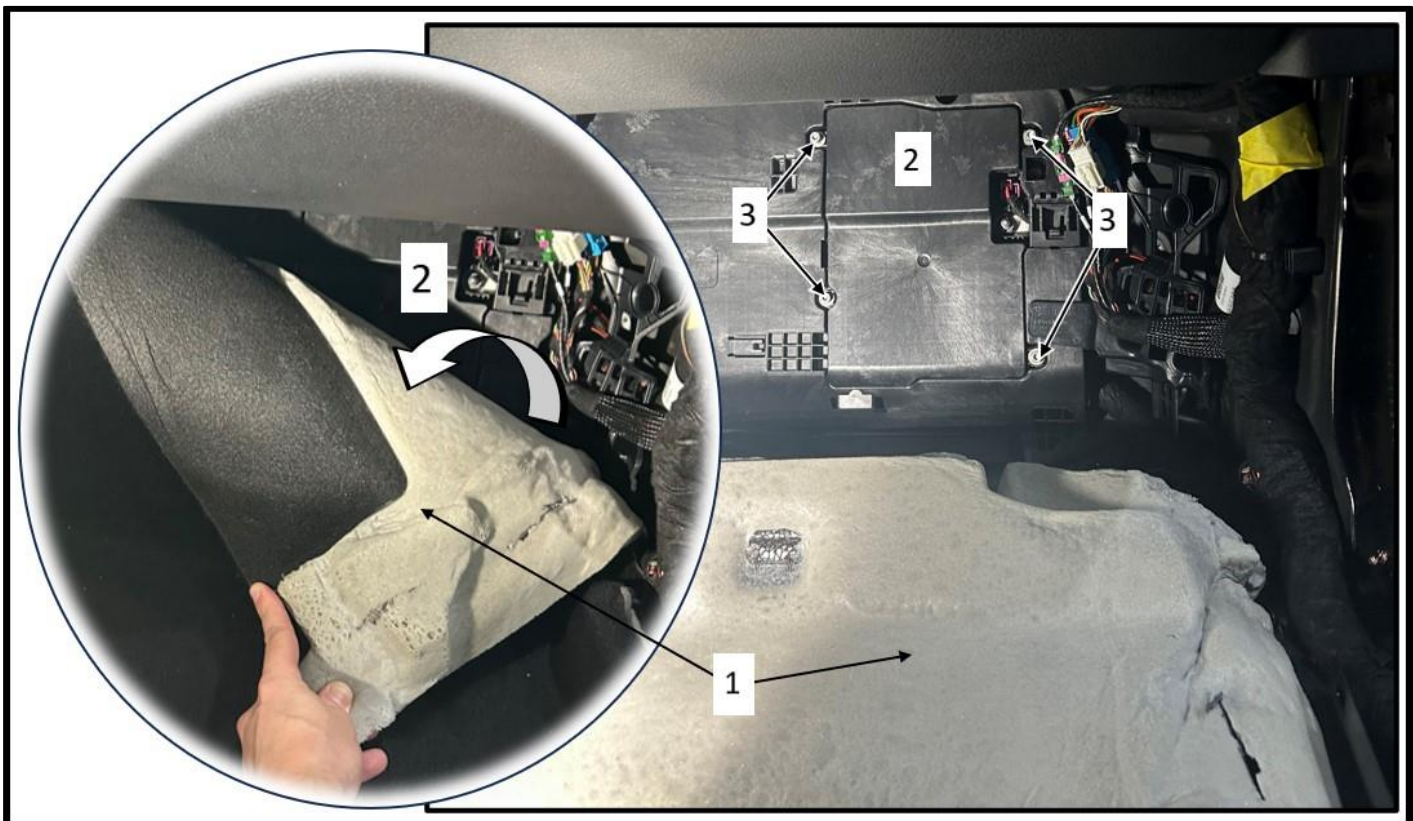
Figure 1

1. Move front passenger seat to rearmost position.
2. Switch off ignition, remove transmitter key from vehicle, and place key outside of transmitter range (at least 2 m).
3. Remove front door sill panel on front passenger side.
i For basic information, see **AR68.30-P-4101MFA**.
4. Fold back the front passenger side floor covering (Figure 1, 1) until the cover (Figure 1, 2) of the fuse and relay module in vehicle interior (Figure 2, F152/4) is accessible.

5. Remove screws (Figure 1, 3) and cover (Figure 1, 2) of fuse and relay module in vehicle interior (Figure 2, F152/4).
i **Installation:** Tighten screws (Figure 1, 3) with a torque of **5 Nm**.
6. Replace electrical **fuse 118** (Figure 2, F152/4f118) for left rear USB port 1 (X39/22) and right rear USB port 2 (X39/23) on fuse and relay module in vehicle interior (Figure 2, F152/4).
i Electrical **fuse 118** (Figure 2, F152/4f118) is located at **slot 2** of the electric connection (Figure 2, M3D) on the fuse and relay module in the vehicle interior (Figure 2, F152/4).
i **Installation:** To do this, **use a new 10 A electrical fuse** (arrow, Figure 2) and install it in slot 2 of the electric plug connection (Figure 2, M3D) on the fuse and relay module in the vehicle interior (Figure 2, F152/4).
i Dispose of the removed electrical fuse properly.

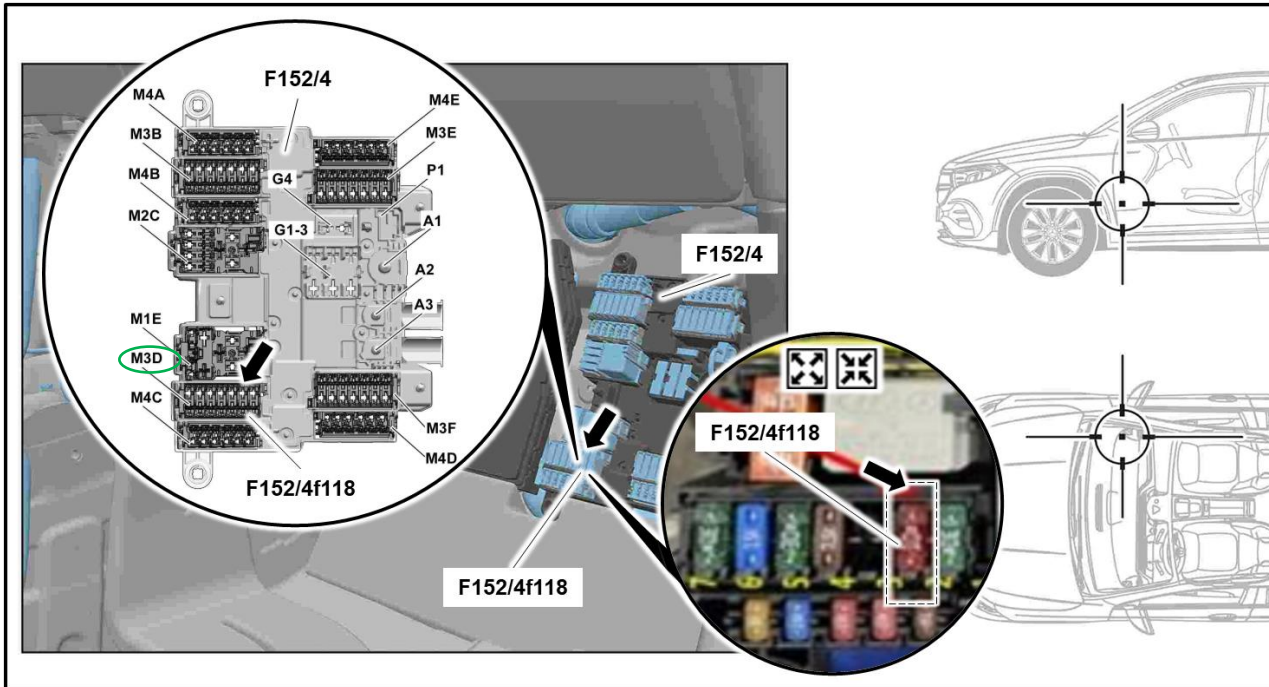
Figure 2

Mercedes-Benz AG, the manufacturer of Mercedes-Benz vehicles, has determined that on certain MY 2024 GLB (247 platform) vehicles, the fuse assignment for the USB ports in the rear passenger compartment does not correspond to current production specifications. It is possible that a 30-Amp fuse was installed instead of a 10-Amp fuse. An authorized Mercedes-Benz dealer will replace the electrical fuse in the interior fuse and relay module.

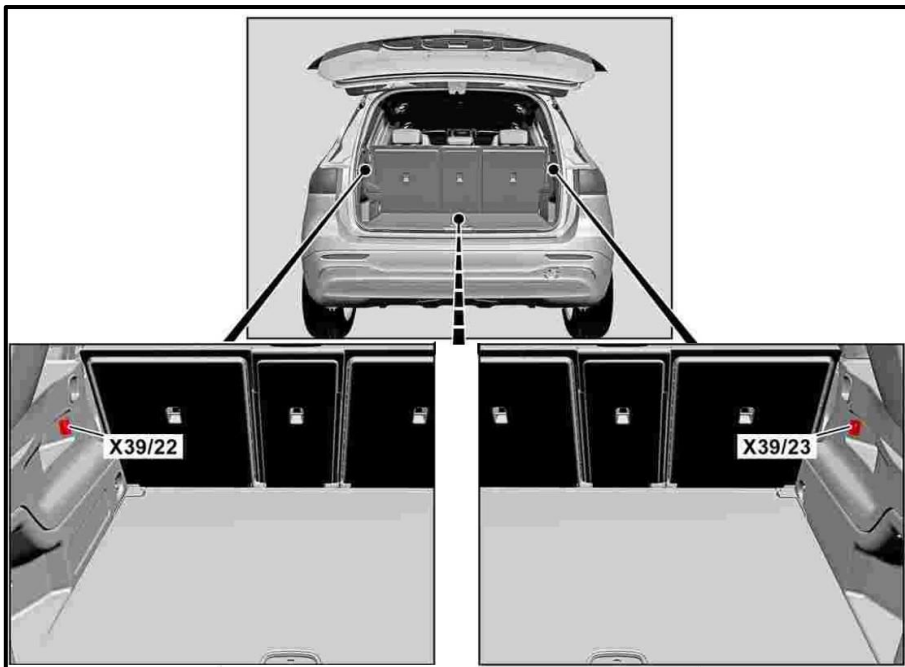
Figure 3

NOTE: The light of left rear USB port 1 (Figure 3, X39/22) and right rear USB port 2 (Figure 3, X39/23) in the third seat row must come on after the ignition is switched on!
