GROUP	MODEL
GEN	2023-2024MY Multiple Models
NUMBER	DATE
099 (Rev 2, 9/12/2024)	February 2024

### SERVICE ACTION: TIRE MOBILITY KIT INSPECTION & REPLACEMENT/REPAIR (SA556)

This bulletin provides information to inspect, and if necessary, replace the Tire Mobility Kit (TMK) sealant can or sealant can cap on certain 2023-2024MY Kia vehicles listed on page 7. Lower ambient temperatures can create a vacuum effect inside the TMK sealant can, causing the sealant can cap to open, resulting in the tire sealant leaking. Follow the procedure outlined in this publication to inspect, and if necessary, replace the sealant can or sealant can cap on the applicable vehicle. Before conducting the procedure, verify that the vehicle is included in the list of affected VINs.

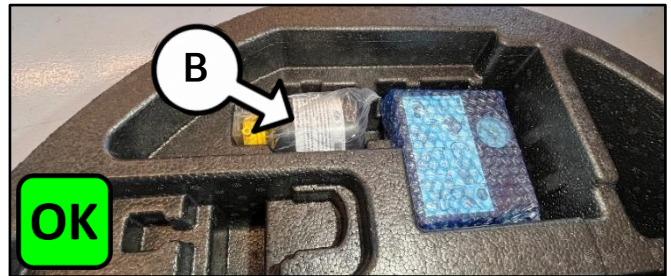
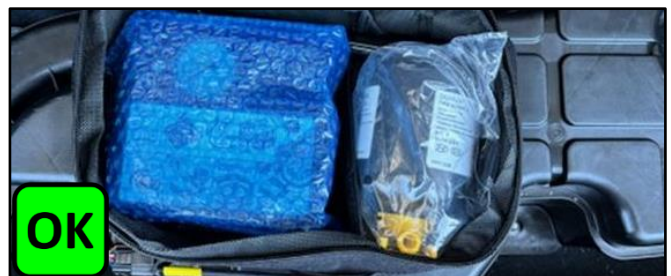
- If sealant has **not** leaked from the TMK can (B) (OK), proceed to step 4.

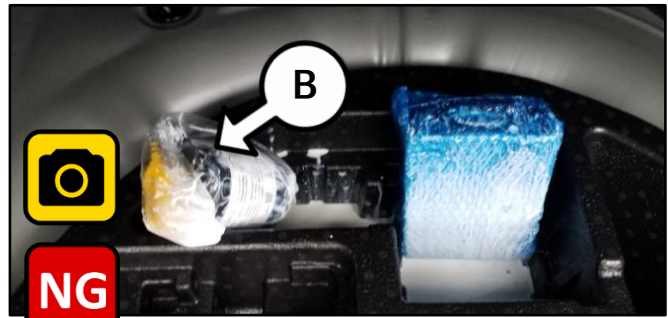
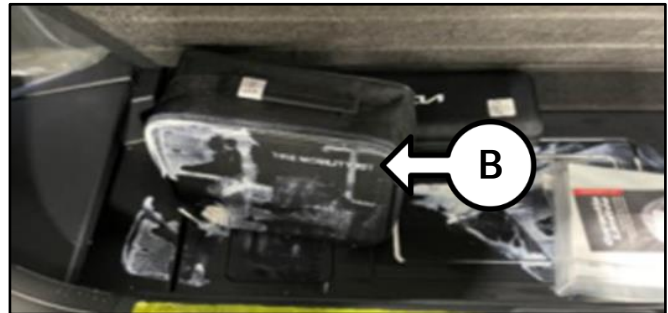
- If sealant **has** leaked from the TMK sealant can (B) (NG), replace the sealant can (B), take one (1) clear KVID photo and proceed to 'Replacement Procedure' on page 5.

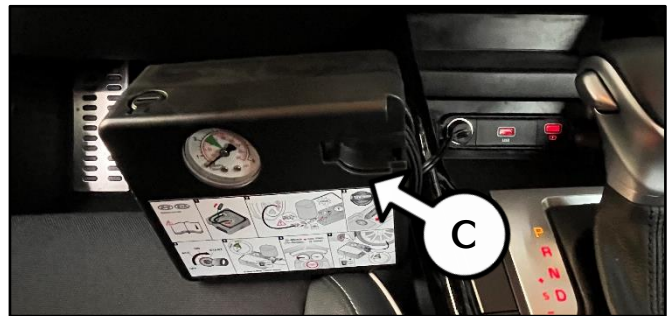
If leaked sealant has penetrated the inflator bag, test the inflator (C) for proper operation. If inflator and/or other damaged parts require replacement due to leaked sealant, follow normal warranty procedures and attach a KVID photo of the damaged component to the warranty claim.

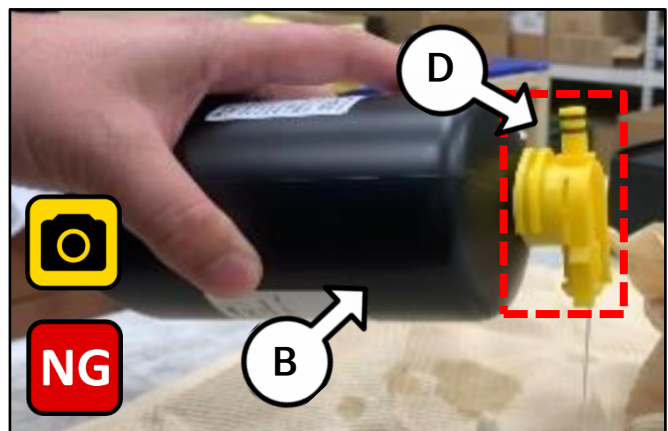
- If sealant has **not** leaked from the sealant can cap (D) (OK), proceed to the 'Repair Procedure' on page 4.
- If sealant has leaked from the sealant can cap (D) (NG), replace the sealant can (B), take one (1) clear KVID photo and proceed to 'Replacement Procedure' on page 5.

4. Remove sealant can (B) from the bag and position horizontally so the spout is facing downward.
