GROUP	MODEL
CHA	2020-2024MY Telluride (ON)
NUMBER	DATE
125	September 2024

TECHNICAL SERVICE BULLETIN

SUBJECT: SELF-LEVELING REAR SHOCK ABSORBER INSPECTION/REPLACEMENT (WTY040)

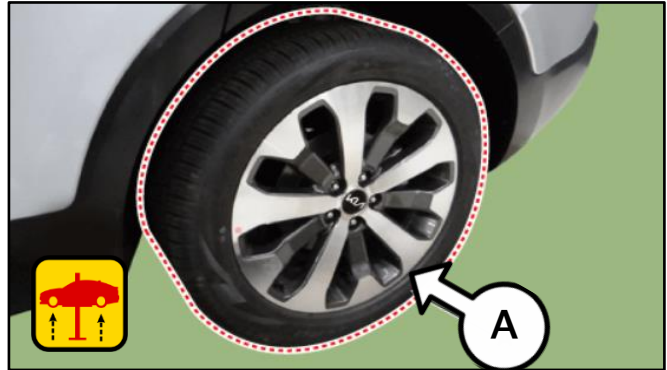
1. Raise the vehicle on a lift.
2. Remove both rear wheel/tires (A).

Tightening torque for lug nuts:
79.6 - 94 lb.ft (107.9 - 127.5 N.m)

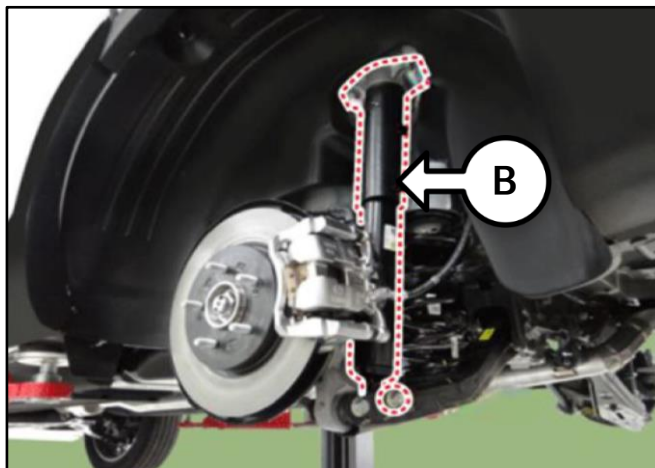
3. Remove the affected (LH and/or RH) rear shock absorber (B) by referring to "Suspension System → Rear Suspension System → Rear Shock Absorber → Repair procedures → Removal and Installation" in the applicable Shop Manual on KGIS.

Tightening torque for upper Bolts:
72.3 - 86.8 lb.ft (98.1 - 117.7 N.m)

Tightening torque for lower Bolt & Nut:
101.3 - 115.7 lb.ft (137.3 - 156.9 N.m)

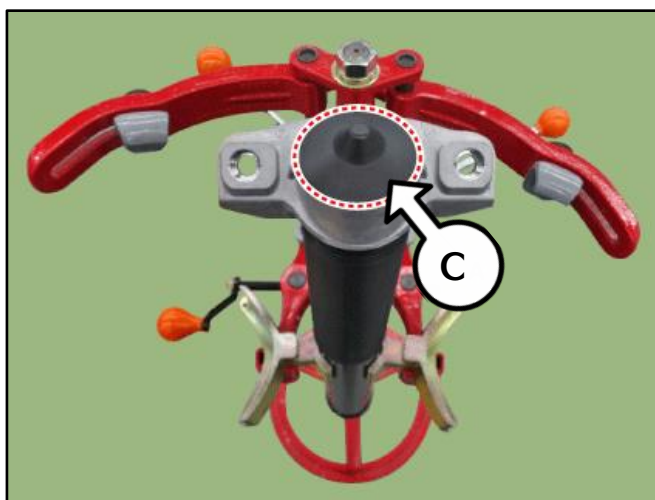
- 4a. Disassemble the affected (LH and/or RH) rear shock absorber(s) by referring to the "Suspension System → Rear Suspension System → Rear Shock Absorber → Repair procedures → Disassembly and Reassembly" chapter in the applicable Shop Manual on KGIS.
- 4b. Reassemble the (LH and/or RH) new rear shock absorber(s) in the reverse order of disassembly.

Note: Install a 'new' self-locking nut (C) when replacing the rear shock assembly. The bottom nut (D) is reusable.
