GROUP	MODEL
CLI	2021-2022MY K5 (DL3a)
NUMBER	DATE
056 (Rev 1, 9/17/2024)	August 2024

TECHNICAL SERVICE BULLETIN

HEATING, VENTILATION, AND AIR CONDITIONING (HVAC) BLOWER MOTOR FUSE RELOCATION (WTY037)

This bulletin provides information associated with the 'Warranty Extension Program' (WTY037) to inspect, and if necessary, relocate the Heating, Ventilation, and Air Conditioning (HVAC) blower motor 40-ampere fuse on certain 2021-2022MY K5 (DL3a) vehicles produced from March 27, 2020 through July 20, 2022. The HVAC system provides cooling and heating to help maintain a comfortable environment inside the vehicle. The blower motor provides primary airflow for the HVAC system. Extended use of the HVAC at high fan speeds may cause damage to the multi-fuse terminals for the HVAC blower motor circuit, which can cause the blower motor to become inoperative, resulting in reduced heat and air conditioning. The warranty coverage for repairs related to the HVAC blower motor have been extended from 5 years / 60,000 miles to 15 years / 180,000 miles, whichever comes first, starting from the date the vehicle was first put into service. Follow the procedure outlined in this publication to relocate

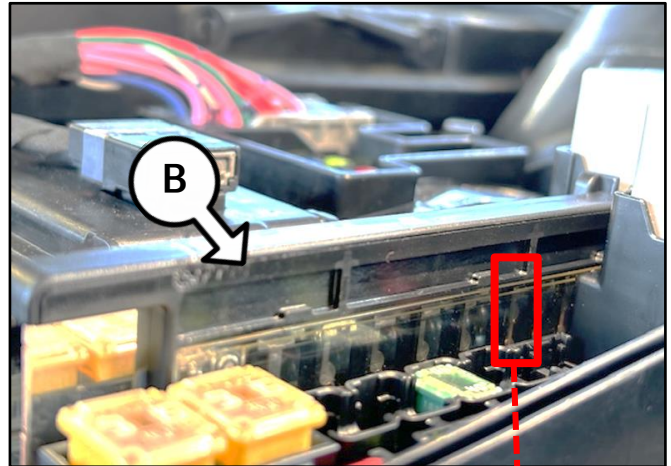
2. Using a flashlight, visually inspect if the multi-fuse (B) location #3 is blown.

- If the multi-fuse (B) location #3 is NOT blown, no further action required.
Claim inspection only labor op.
- If the multi-fuse (B) location #3 IS blown, proceed to the 'Repair Procedure' on page 3.

If the multi-fuse location #3 is blown, the multi-fuse does NOT need to be replaced.

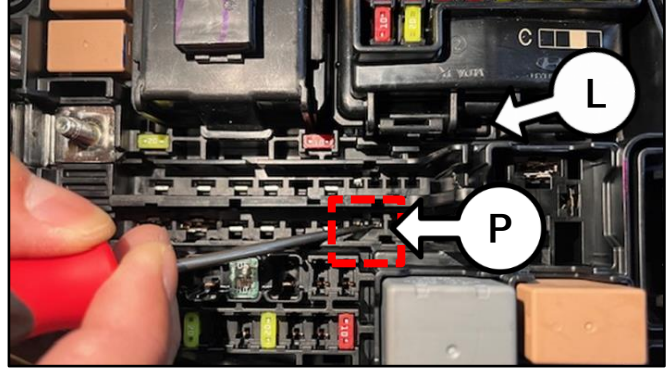
13. Using a pick/awl, disengage the wiring pin (P) release tab from the multi-fuse (K) #3 position on the junction block (L).

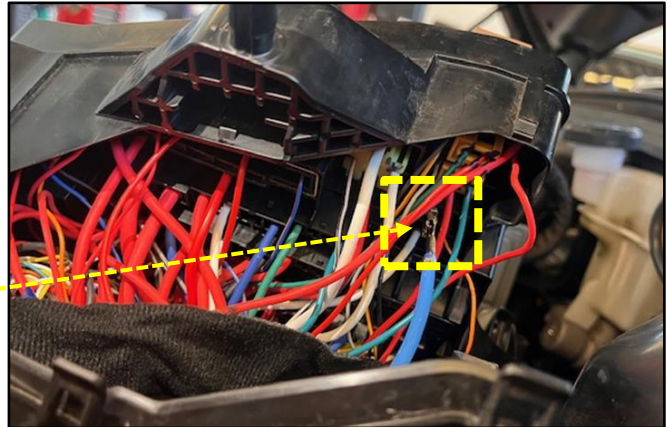
14. Install one end of the new wire in the blower motor relay (I) position on the junction block (L), as shown.

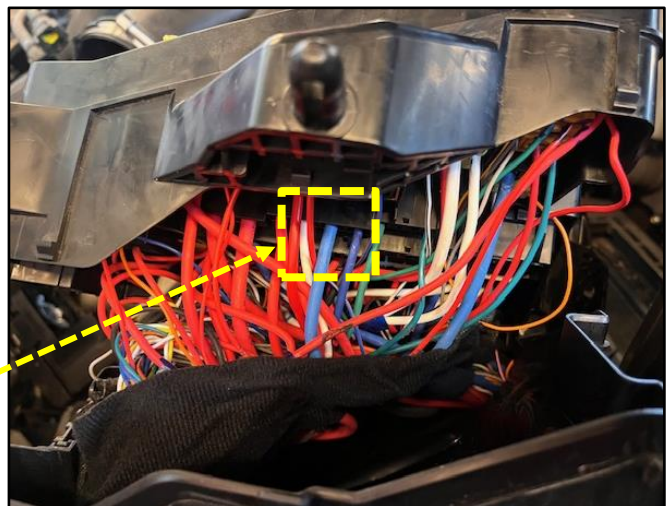
15. Insert the other end of the new wire in the multi-fuse (K) #6 position on the junction block (L), as shown.

Note: Ensure that the new wire is secured behind the fabric tape, as shown.
