TECHNICAL SERVICE BULLETIN

Classification: HA23-004B	Reference: NTB23-032B	Date: September 10, 2024
------------------------------	--------------------------	-----------------------------

HVAC BLOWER DOES NOT OPERATE ON COLD STARTS

APPLIED VEHICLES: 2021-2023 Rogue (T33)

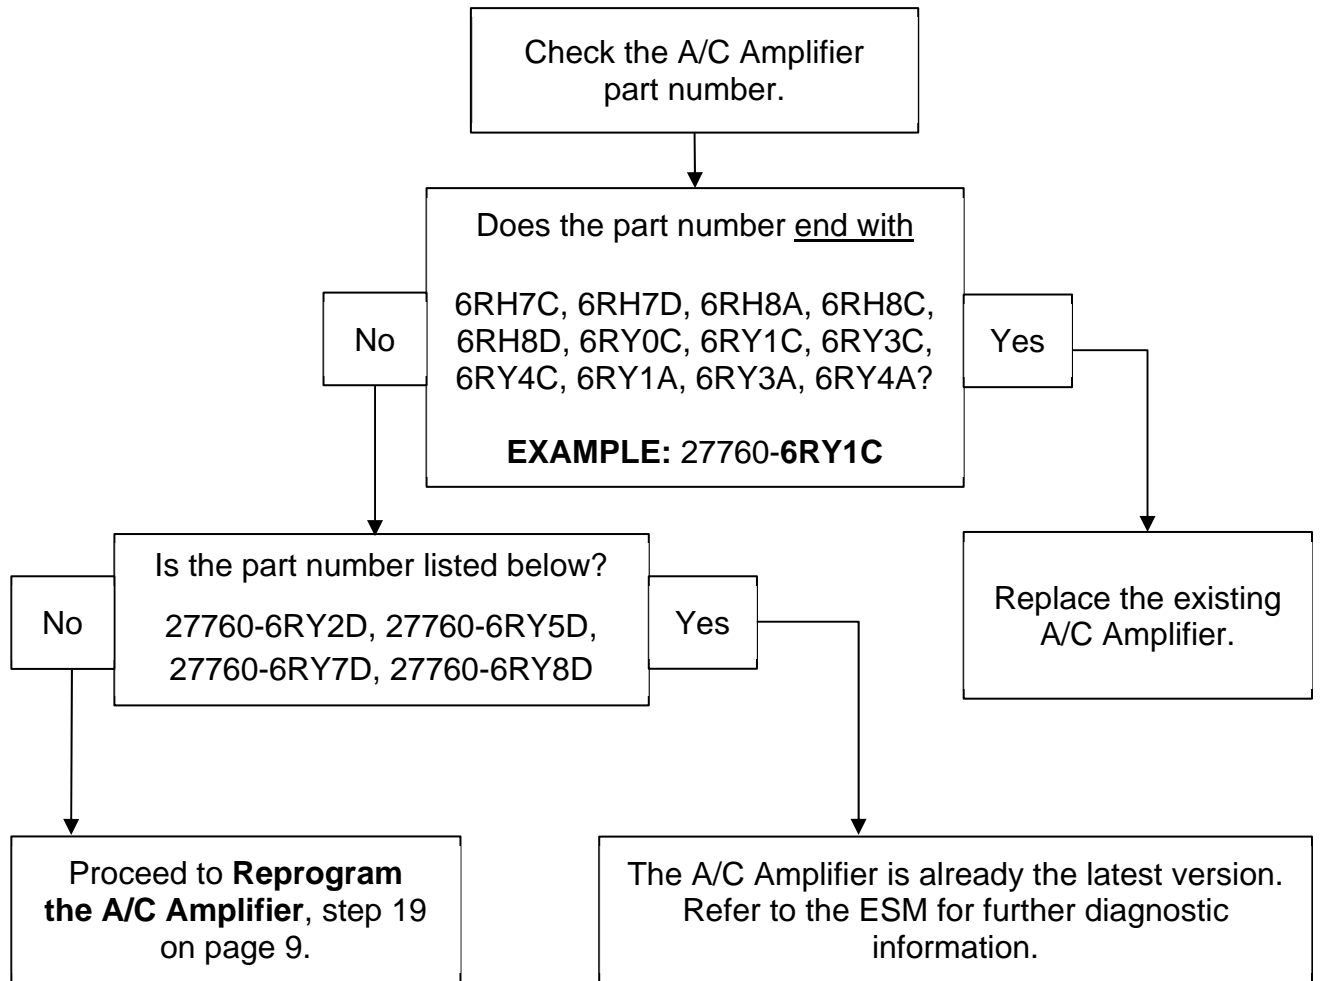
Part Number Inspection

17. Does the part number end with 6RH7C, 6RH7D, 6RH8A, 6RH8C, 6RH8D, 6RY0C, 6RY1C, 6RY3C, 6RY4C, 6RY1A, 6RY3A, or 6RY4A?

18. Is the part number 27760-6RY2D, 27760-6RY5D, 27760-6RY7D, or 27760-6RY8D?

YES: Replace the A/C Amplifier.

- Refer to the ESM: **VENTILATION, HEATER & AIR CONDITIONER > HEATER & AIR CONDITIONING CONTROL SYSTEM > AUTOMATIC AIR CONDITIONING > REMOVAL AND INSTALLATION > A/C AMP**

YES: The A/C Amplifier is already the latest version. Refer to the ESM for further diagnostic information.

NO: Proceed to step 19 on page 9 to perform **Reprogram the A/C Amplifier**.

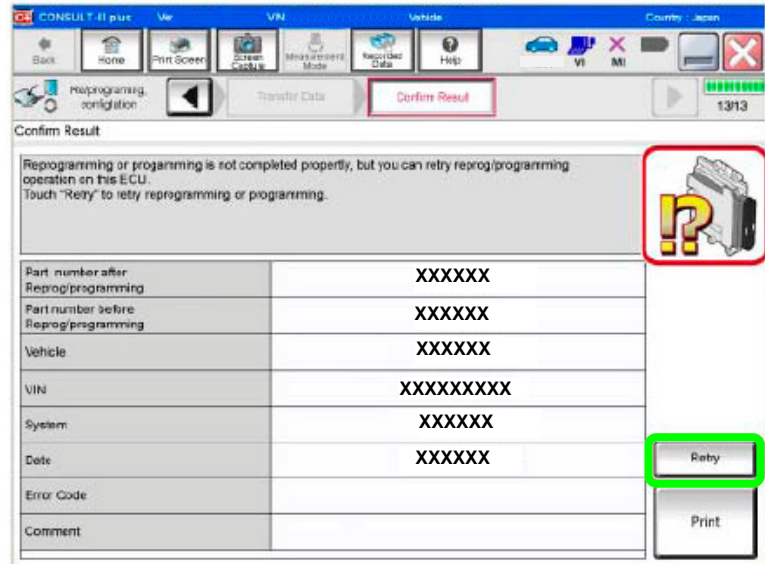
Figure 12

If reprogramming does not complete, and the “!?” icon displays as shown in Figure 12:

- Check battery voltage (12.0 V – 13.5 V).
- Ignition is ON, engine is OFF.
- External Bluetooth® devices are OFF.
- All electrical loads are OFF.
- Select retry and follow the on screen instructions.
- “Retry” may not go through on first attempt and can be selected more than once.

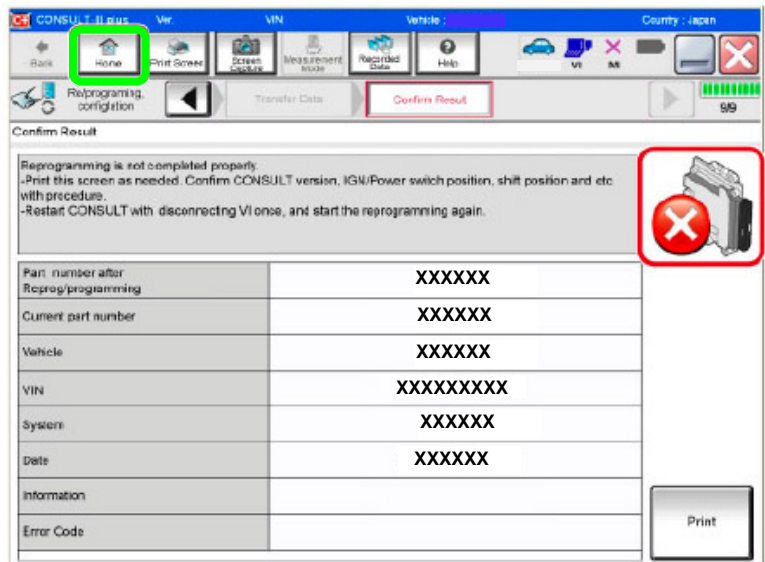
Figure 13

If reprogramming does not complete, and the “X” icon displays as shown in Figure 13:

- Check battery voltage (12.0 V – 13.5 V).
- CONSULT A/C adapter is plugged in.
- Ignition is ON, engine is OFF.
- Transmission is in Park.
- All C-III plus / VI cables are securely connected.
- All C-III plus updates are installed.
- Select Home, and restart the reprogram procedure from the beginning.
