Subject: N242436170 - Customer Satisfaction Program  
Multiple Module Reprogramming

Models: 2023 GMC HUMMER EV

# Customer Satisfaction Program

## N242436170 Multiple Module Reprogramming

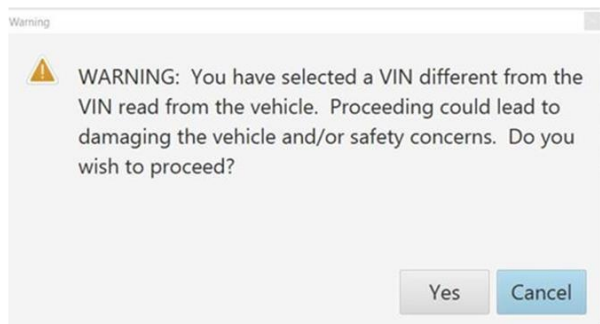
5877000

**Important:** If the vehicle VIN DOES NOT match, the message below will be shown.

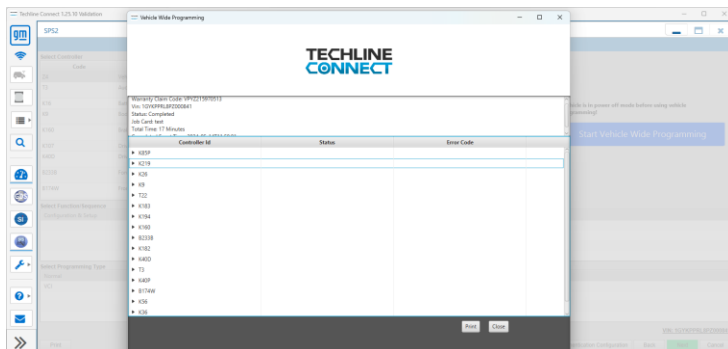
6693875

**Note:** The screenshot above is an example of Vehicle Wide Programming and may not be indicative of the specific modules that are being programmed. VIN information has been blacked out.

**Important:** To avoid warranty transaction rejections, you MUST record the Total Time provided on the Warranty Claim Code (WCC) screen shown above on the job card.

4. Print a copy of the Warranty Claim Code screen and attach to the repair order. “Status Completed” or “Status Blocked” must be achieved to close out the field action. It is also critical to record the total time in order to close out the Field Action.
