Customer Satisfaction Program

N242444180 Multiple Module Reprogramming

Release Date: September 2024

Condition	Certain 2024 model year Cadillac XT4 vehicles may require software updates that improve the customer experience and optimize future over-the-air updates.
Correction	Dealers will perform a comprehensive software update.

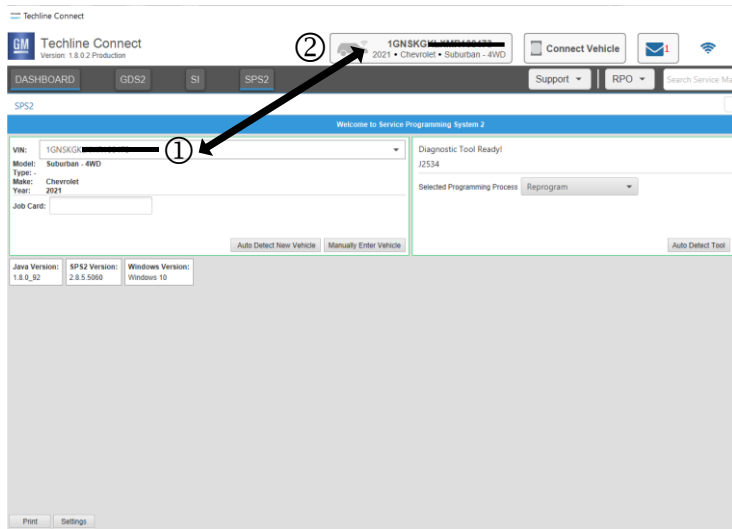
5743643

Caution: Be sure the VIN selected in the drop-down menu (1) is the same as the vehicle connected (2) before beginning programming.

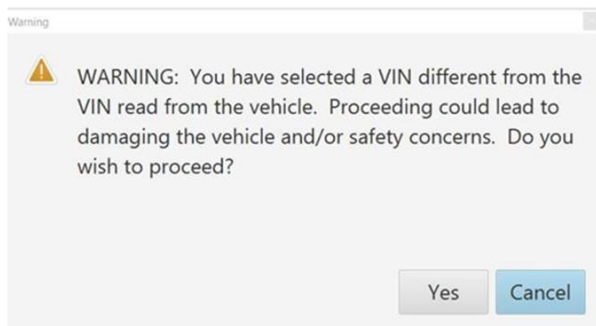
5877000

Important: If the vehicle VIN DOES NOT match, the message below will be shown.

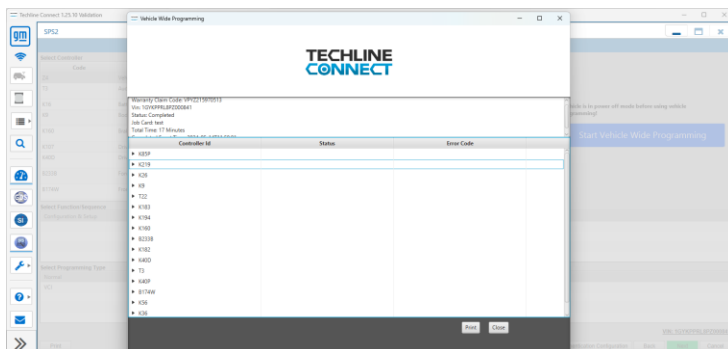
6693875

Note: The screenshot above is an example of Vehicle Wide Programming and may not be indicative of the specific modules that are being programmed. VIN information has been blacked out.

Important: To avoid warranty transaction rejections, you MUST record the Total Time provided on the Warranty Claim Code (WCC) screen shown above on the job card.

4. Print a copy of the Warranty Claim Code screen and attach to the repair order. “Status Completed” or “Status Blocked” must be achieved to close out the field action. It is also critical to record the total time in order to close out the Field Action.
