## Product Update: 2023 HR-V Rear Window Inspection

Supersedes 24-017, dated July 17, 2024, to update the parts information in **yellow**.

### BACKGROUND

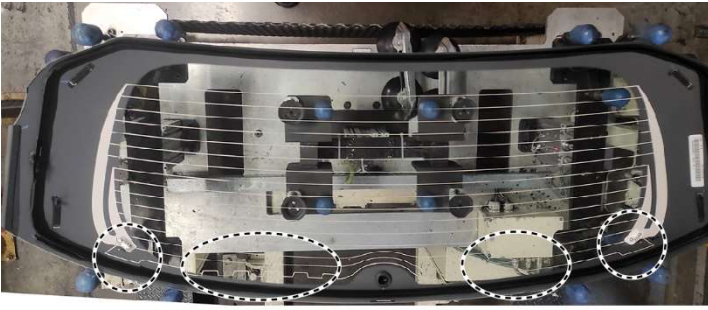
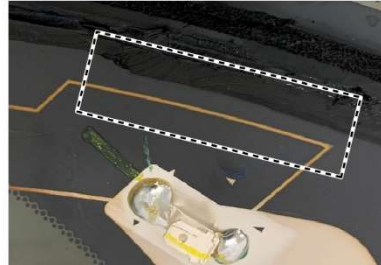
During the assembly process for some vehicles, the sealer used to secure the rear glass have contacted the defroster heating elements. This can lead to a hot-spot and the weakening of the glass over time as the defroster is used.

3. Inspect the urethane sealer for contact with the defroster grid lines.

**IMPROPER APPLICATION**

**CORRECT APPLICATION**

4. **For incorrect** urethane sealer application take a photo of the **VIN plate** and **two photos**, one of **each coupler** where the urethane contacts the defroster grid line. Then, proceed to step 4 of the REPAIR PROCEDURE.

**For correct** urethane sealer application: the inspection is complete, and no repair is required.

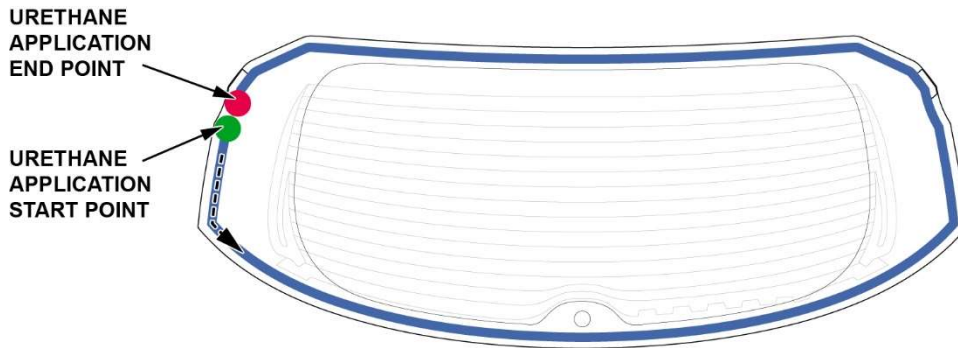
NOTE: Make sure the urethane **does not** contact the defroster grid lines.

19. Apply the urethane.

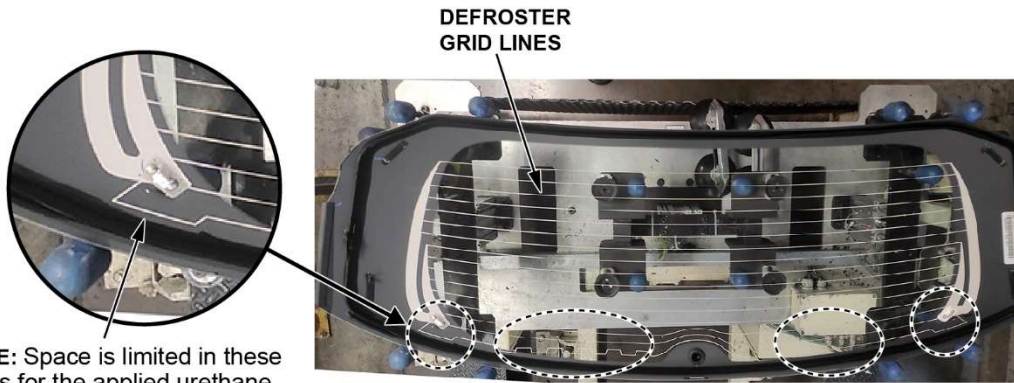
**NOTE:** Space is limited in these areas for the applied urethane, which cannot contact the defroster grid lines.

- For more information refer to the service information; enter keyword **Rear Window**, then select **Rear Window Area** from the list.
- The applied urethane cannot contact the defroster grid lines, especially at the bottom area of the glass where space is limited during installation.

20. Inspect the applied urethane.

21. Install the new window, leaving a **5 mm–6 mm** space between the urethane and defroster gridlines.
