# Service Bulletin

Bulletin No.: 24-NA-160

**Subject: Malfunction Indicator Lamp (MIL) Illuminated - DTC P0A7B and/or P0E3C Set**

Brand:	Model:	Model Year:		Build Date:		Engine:	Transmission:
		from	to	from	to		
Chevrolet	Corvette E-Ray	2024	2025	—	—	6.2L (LT2)	8-Speed Dual Clutch (MLH)

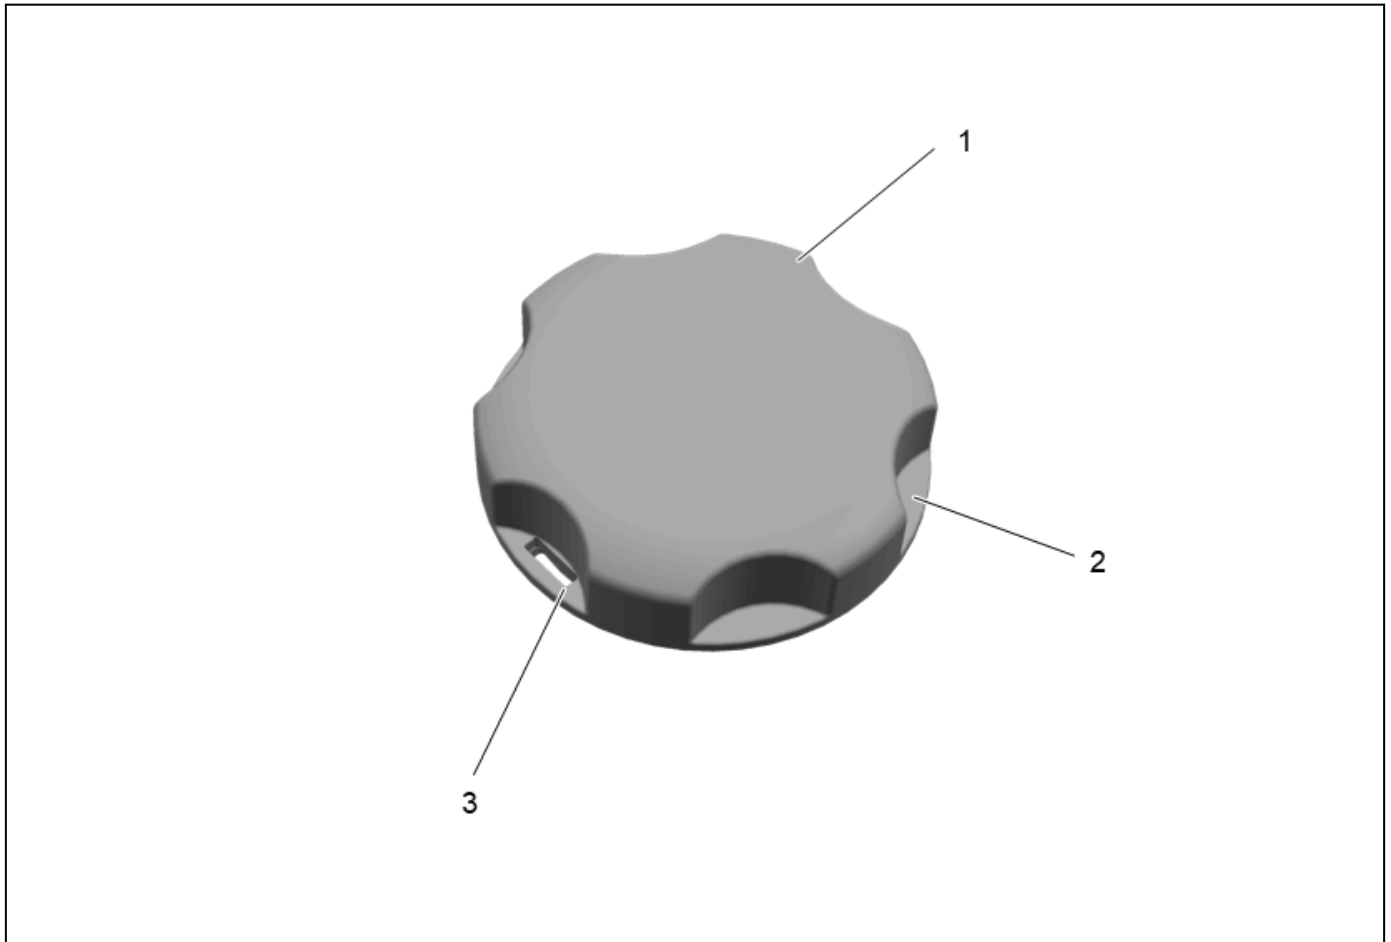
6660034

5. In the engine compartment, rotate the high voltage battery coolant (RESS) surge tank cap upper cover (1) counterclockwise to align the slot (3) in the cap cover with the slot in the cap body (2).

6. Insert a suitable flat-bladed tool into the slot, no wider than 8 mm (5/16").
7. With the cap sections engaged, rotate the high voltage battery coolant (RESS) surge tank cap counterclockwise by hand to loosen and remove.
