# Service Bulletin

Bulletin No.: PIE0794B

**Subject:** Engineering Information - (EI Lite) - (Pictures Only) Oil Leaking from Oil Pan

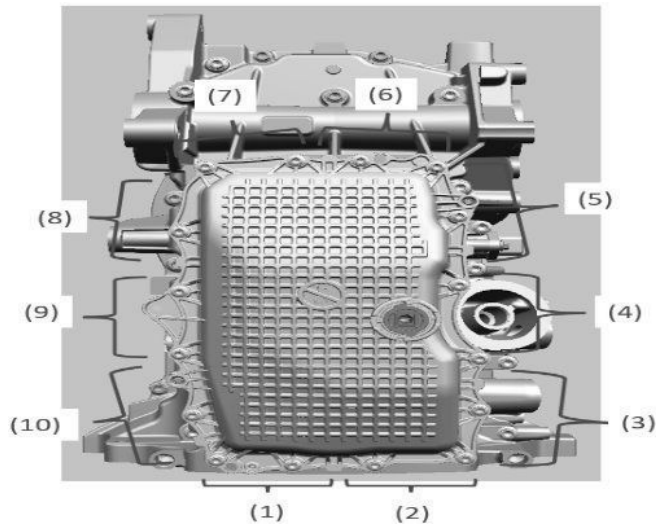
6664231

#### CT4 and CT5 Oil Pan

Make an assessment based on which leak "zone" the oil is originating from on the oil pan and take a clear picture. Circle the identified leak area on a printout or PDF of the provided oil pan call out locator.

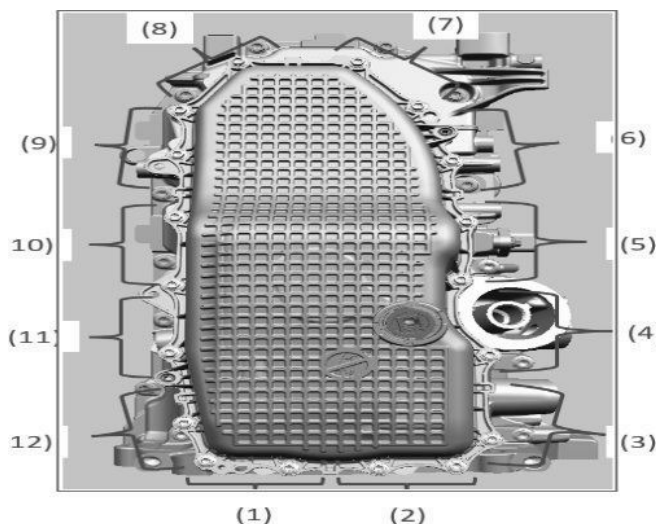
6664230

#### XT4, XT5, XT6, Blazer, and Acadia Oil Pan
