# Service Bulletin

Bulletin No.: 23-NA-086

**Subject: Information on Dark Spots Noticed in Headlamp Pattern When Vehicle is Pulled Up to a Wall or Garage**

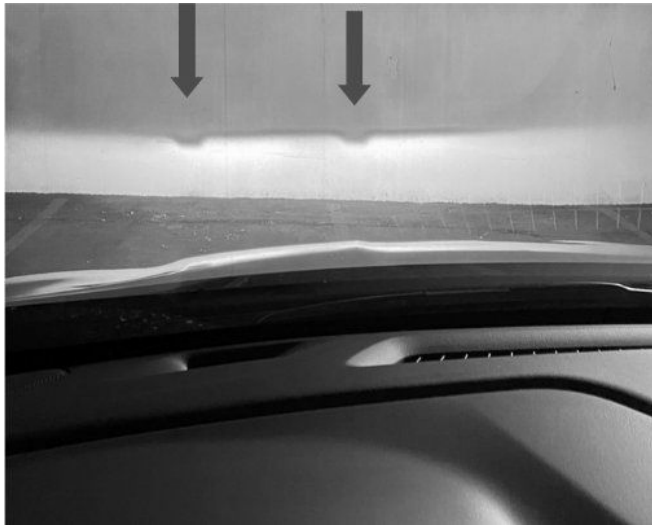
6340797

<p>Shown in the picture above is an example for Enclave, Blazer, and Traverse headlamp.</p>

<b>Cause</b>	This dark spot in the lighting pattern is <b>NORMAL</b> and part of compliance with the IIHS safety standards to minimize glare to oncoming traffic.
<b>Correction</b>	<b>DO NOT</b> replace the headlamps for this condition. This is a normal function of the lamps.

Please communicate to the customer that the headlamp system is functioning as designed and this is a normal condition of their vehicle. Please share this information with the customer, including a copy of this bulletin.

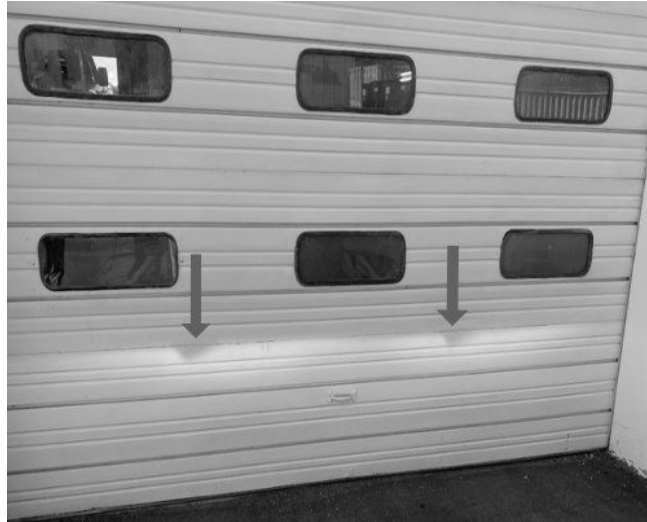
Shown in the picture above is an example for Encore, Encore GX, Envista, Trailblazer, and Trax headlamp. 6472911
