Technical Service Bulletin (TSB)
Radio Over The Air Update from
U29.44 to U33.43 Software Version (FOTA)

REFERENCE:	TSB: 08-203-24 GROUP: 08 - Electrical	Date:	September 18, 2024	REVISION:	-
VEHICLES AFFECTED:	<p>2024 (JL) Jeep Wrangler 2024 (JT) Jeep Gladiator This bulletin applies to vehicles equipped with a Global Telematics Box Module (TBM) (Sales Code RDG) and one of the following radios:</p> <ul style="list-style-type: none"> • Uconnect 5 NAV W 12.3" Display (USA) (Sales Code UBX). • Uconnect 5 W/ 12.3" Display (USA) (Sales Code UBP). • Uconnect 5 Nav W 12.3" Display (CAN) (Sales Code UEX). • Uconnect 5 W/ 12.3" Display (CAN) (Sales Code UEP). 			<p>MARKET APPLICABILITY:</p> <p><input checked="" type="checkbox"/> NA <input type="checkbox"/> MEA <input type="checkbox"/> SA <input type="checkbox"/> IAP <input type="checkbox"/> EE <input type="checkbox"/> CH</p>	
CUSTOMER SYMPTOM:	<p>Customers may experience one or more of the following:</p> <ul style="list-style-type: none"> • Unable to select the Turn by Turn Nav. • Blank performance pages. Rearview Camera (RVC) functions normally. • Android Auto® Voice Recognition (VR) inoperative. • Media Tuner delayed. • Charge schedule Hu

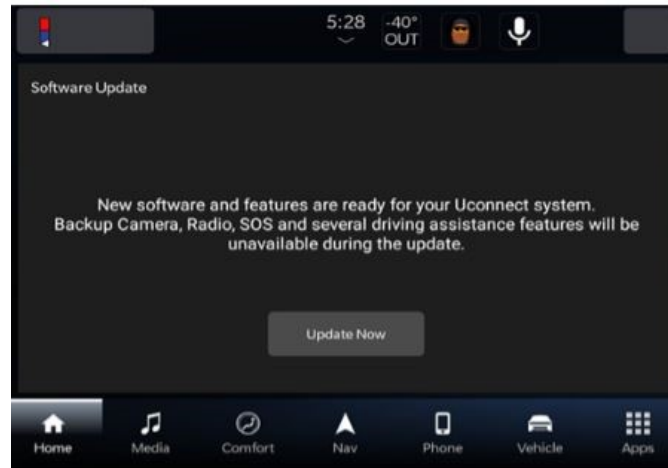
**Fig. 1**

Software Acceptance Screen

1. The vehicle needs to be in 'Park'. The ignition needs to be in the off position.
2. If the customer selects "Update Now" [Fig. 1](#) they can shut off the vehicle and leave. The update will be completed automatically.

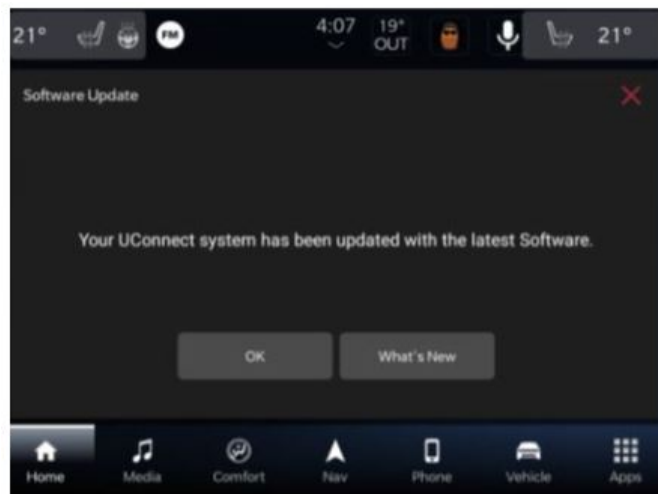
**Fig. 2**

3. Upon completion of update, the radio will display a confirmation message [Fig. 2](#).

Software Update Confirmation Screen
