Technical Service Bulletin (TSB)
R1H Radio Software USB Update to U31.42

REFERENCE:	TSB: 08-206-24 GROUP: 08 - Electrical	Date:	September 21, 2024	REVISION:	—
VEHICLES AFFECTED:	2024 (VF) RAM ProMaster This bulletin applies to vehicles built on and before July 01, 2024 (MDH 0701XX) equipped with a Uconnect 5 W 10.1” Display (Sales Codes UBN, UEN or UFN).			MARKET APPLICABILITY: <div><input checked="" type="checkbox"/> NA<input type="checkbox"/> MEA</div> <div><input type="checkbox"/> SA<input type="checkbox"/> IAP</div> <div><input type="checkbox"/> EE<input type="checkbox"/> CH</div>	
CUSTOMER SYMPTOM:	The following software enhancements are available: <ul style="list-style-type: none">Improvements to CarPlay®, Android Auto® and navigation media screen.				
CAUSE:	Radio software

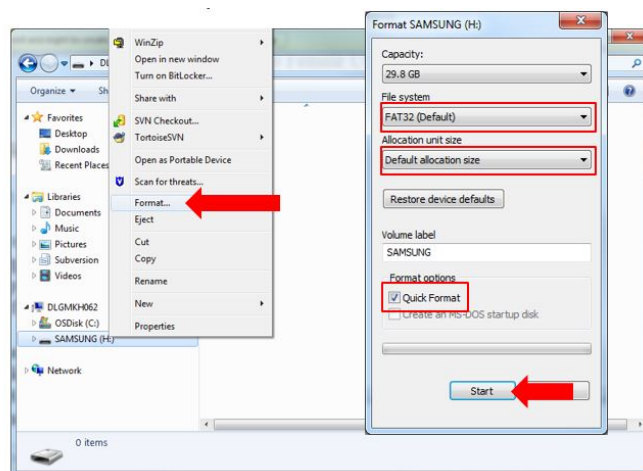
Fig. 1

Formatting The USB Flash Drive

1. Check if the radio software has been updated. Go to “Vehicle Settings” then select "System Information" and look for “Radio Version”.
2. Was the radio software at or above U31.42?
 - YES >>> This bulletin does not apply.
 - NO >>> Proceed to [Step 3](#).
3. Has a **4 GB** USB flash drive been created?
 - YES >>> Proceed to [Step 13](#).
 - NO >>> Proceed to [Step 4](#).
4. Perform the following steps to format the USB flash drive [Fig. 1](#).
 - Select “NTFS” format.
 - Select “Default allocation size” under Allocation Unit Size.
 - Select “Quick Format” under Format Options.
 - Click “Start”.

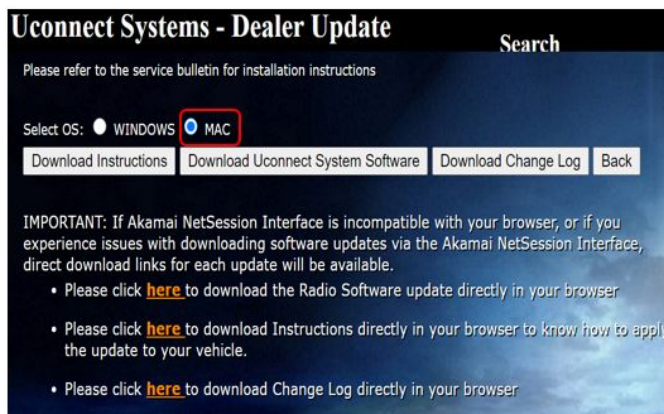
Fig. 2

MAC Download Steps

7. Download the software update file to your local PC's desktop. Make sure to select the "MAC" radial button for all downloads [Fig. 2](#).

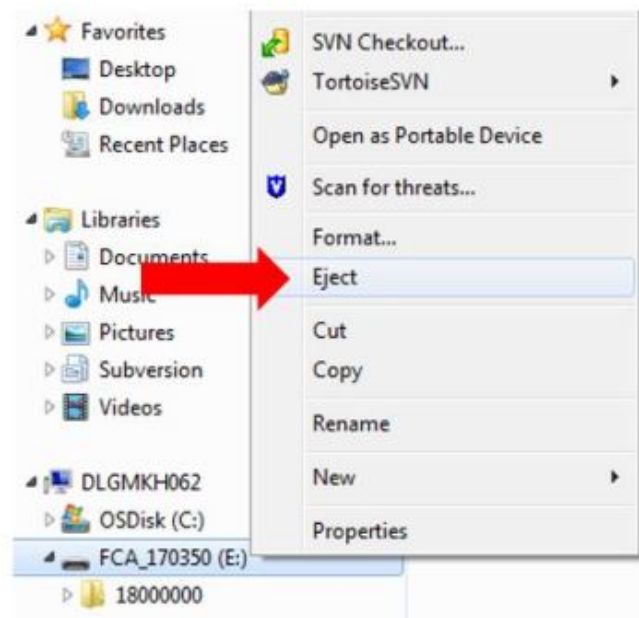
**Fig. 3**

Ejecting The USB Flash Drive

11. Perform the following steps to properly eject the USB flash drive [Fig. 3](#):
 - a. Right click on the location of the USB flash drive.
 - b. Click "Eject" to avoid data corruption.
 - c. Remove the USB flash drive from the PC.

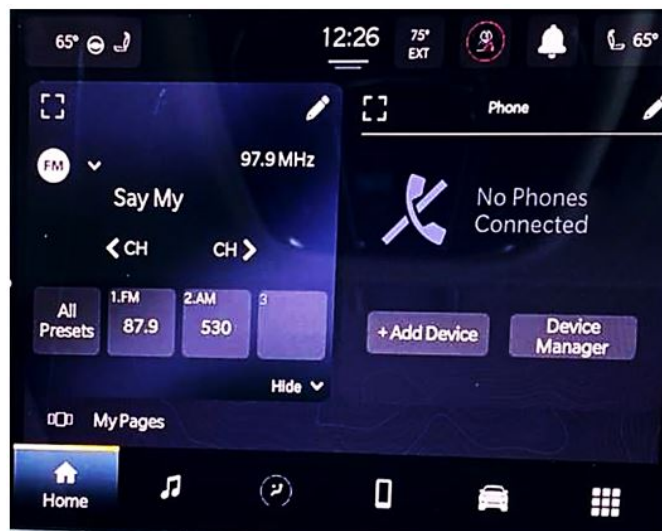
**Fig. 4**

Home Screen

14. Start the vehicle and insert the USB flash drive into the USB port.
15. Vehicle must be out of "Ship Mode". Starting at the radio 'Home' screen [Fig. 4](#).

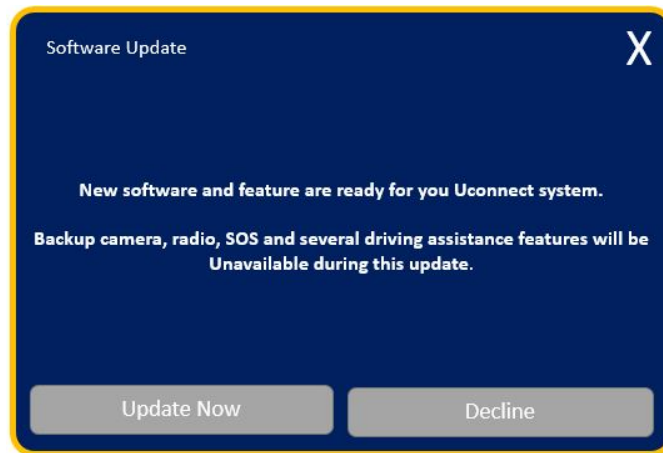
Fig. 5
Software Update Screen

16. The radio will prompt you if you want to update to the newest software version [Fig. 5](#).

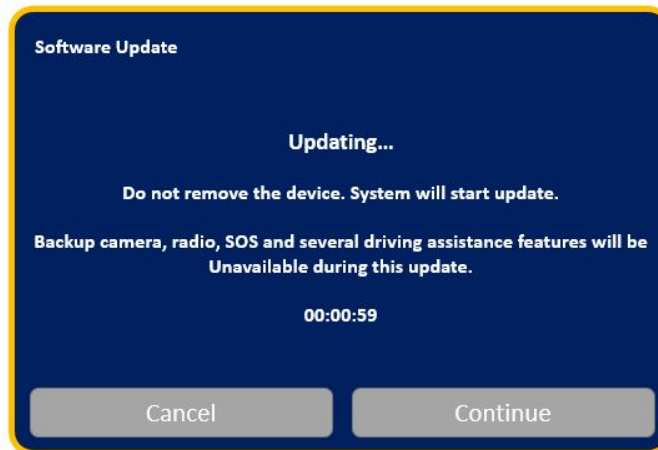
Fig. 6
Software Updating Screen

18. The radio will prompt you if you want to continue updating to the newer software [Fig. 6](#).

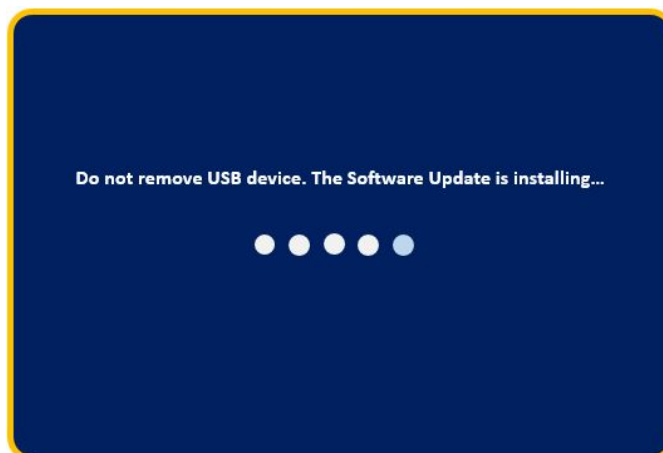
Fig. 7
Installing Update Screen

19. Select "Continue" [Fig. 7](#).

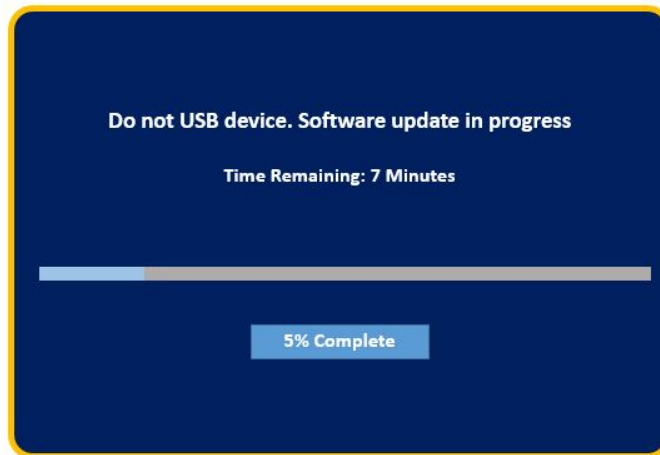
Fig. 8

Update In Progress Screen

20. The update will take approximately 15-20 minutes [Fig. 8](#).

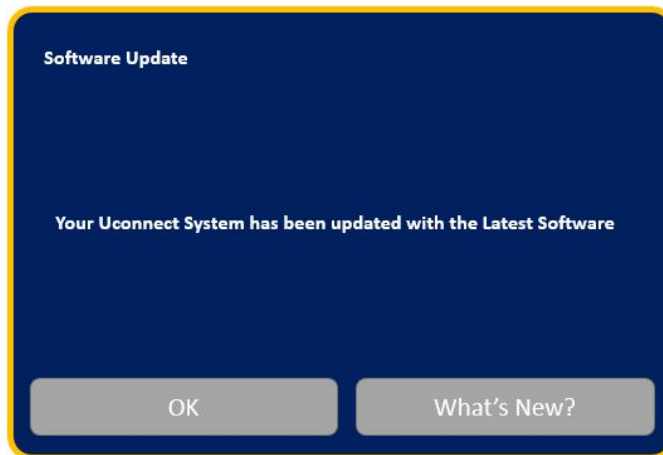
Fig. 9

Software Updated Screen

21. The radio will reboot and you will observe the update screen after the splash screen once the update has been successful [Fig. 9](#).

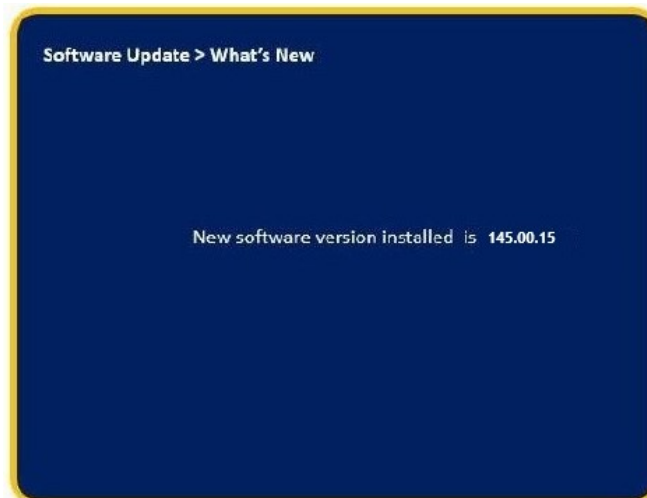
Fig. 10

What's New Screen

22. Select "What's new" to confirm the software has been updated to U31.42 [Fig. 10](#).
