## **G-FACELIFT 2018: White Stains In Magno Night Black Paintwork On Hood**

Topic number	LI98.00-P-078306
Version	1
Function group	98.00 - General
Date	9/20/24
Validity	Model 463 as of model year 2019 with code 056U Magno night black
Reason for change

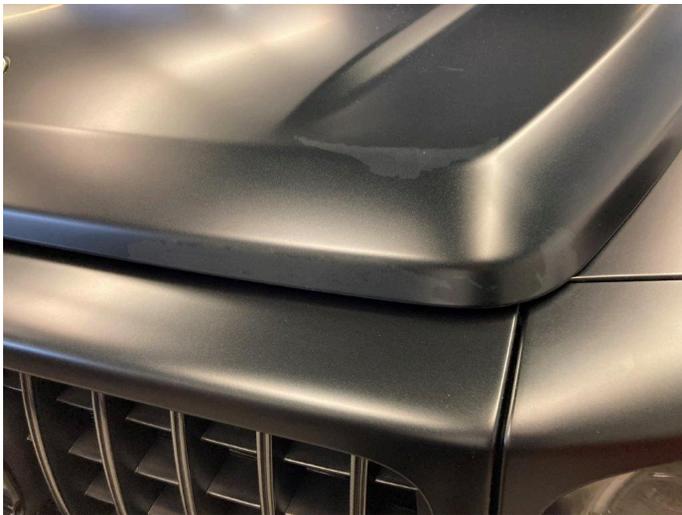
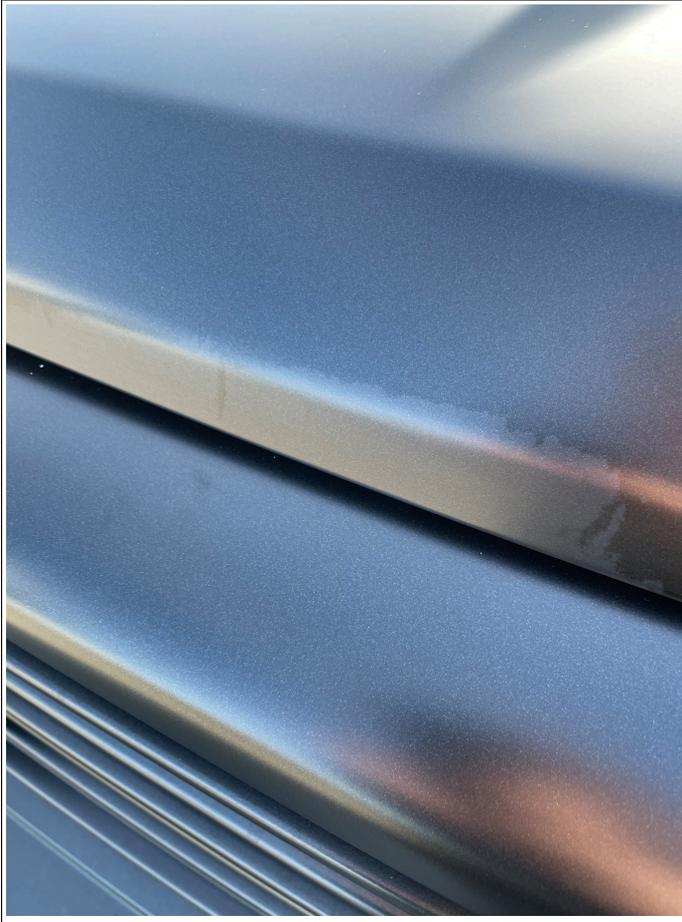
When unpacking vehicles with magno night black paint (code 056U) from the full transportation packaging, the paintwork may exhibit white stains/shades on the hood. These are mainly present on the hood, fenders and the bumpers.

Carefully heat any prominent areas using a heat gun (up-to 900°F, at distance of approx. 3-5 inches), it may be necessary to repeat this process several times. Use a maximum of 120 °C for component parts made of plastic, such as bumpers.

If this method does not provide a remedy, the paint structure is irreversibly damaged and not repairable. In such instances, the component part must be repainted.

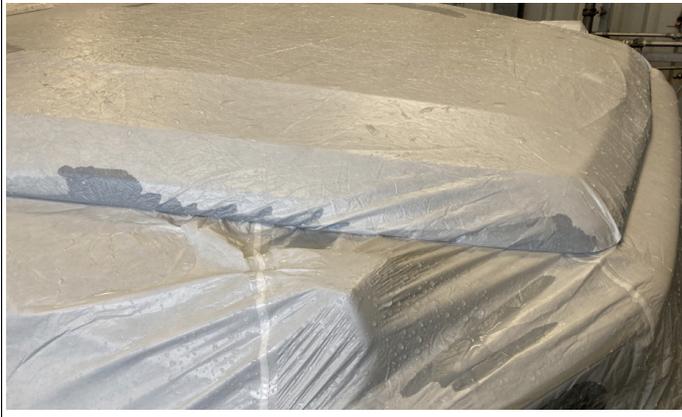
Moisture ingress under the full transportation packaging can lead to it penetrating the fresh paint thereby causing it to swell up. Easily visible, white stains/shades on the paint surface would be the consequence.
