## A26/17 - MBUX multimedia system (Head unit) NTG7 - Radio function is not available

Topic number	LI82.60-P-077495
Version	3
Function group	82.60 - Radio, audio, video systems
Date	9/19/24
Validity	NTG7*2 model series 118, 167, 177 and 247 with SA code 521, 525, 534 with software release E329.5 or E330.6
Reason for change	Validity extended to include model series 254

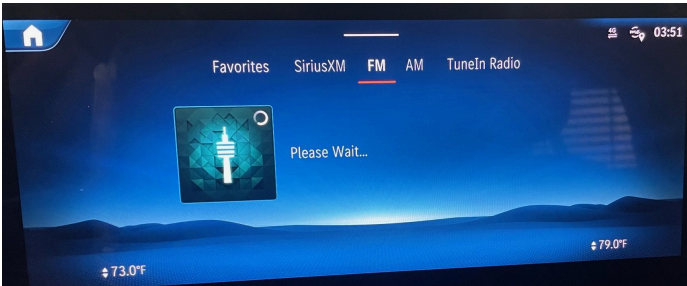
Attachments	
File	Description
LI82.60-P-077495.jpg	Radio screen loading

After clicking on the "Radio" selection function, the radio does not start and instead a permanent loading wheel is displayed. See attached picture for example.

Software version

A26/17 - MBUX multimedia system (Head unit) unit must be replaced. When the head unit is in this condition, a software update will not remedy the situation.
