# Service Bulletin

Bulletin No.: 24-NA-158

**Subject: Malfunction Indicator Lamp Illuminated with Active DTC P0102 and Possibly U060F and U1346 at the Mass Air Flow Sensor**

Brand:	Model:	Model Year:		VIN:		Engine:	Transmission :
		from	to	from	to		
Cadillac	Escalade Models	2023	2024	-	-	L87 or L84	All
Chevrolet	Suburban						
	Tahoe						
GMC	Yukon Models

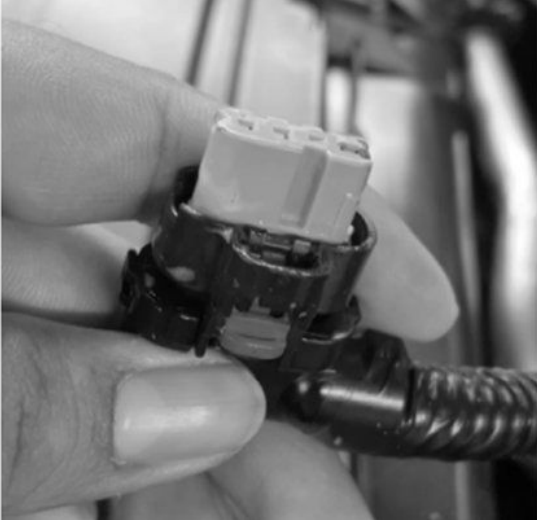
6719228

<b>Involved Region or Country</b>	North America
<b>Additional Options (RPOs)</b>	Equipped with Gas Engine 8-Cyl (RPO L84 or L87)
<b>Condition</b>	Some customers may comment on a malfunction indicator lamp illuminated. During diagnosis a technician may find an Active DTC P0102 and possibly U060F and U1346 at the Mass Air Flow Sensor.
<b>Cause</b>	The cause of the condition may be water infiltration in the MAF (Mass Air Flow) connector during assembly.
<b>Correction</b>	Complete the procedure below to correct the condition.

Replace the MAF sensor and MAF sensor connector with a service connector.

Refer to *Mass Airflow Sensor Replacement* in SI.

**Note:** Be sure to reuse the MAF sensor connector dress cover when completing the repair.
