# Service Bulletin

Bulletin No.: 24-NA-170

**Subject: Check Engine Lamp Illuminated with HVAC Related DTC**

Brand:	Model:	Model Year:		VIN:		Engine:	Transmission:
		from	to	from	to		
Chevrolet	Colorado	2024	2024	—	—	—	—
GMC	Canyon	2024	2024	—	—	—	—

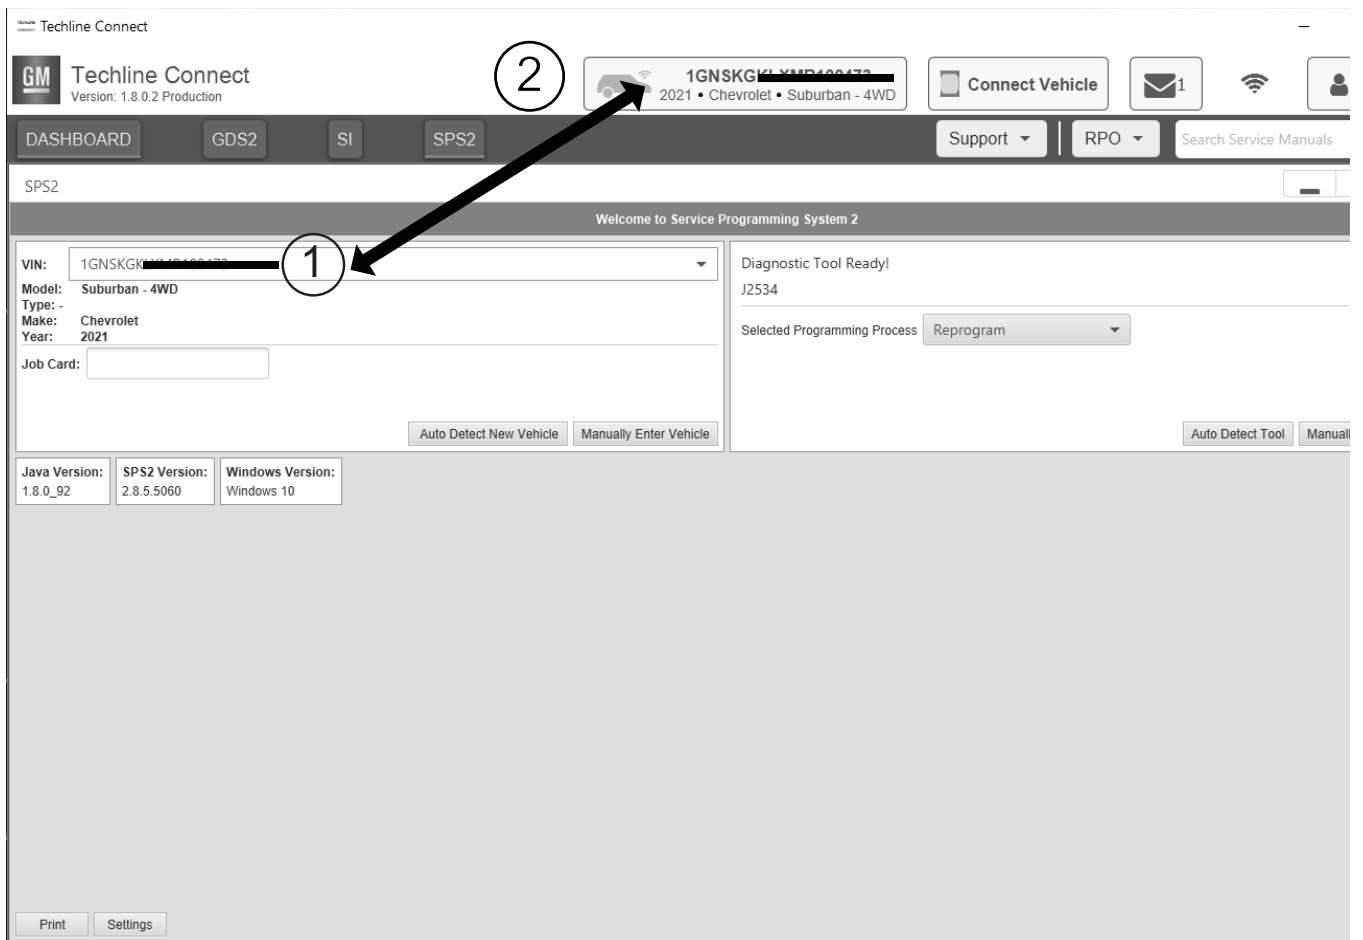
5743643

**Caution:** Be sure the VIN selected in the drop down menu (1) is the same as the vehicle connected (2) before beginning programming.

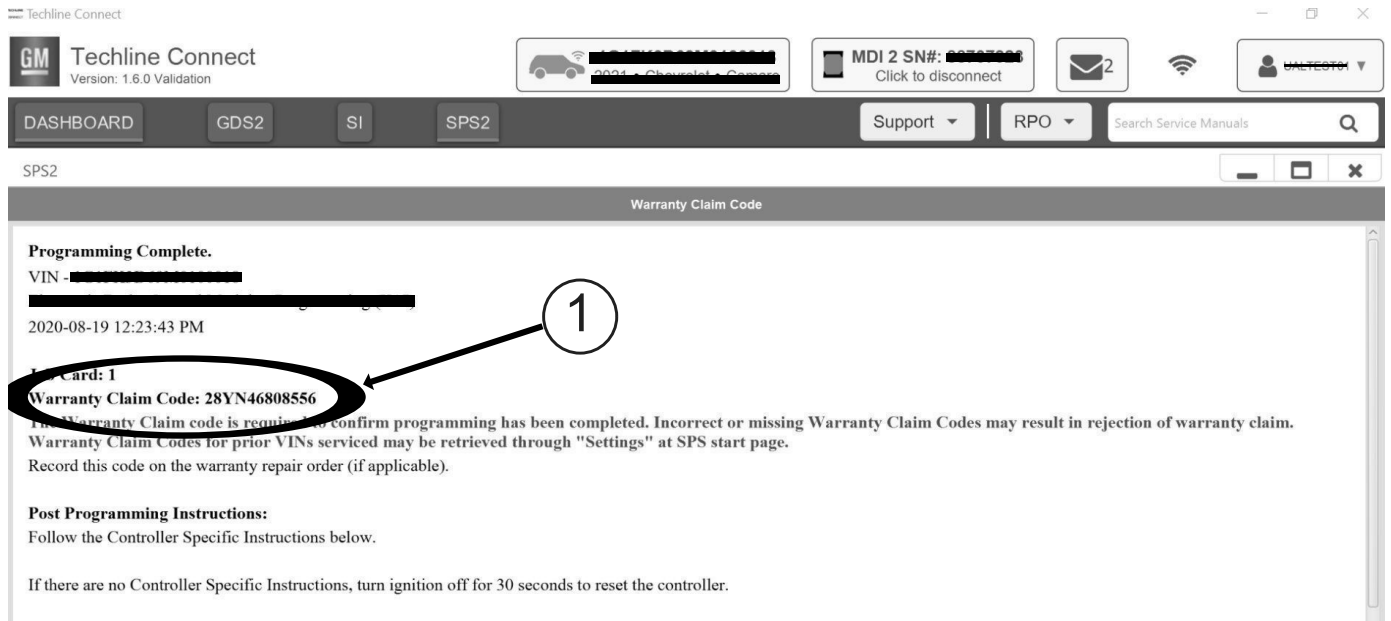
5644478

**Important:** To avoid warranty transaction rejections, you **MUST** record the warranty claim code provided on the Warranty Claim Code (WCC) screen shown above on the job card. Refer to callout 1 above for the location of the WCC on the screen.

2. Record the SPS Warranty Claim Code on the job card for warranty transaction submission.
