**HYUNDAI**
Technical Service Bulletin

GROUP CAMPAIGN	NUMBER 24-01-064H
DATE AUGUST 2024	MODEL(S) IONIQ 5 N (NE N)

SUBJECT: IEB SOFTWARE UPDATE FOR IMPROVED ELECTRONIC BRAKE FORCE DISTRIBUTION (EBD) OPERATION (SERVICE CAMPAIGN 9B7)

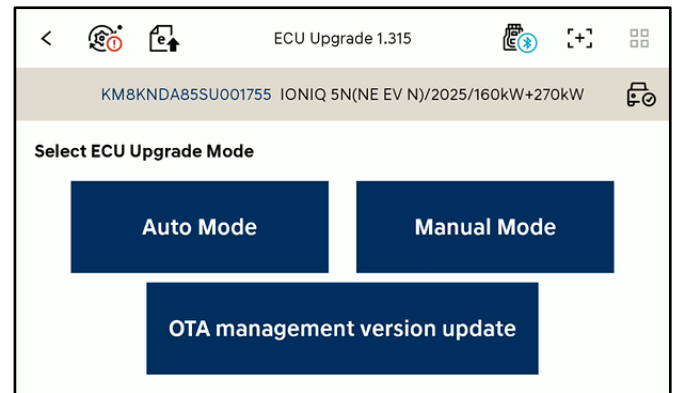
Use the **ID Check** to verify the ROM ID before updating the software.

1. Perform the ECU update in **Auto Mode**.

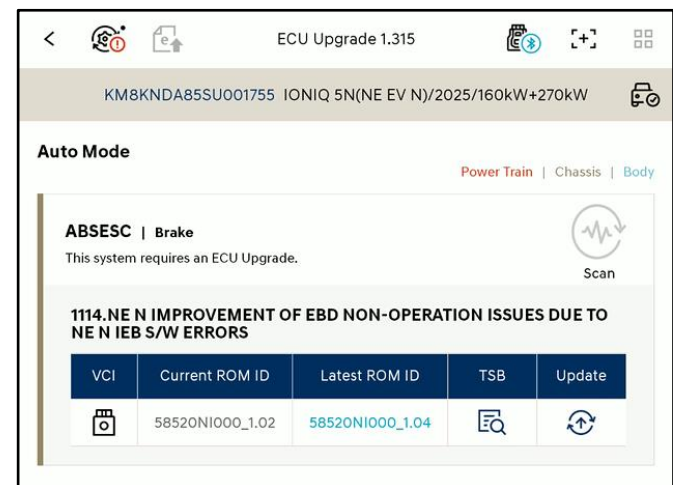
Check the current ROM ID version and compare it to the ROM ID Information table before attempting to perform the software update.

2. Select the **ABS/ECU** system to scan the vehicle’s current ROM ID.

If the upgrade fails, please remove the power connector or the battery (-) connector from the indoor fuse box for at least 5 seconds and reassemble it to retry the upgrade.
