Technical Service Bulletin

GROUP CAMPAIGN	NUMBER 24-01-077H
DATE SEPTEMBER 2024	MODEL(S) KONA (SX2)

SUBJECT: FRONT CAMERA SOFTWARE UPDATE FOR FCA & LKA LOGIC IMPROVEMENT (SERVICE CAMPAIGN TCF)

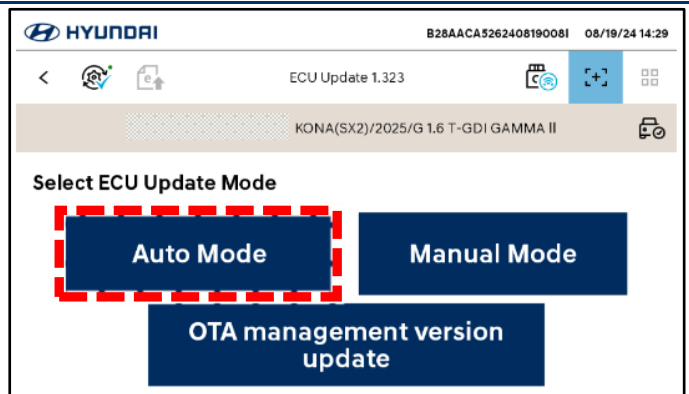
- Select the **FR_CM** system to scan the vehicle's current ROM ID.

1. Perform the ECU update in **Auto Mode**.

Use the **ID Check** to verify the ROM ID before updating the software.
