Technical Information

Date: **July 23, 2024**

Subject: **Ignition switch wire relocation**

Product: **LXP 950 Orioli \ Enduro Veloce**
All affected VINs are linked in Dealer.net

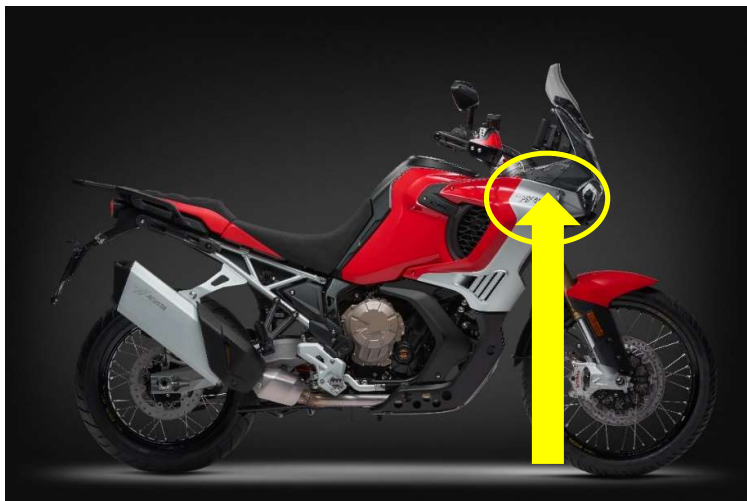
- Locate the wiring coming out of the vehicle's ignition switch on the right side of the motorcycle in the steering head area:

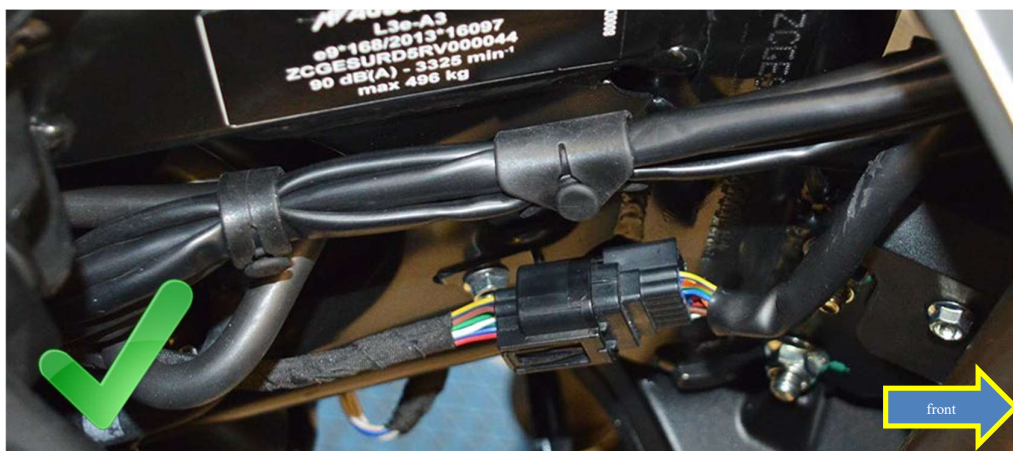
- Check the wiring layout; the cable must have the routing as shown in the picture:

- **If the wiring is already in the position shown in the photo, no action will be necessary.**
- **In the case that there are other routings or positioning of the wiring different from the layout shown in the picture, it will be necessary to reposition it according to the procedure indicated in the next points reported.**
