344 MV
n°

Technical Information

Subject: Crankcase screw replacement

Product: LXP 950 Orioli \ Enduro Veloce
All affected VINs are linked in Dealer.net

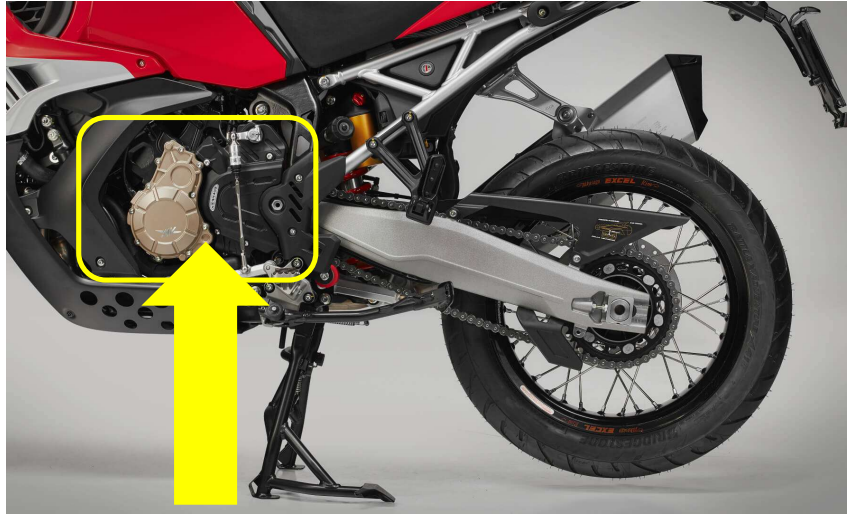
- The operations will be carried out on the crankcase closing screw accessible from the left side of the vehicle:

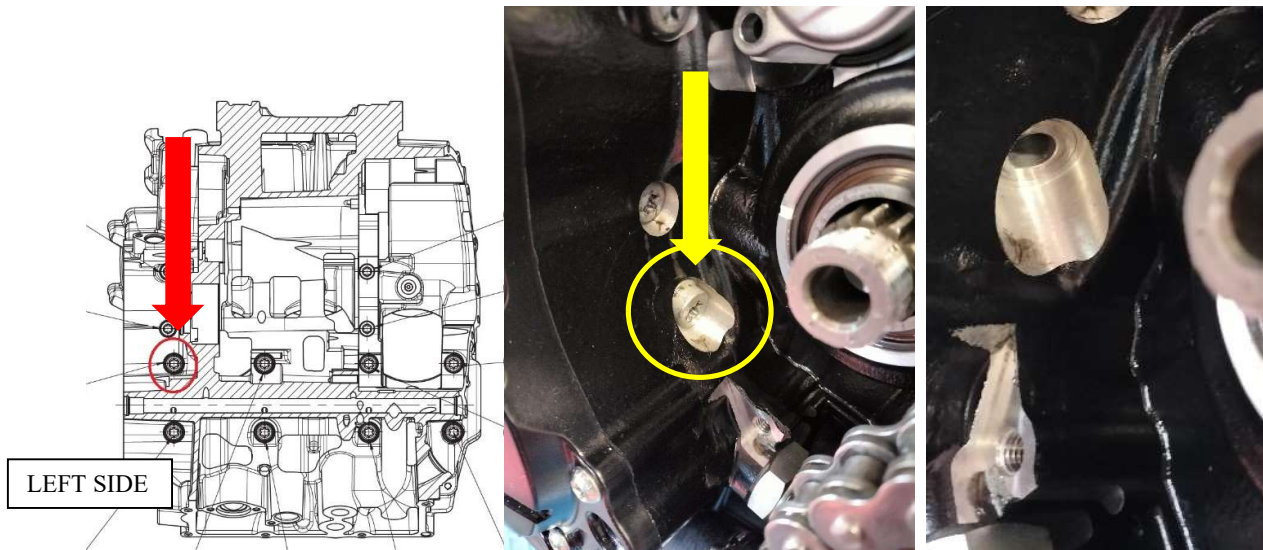
Following continuous monitoring of the quality of our product, it has been found that on the abovementioned vehicles it is necessary to replace one of the crankcase's closing screws.

- Locate the crankcase closing screw and clean accurately the screw's seat and all the area around the screw.
- Remove using a torx 45 insert; **the removed screw must NOT be reused.**
