345 MV
n°

Technical Information

Subject: **Retention strip addition**

Product: **LXP 950 Orioli \ Enduro Veloce**
All affected VINs are linked in Dealer.net

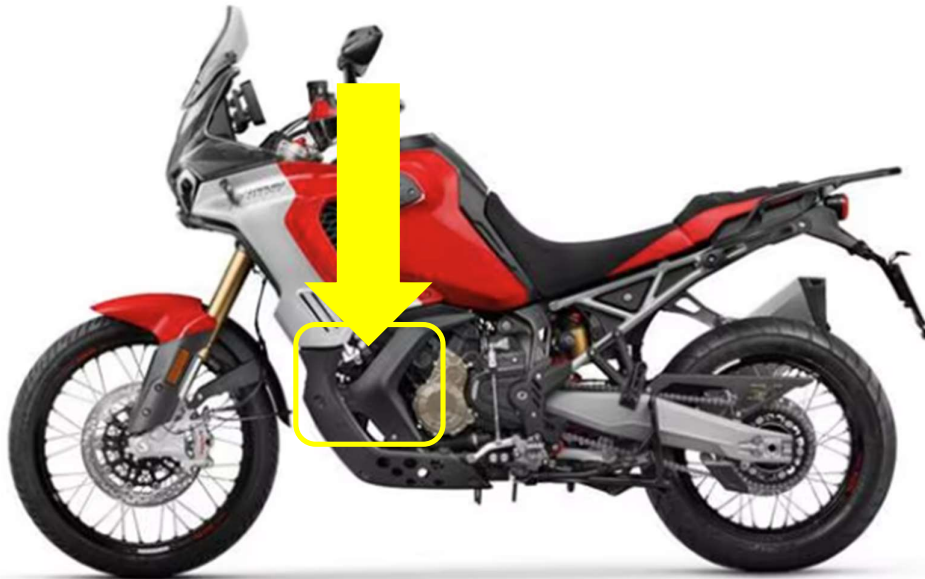
- The operations will be carried out on the left side of the motorbike in the area of the pump radiator hose:

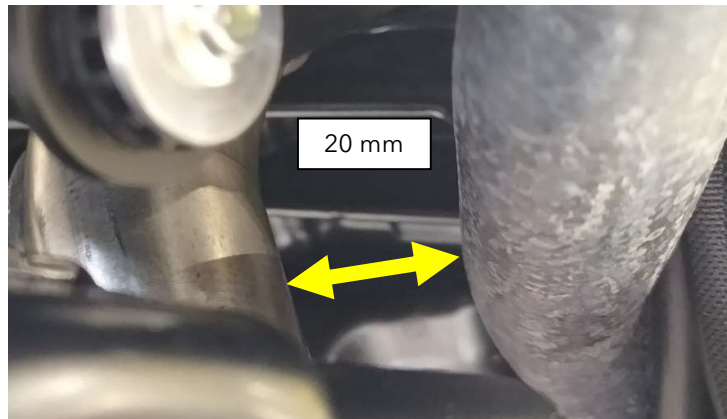
Following continuous monitoring of the quality of our product, it has been found that on the vehicles mentioned above it is necessary to add a retention strip on the water hose to ensure the correct distance of the same from the exhaust manifold in every situation.

- Check that there is a **minimum distance of 20 mm** between the exhaust manifold n°1 and the pipe code. SPMV8000D1694:
