GROUP	MODEL
FUE	2017-2021MY Multiple Models 3.3L GDI Lambda II
NUMBER	DATE
067 (Rev 1, 9/20/2024)	May 2024

TECHNICAL SERVICE BULLETIN

HIGH-PRESSURE FUEL PUMP REPLACEMENT

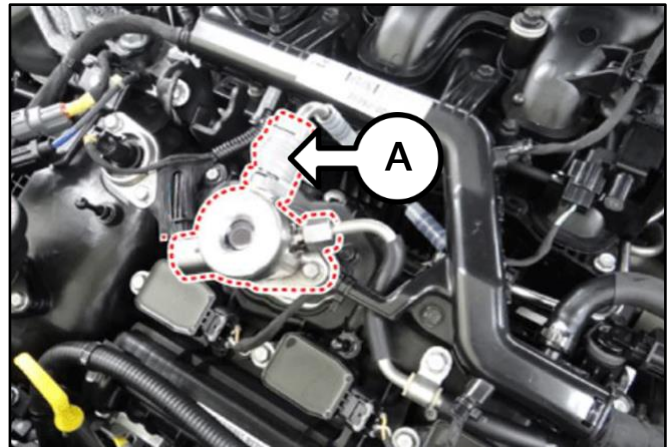
The fuel control valve (FCV) plunger in the vehicle's high-pressure fuel pump may wear unevenly, and, over time, become stuck in the open position. If this condition occurs, the customer may experience rough running, engine hesitation, and/or illumination of the MIL. In rare cases, the engine may shut off while the vehicle is at a stop, although it can be immediately restarted (after shifting into Neutral or Park). The warranty coverage for repairs related to the high-pressure fuel pump will be extended from 5 years / 60,000 miles to 15 years / 180,000 miles, whichever comes first, starting from the date the vehicle was first put into service. Follow the procedure outlined in this publication to inspect the vehicle and check for DTC P0088 and, if necessary, replace the high-pressure fuel pump and related parts on the applicable vehicle.

2. Release the residual pressure in the fuel line by referring to “Engine Control / Fuel System → Fuel Delivery System → Release Residual Pressure in Fuel Line” in the applicable Shop Manual on KGIS.
3. Replace the High-Pressure Fuel Pump (HPFP) (A) by referring to “Engine Control / Fuel System → Fuel Delivery System → High Pressure Fuel Pump → Repair procedures” in the applicable Shop Manual on KGIS.

Tightening torque for bolts:
9.4 - 10.9 lb.ft (12.8 - 14.7 N.m)

Note: DO NOT reuse HPFP bolts or high-pressure fuel pipe. Refer to [VIDO20](#) for HPFP and Line Installation.
