2020-2024MY
Telluride (ON)

125 (Rev 1, 09/20/2024)

TECHNICAL SERVICE BULLETIN

SELF-LEVELING REAR SHOCK ABSORBER
INSPECTION/REPLACEMENT (WTY040)

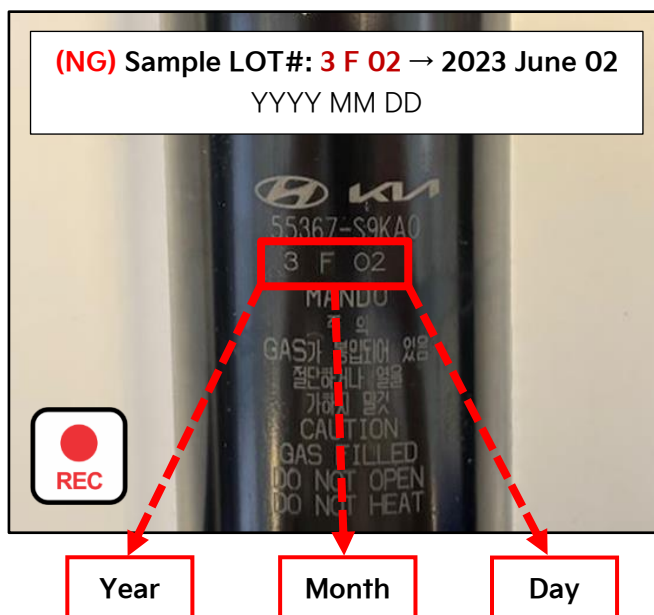
2. Inspect both (LH & RH) 'self-leveling' rear shock absorber LOT#s (Refer to the LOT/DATE conversion table below):

- Produced 'on or after' 3 F 05
(2023 June 05) (OK), then this publication 'Warranty Extension' is not applicable to the inspected shock absorber. Claim Op Code: 242A3510
- Produced 'on or before' 3 F 04
(2023 June 04) (NG), then take a KVID video starting from the VIN label on the door and then move to capture the LOT number stamped on the affected rear shock absorber, and then proceed to step 3 to replace the affected LH and/or RH rear shock absorber.
