## STAR ONLINE PUBLICATION

**Case Number:** S2408000105

**Symptom/Vehicle Issue:** Malfunction Indicator Lamp (MIL) on, Battery Lamp on

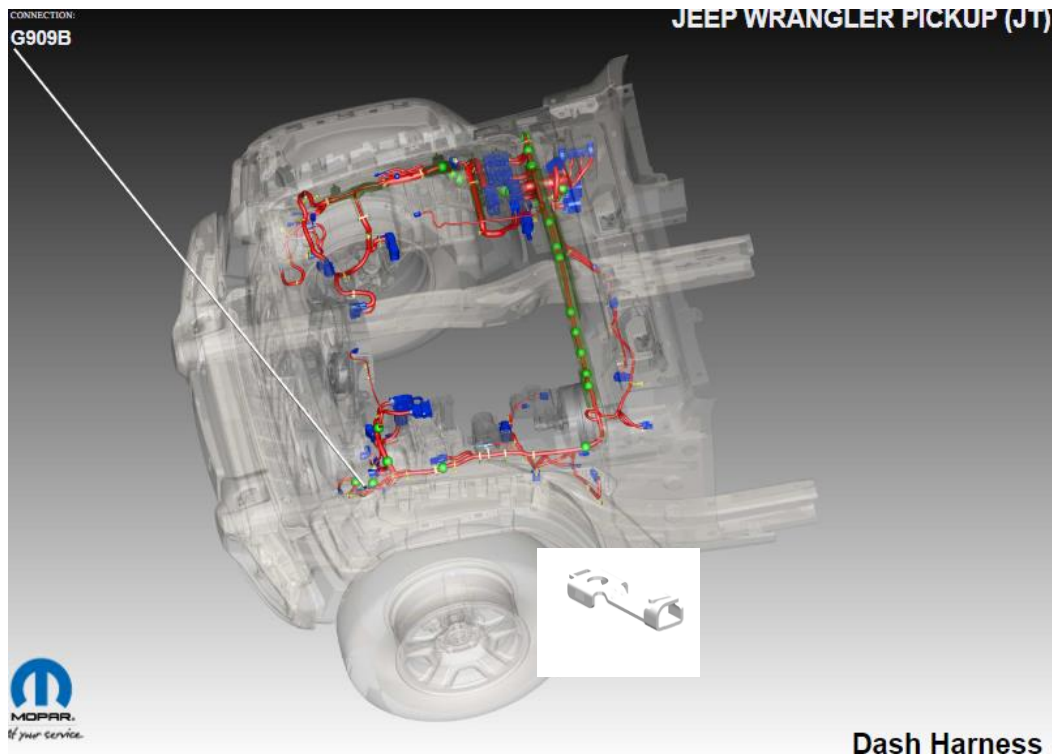
**Customer Complaint/Technician Observation:** The customer may experience one or more of the following, MIL lamp or battery lamp on, vehicle may enter a limp in mode condition. The technician observed the vehicle setting one or more Diagnostic Trouble Codes (DTCs) P1614-00 Transmission Control Module TCM ECU Reset Recovery, U0101-00 Lost Communication With the TCM, or P2504 Charging System Output, P0563 Battery System Voltage High.

**Repair Procedure:** Inspect, clean and secure the G909B ground location, no parts required.
