STAR ONLINE PUBLICATION

Case Number: S2408000106

Symptom/Vehicle Issue: Service SOS System Message Displayed on the Radio Display, Intermittent Microphone Cuts Out During Usage Attempts

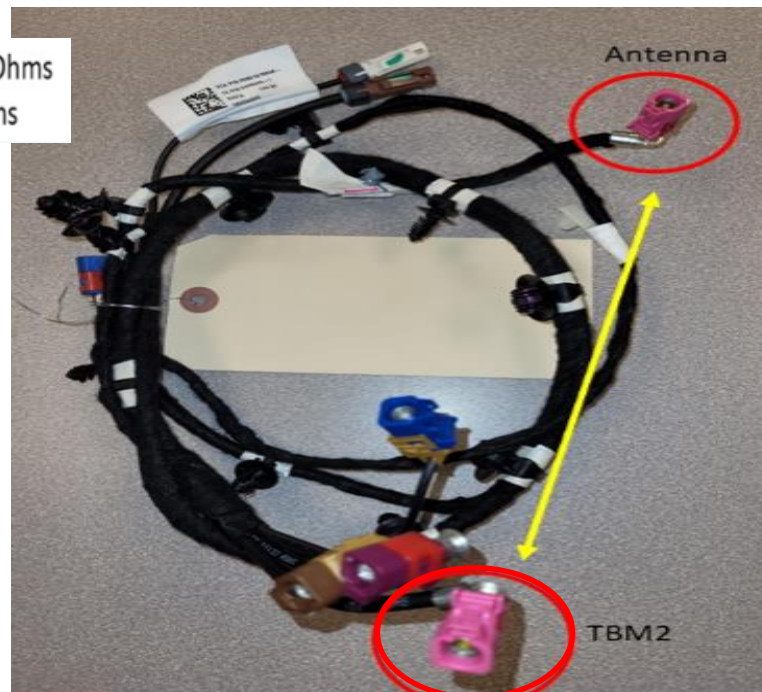
Original Coax Measured-0.08 Ohms
New Coax Measured-0.04 Ohms

Repair Procedure: For vehicles with sales code UBX and RDG refer to Technical Service Bulletin (TSB) 08-080-24 to ensure the most current software updates have been installed. Verify the coaxial connections at the Telematics Box Module (TBM) and the antenna. Test the coaxial resistance for shorts or opens or high resistance end to end and replace as needed.
