Service Bulletin

Bulletin No.: 24-NA-027

Subject: DTC U3000 Setting in Automated Map Module (HDLM) - SuperCruise Unavailable

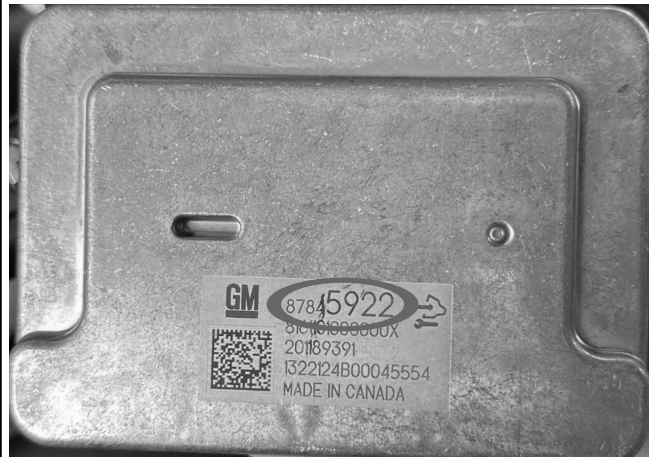
Involved Region or Country	U.S., Canada
Additional Options (RPOs)	Equipped with RPO UKL
Condition	Some customers may comment that when trying to engage SuperCruise, the cluster will display the message "SuperCruise unavailable – No road info". Technician will find DTC U3000 setting in the module.
Cause	The cause of the condition may be due to a reset condition in the module causing the message to display and the U3000 DTC to set in the HDLM.
Correction	Technicians are asked to verify the condition by driving on 2 different verified SuperCruise roads. Replace the HDLM module if, and only if, the part number of the HDLM in the vehicle is listed in Parts Information. Important: Please refer to the Electronic Parts Catalog (EPC) to order the latest release part number for this module.

If one of these Map module part numbers listed in Parts Information is not installed in the vehicle, and the map module is setting the U3000 DTC with SuperCruise being unavailable, do not replace the module until additional diagnostics through SI are completed. 6553204
