# Service Bulletin

Bulletin No.: 24-NA-052

**Subject: Radio Software Version Z171 – Multiple Updates for IOK**

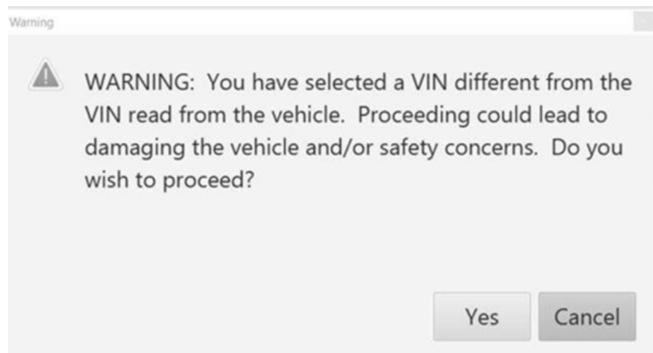
5877000

**Important:** If the vehicle VIN DOES NOT match, the message below will be shown.
