# Service Bulletin

Bulletin No.: 24-NA-169

**Subject: SuperCruise Dropping Out After Driving 30–60 Seconds and/or Service Driver Assist Message Illuminated with DTCs U1626, U3000, and/or B2BA1**

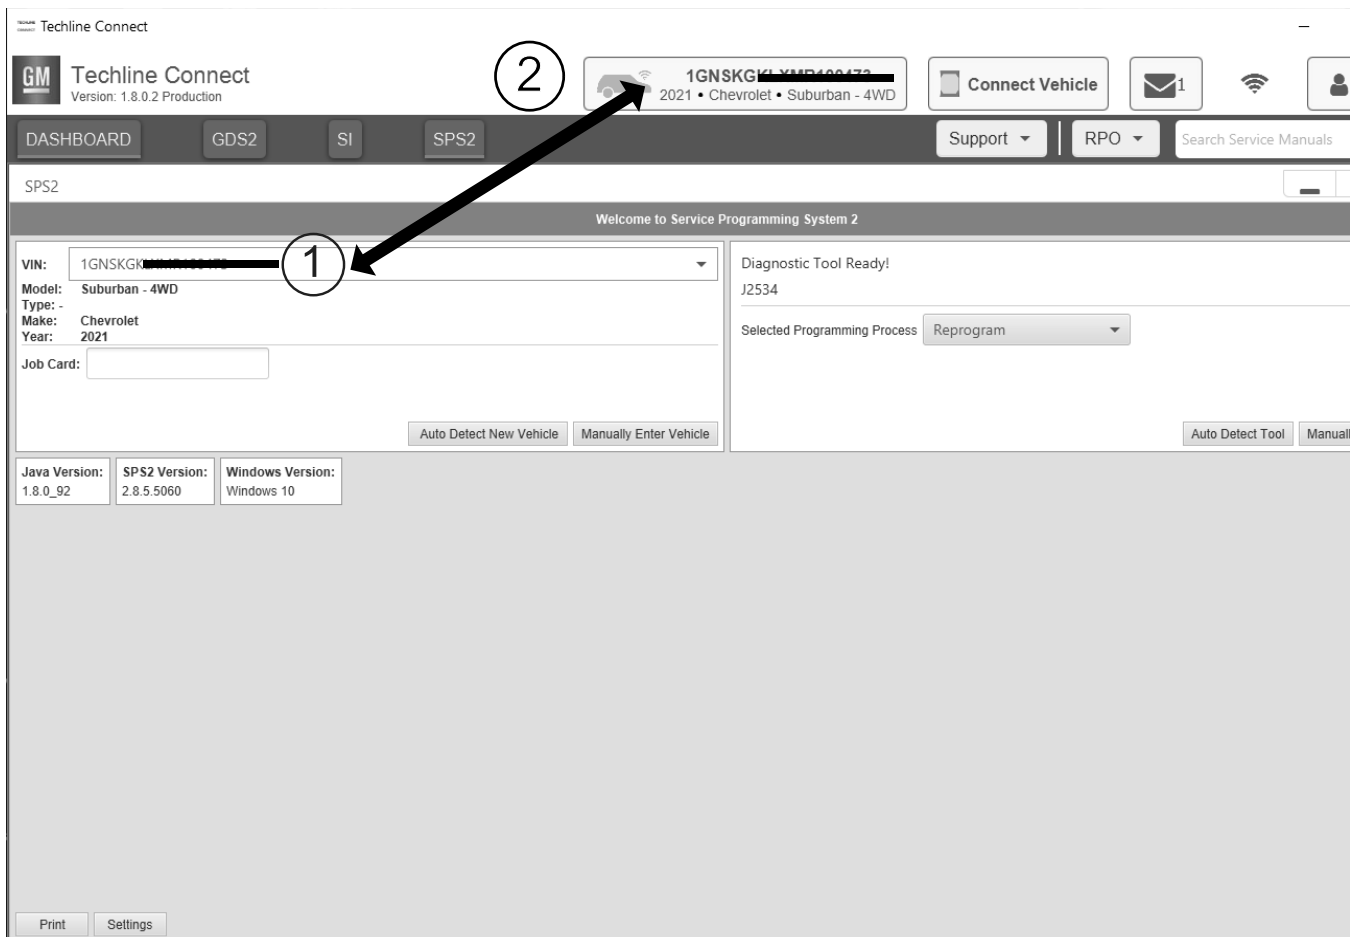
5743643

**Caution:** Be sure the VIN selected in the drop down menu (1) is the same as the vehicle connected (2) before beginning programming.
