# Service Bulletin

Bulletin No.: 24-NA-172

**Subject: Intermittent No Power or Vehicle will Hesitate DTC P0700, P0EFF, U1611, U0401**

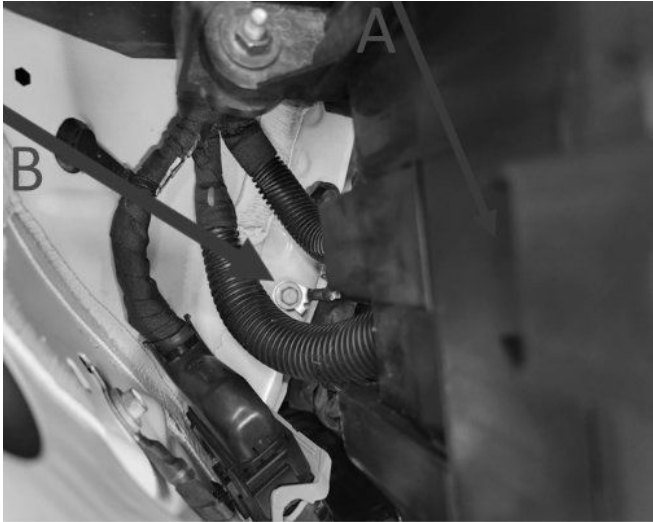
6719974

| <b>Cause</b> | The cause of the condition may be due to an unsecured ground G201A. |

A - Fuse Junction Block

B - Ground that needs cleaned and tightened.

| <b>Correction</b> | If you encounter a vehicle with the above concern, clean and tighten the ground shown below. |
