Service Bulletin

Bulletin No.: 24-NA-175

Subject: Vibration or Rough Idle while in Drive or Park

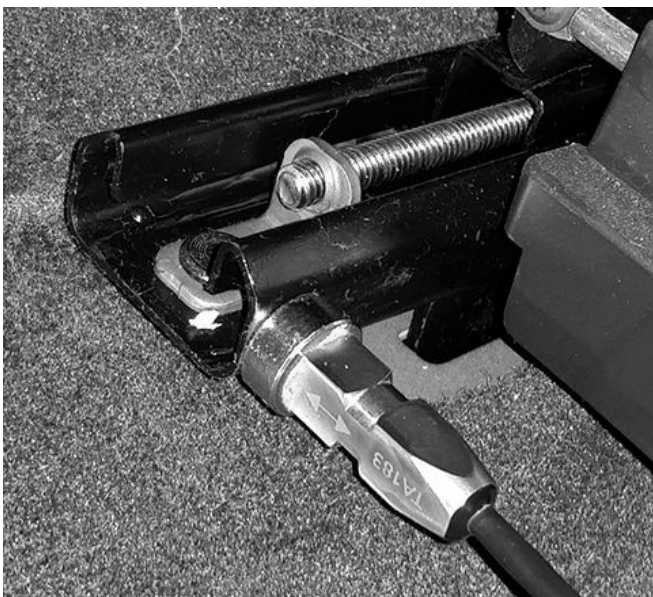
4532456

(TA183 single axis Pico sensor shown / TA143 is tri-axis sensor).

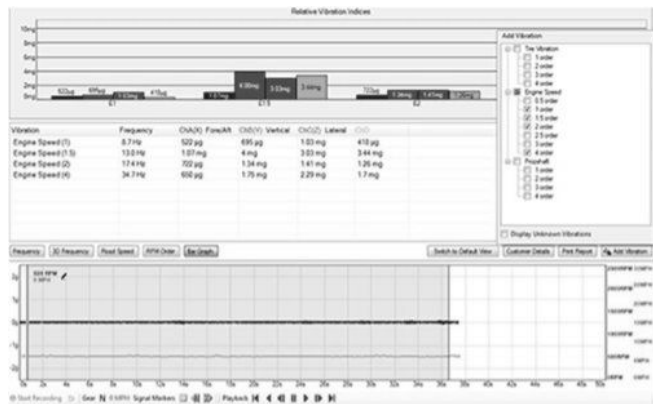
5786964

Add E1.5 to the displayed data and turn Off T and P related data (under Add Vibration in Pico) since issue occurs with vehicle stationary.

Note: Amplitude (mg) readings from a single-axis Pico sensor will be approximately 10% lower than with a tri-axis sensor. For example, a reading of 4 mg using a tri-axis sensor, would likely measure as about 3.6 mg on a single-axis sensor.

If the disturbance frequency measures at the seat track as E1.5 with amplitude of approximately 2 mg or higher using a tri-axis sensor, continue with steps in this bulletin to reduce the amplitude (mg) of the disturbance, then exercise the vehicle and re-measure using Pico to determine level of improvement.
