## A26/17 - MBUX multimedia system (Head unit) NTG7 - Radio function is not available

Topic number	LI82.60-P-077495
Version	4
Function group	82.60 - Radio, audio, video systems
Date	9/27/24
Validity	NTG7*2 model series 118, 167, 177 and 247 with SA code 521, 525, 534 with software release E329.5 or E330.6
Reason for change	Operating number corrected

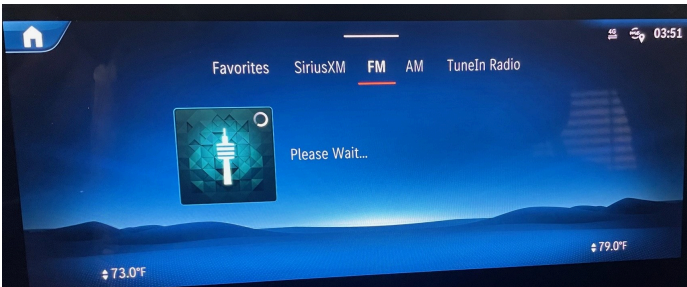
Attachments	
File	Description
LI82.60-P-077495.jpg	Radio screen loading

After clicking on the "Radio" selection function, the radio does not start and instead a permanent loading wheel is displayed. See attached picture for example.

Software version

A26/17 - MBUX multimedia system (Head unit) unit must be replaced. When the head unit is in this condition, a software update will not remedy the situation.
