Service Bulletin

Bulletin No.: 24-NA-177

Subject: Information on Visual Engine Coolant Leak on Ground and/or from Front of Engine

Brand:	Model:	Model Year:		Build Date:		Engine:	Transmission :
		from	to	from	to		
Chevrolet	Corvette	2023	2024	—	—	5.5L (LT6)	—

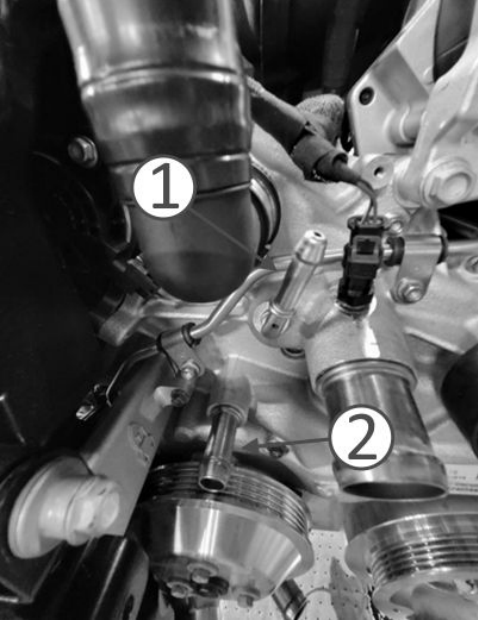
Involved Region or Country	North America, Europe, Middle East, Israel, Palestine, Japan, Philippines, Australia/New Zealand
Condition	Some customers may comment on a coolant leak noticed on the ground or on the front of engine after vehicle is parked for a short time. Technicians may comment on finding coolant around the water pump area.
Cause	<p>This condition may be caused by one or more of the following:</p>

<ul style="list-style-type: none"> • (1) Bleed tube hose not installed properly. • (2) A loose clamp at the upper water pump inlet hose. <p style="text-align: right;">6724854</p>
Correction	<p>If you find that the coolant leak is coming from the bleed tube area, inspect that the spring clamp is positioned correctly, and the hose is inserted onto the bleed tube nipple all the way.</p> <p>If you find that the coolant leak is coming from the water pump area, inspect that the clamp is positioned correctly.</p>
