This Service Information Bulletin (Revision 7) replaces SI B54 11 19 **dated January 2024**.

F95 (X5 M Sports Activity Vehicle)	F96 (X6 M Sports Activity Coupe)	F97 (X3 M Sports Activity Vehicle)	F98 (X4 M Sports Activity Coupe)
G01 (X3 Sports Activity Vehicle)	G02 (X4 Sports Activity Coupe)	X5 (Sports Activity Vehicle)	X6 (Sports Activity Coupe)
X7 (Sports Activity Vehicle)

This bulletin outlines known areas of possible water entry, operational noise, or wind noise for the vehicles listed above. It serves only as a diagnostic resource in troubleshooting complaints from the roof area.

SUNROOF DIAGNOSIS

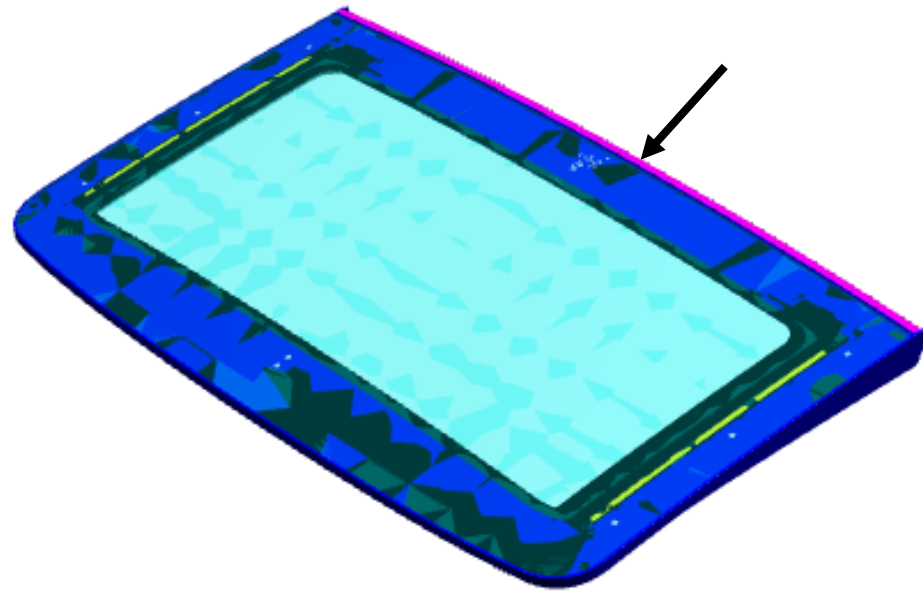
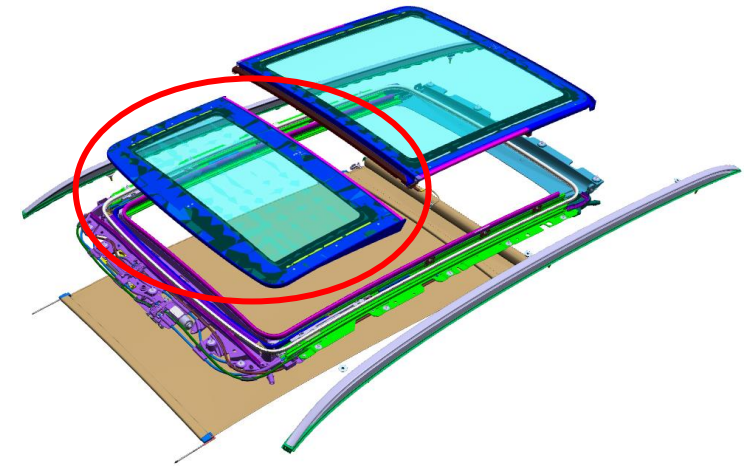
FRONT CENTER SEAL LOOSE/SHRINKING

Defect: separated

Defect: shrunken / gap

Situation: Excessive water enters through the sunroof seals.

Repair: Look for gap near end of the seal on front glass. If found, replace seal according to ISTA/AIR instructions REP 54 13 052. Also refer to B54 04 21.

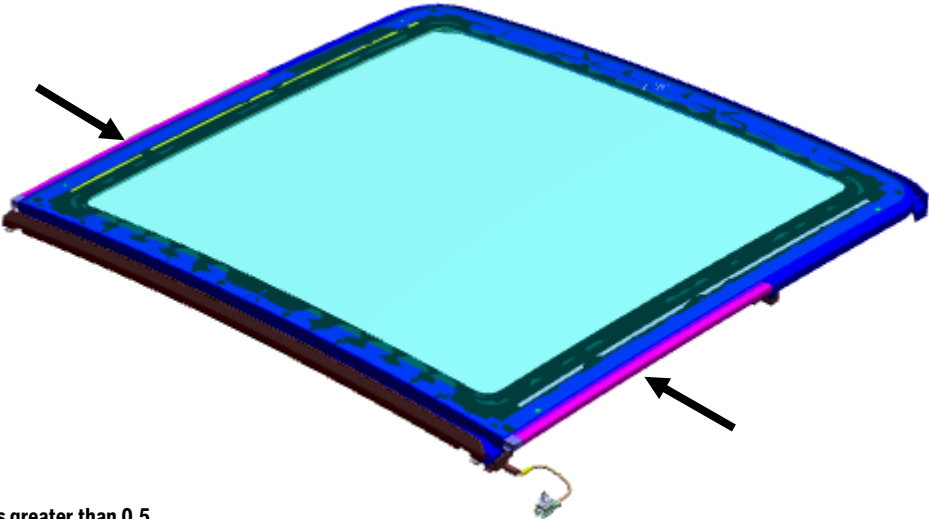
SIDE SEAL LOOSE/SHRINKING

Situation : Excessive water enters through the sunroof seals. (see pictures)

If gap is greater than 0.5 mm. Ensure that the locking tab is present on the glass panel

Defect: gap

Seal not engaged over the locking tab. Vent the glass and reattach.

Defect: twist

Defect: loose

Repair: Look for gap near ends or twist in seal. If found, replace seal according to ISTA/AIR instructions.
REP 54 13 050

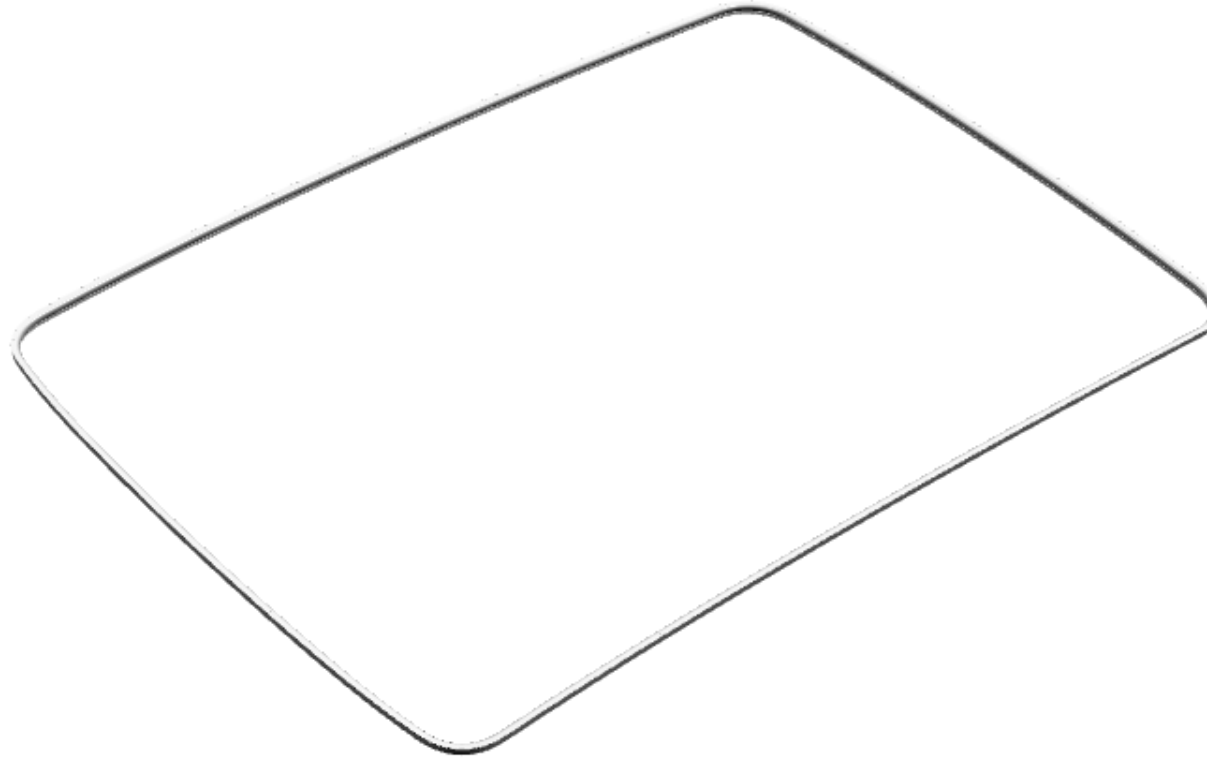
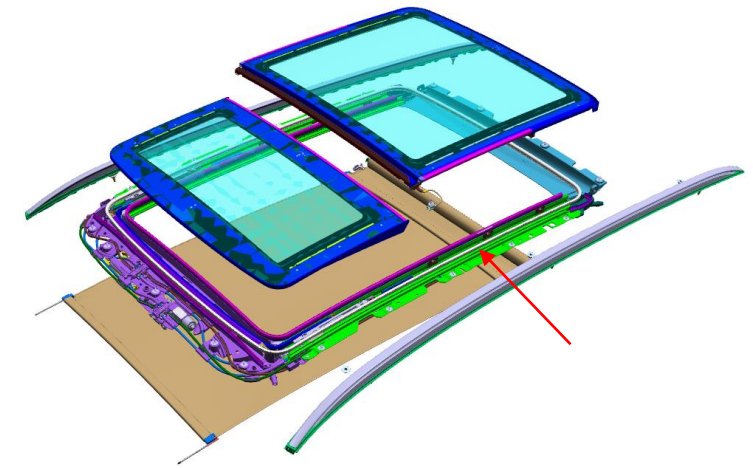
BODY SEAL NOT ATTACHED

Situation : Excessive water enters through the sunroof seals.

example: gap/not flush

Repair: Inspect the sunroof perimeter seal for defects. Replace body seal according to ISTA/AIR instructions REP 54 13 055.

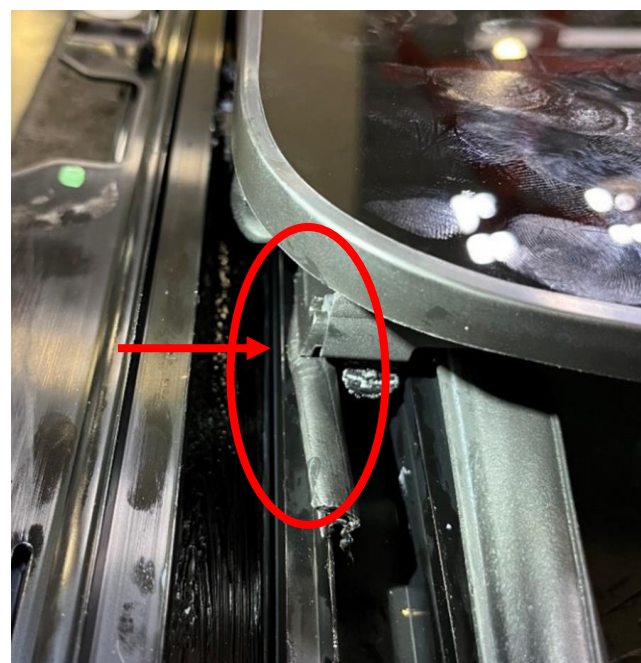
Check the position of the Dyko seal. It should be tucked under the outer edge of the rear glass encapsulation. In the photo above it is not in the correct position. This can cause water ingress to the pano roof.

- Possible corrections to foam/ seal;
- Ensure that the outside edge of the foam/seal is tucked under/ behind the lip of the rear glass drain channel. (See correct position in photos below).
 - Ensure the Z height setting of the rear glass panel is correct so water flows into the outer channel of the cassette.(See correct position in photos below).

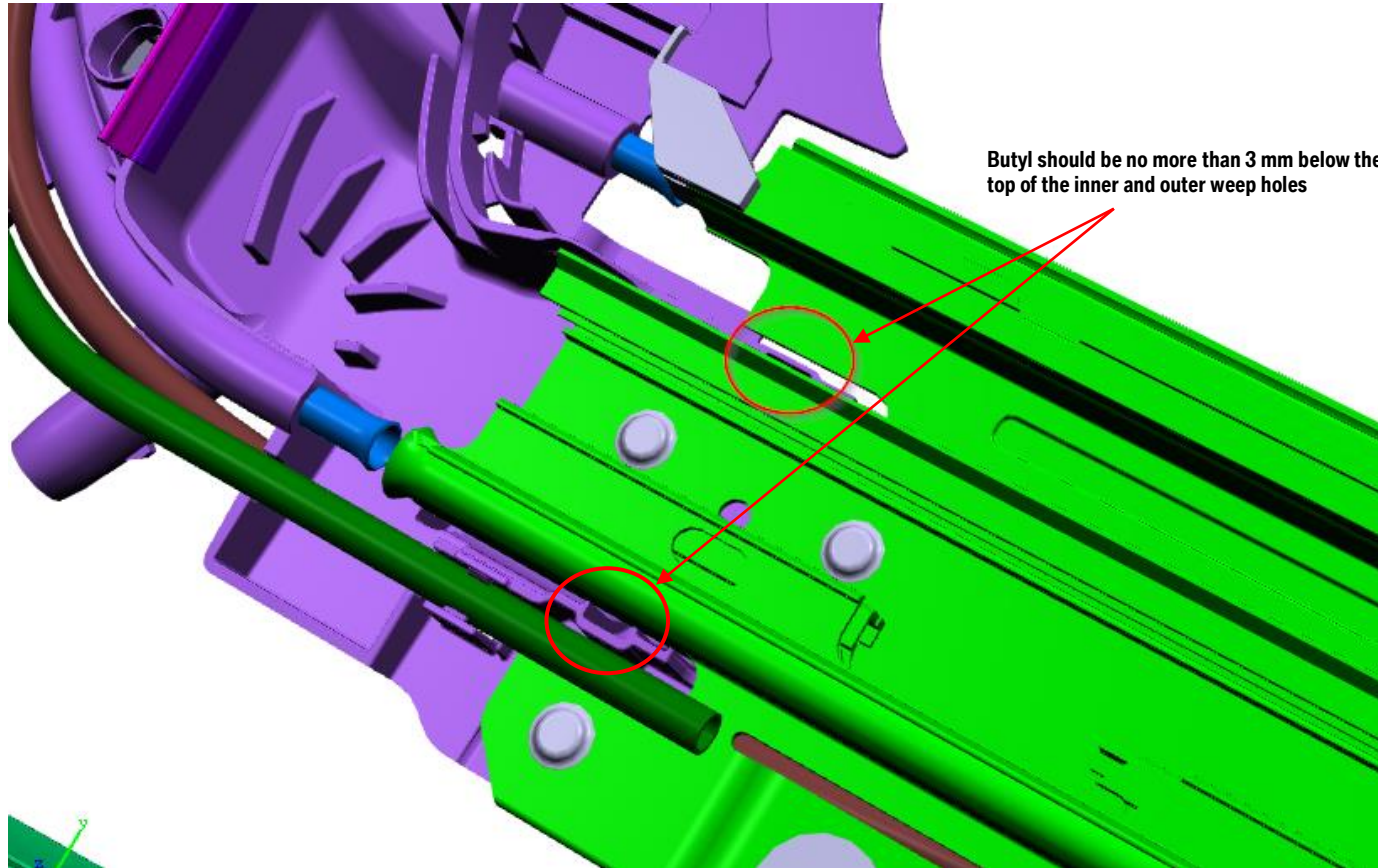
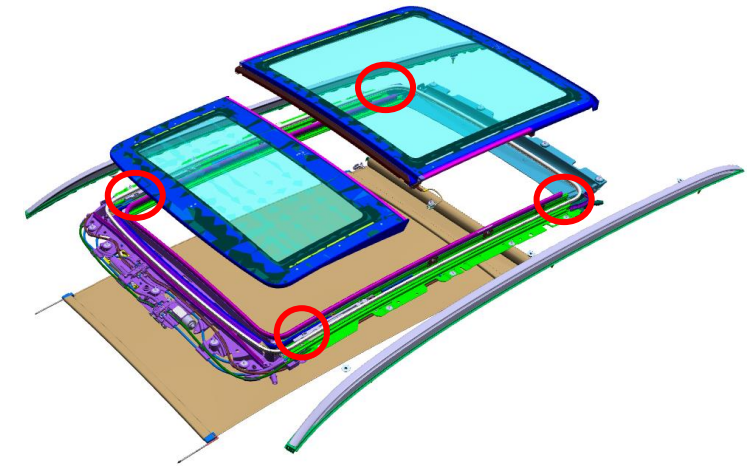
MISSING BUTYL BETWEEN SIDE GUIDES AND BEAM

Situation : There is a water leak running between front/rear beam and side guide.

Repair: There may be missing butyl sealer. ENSURE ALL OTHER WATER MANAGEMENT (SEALS, DRAINS) ARE CHECKED FIRST. ENSURE PROPER WATER TESTING PROCEDURES ARE BEING FOLLOWED (DO NOT OVERFLOW THE SEALED TRACK)

Replace frame according to ISTA/AIR instructions REP 54 13 261.

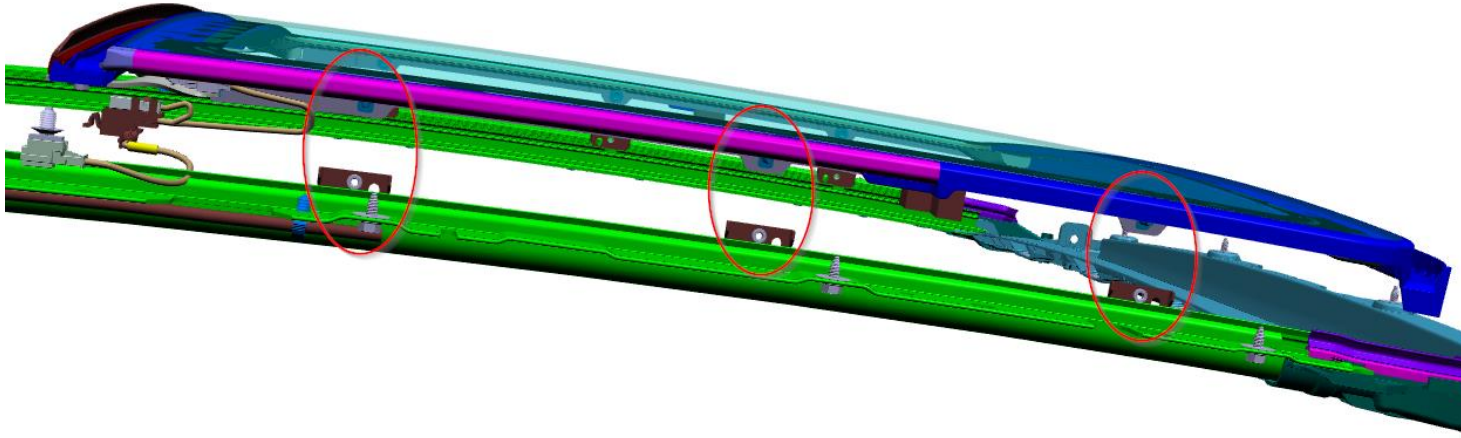
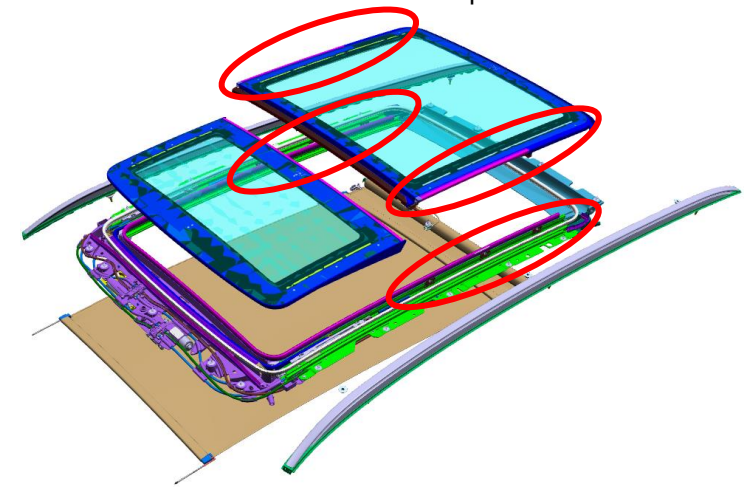
REAR GLASS NOT ALIGNED LEFT TO RIGHT

Situation: Excessive water enters a gap between the side seals and body.

Repair: Inspect the seals. If seals are OK, check glass alignment in Z. If correct, loosen guide bracket screws to the side rails by 360 degrees on all brackets. Shift the panel side to side to assure it is loose and centering to the body seal. Tighten all screws to 5.8 Nm. Verify gaps with the body seal are gone. If issue persists, then replace frame according to ISTA/AIR repair instructions REP 54 13 261.

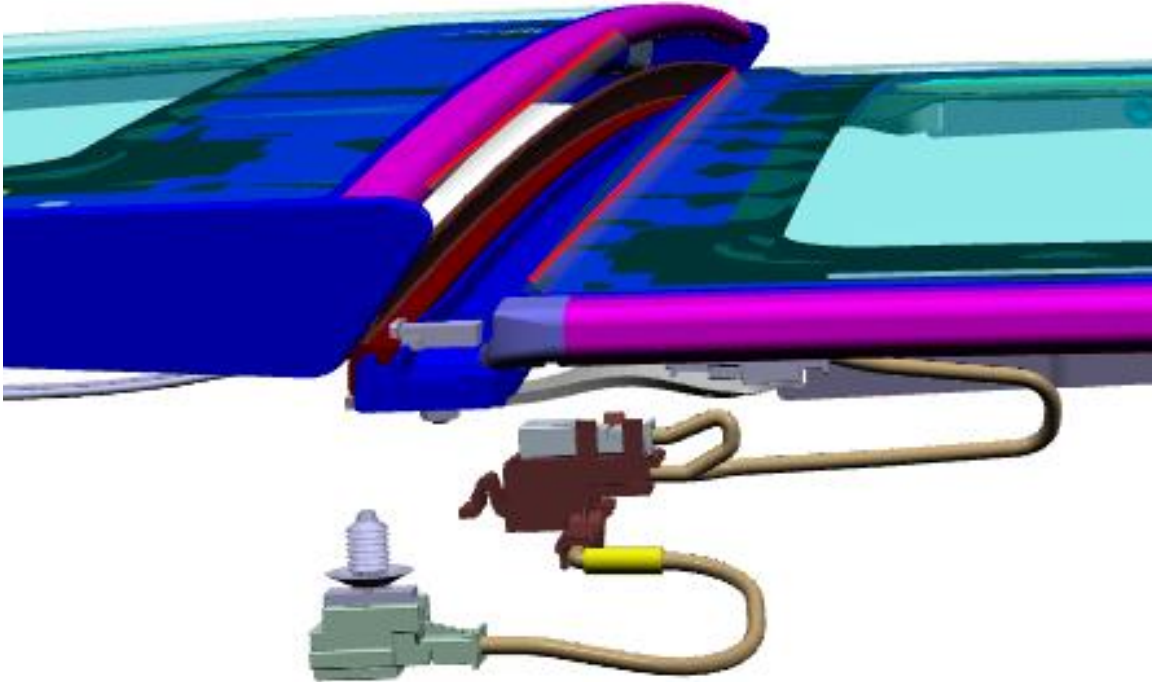
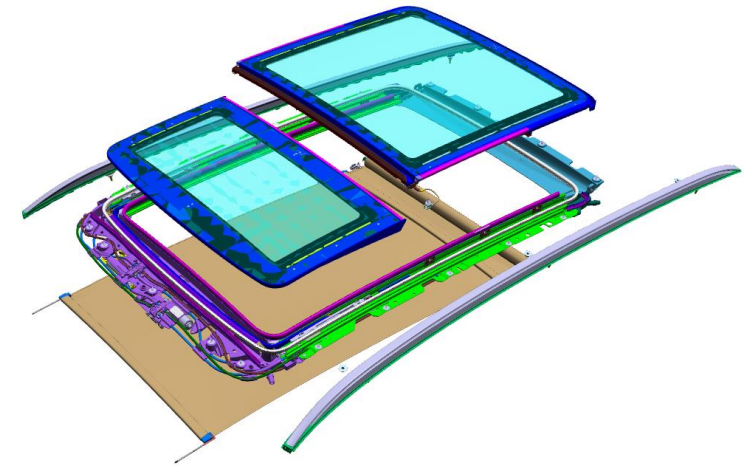
FRONT/REAR GLASS NOT ALIGNED IN X

Situation: Excess water enters the perimeter of the glass. Front and/or rear glass panels misadjusted front to rear.

Repair: Adjust both sunroof glass panels according to ISTA/AIR instructions REP 54 13 002.

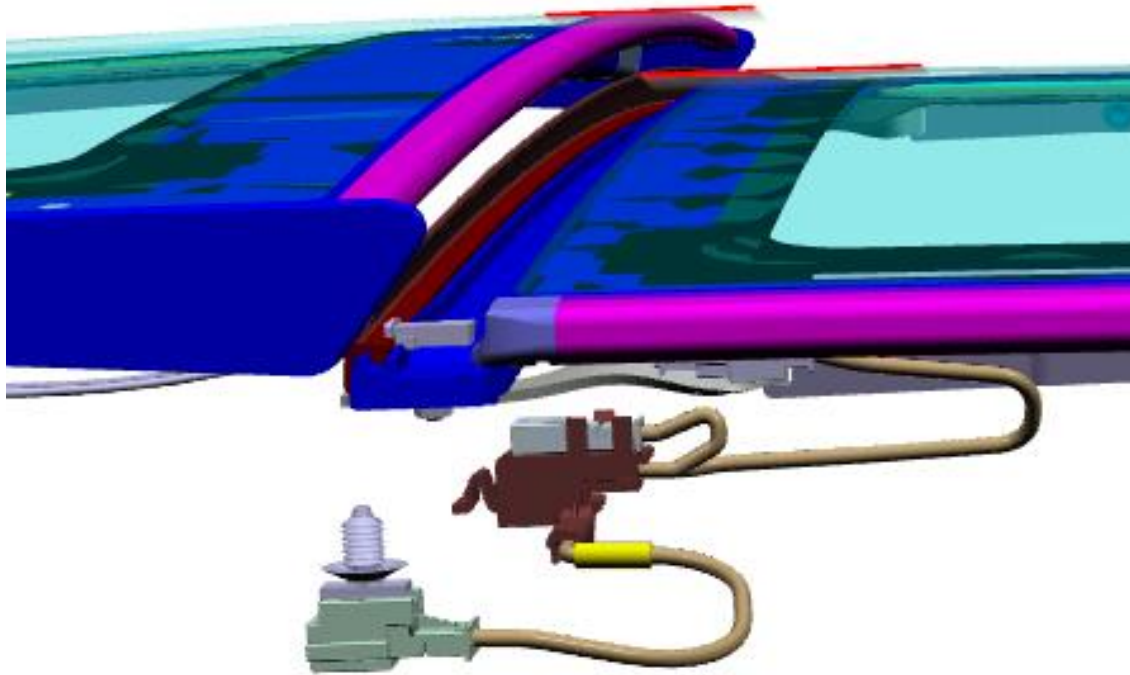
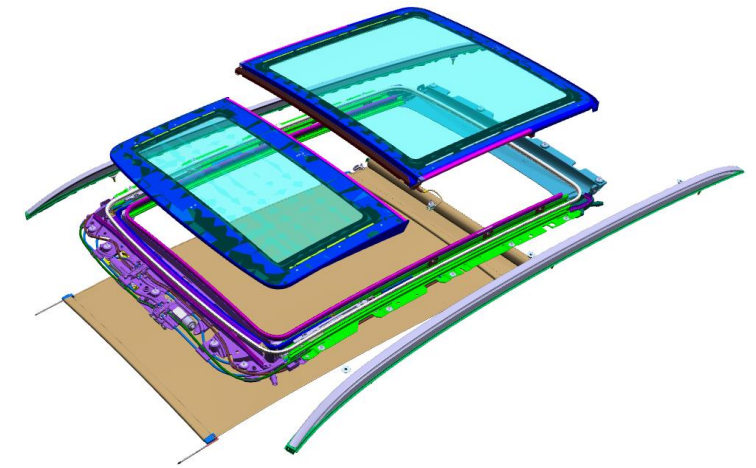
FRONT/REAR GLASS NOT ALIGNED IN Z

Situation: Excess water enters between the glass panels. Front and/or rear glass panel height misadjusted.

Repair: Adjust both sunroof glass panels according to ISTA/AIR instructions REP 54 13 002.

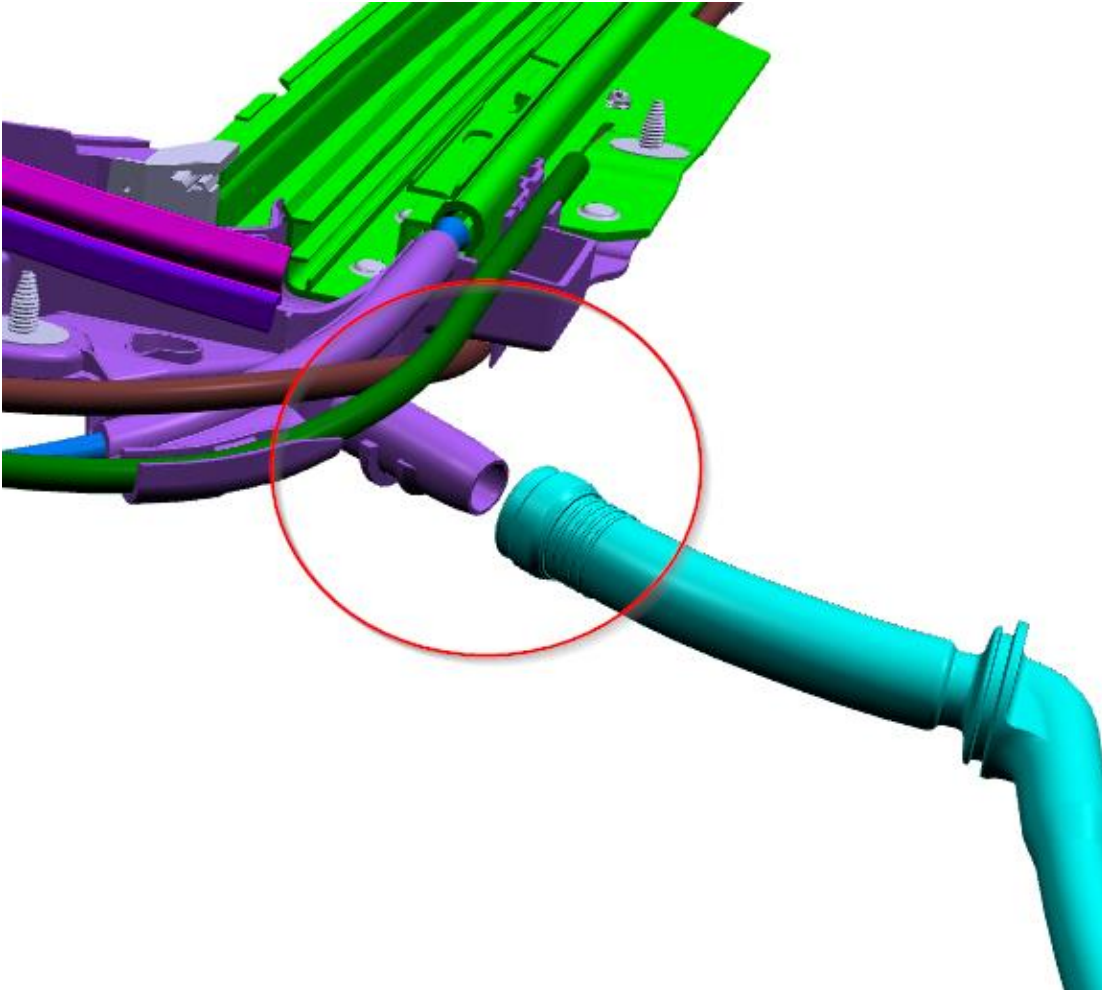
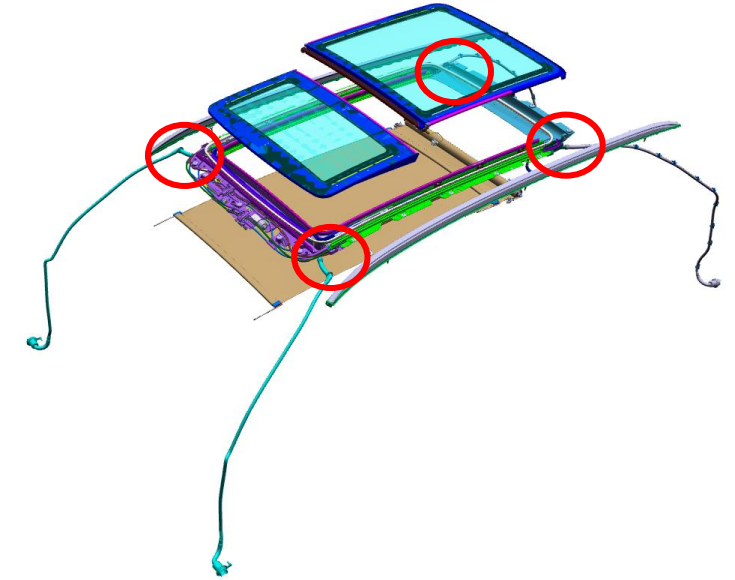
DRAIN TUBE NOT CONNECTED AT TOP

Situation: There is a water leak near the trunk area or you have a water leak near the front carpets. The drain tubes may not be properly connected at the sunroof frame (the top).

Repair: Check the drain tube connections at the sunroof. Reconnect if necessary.

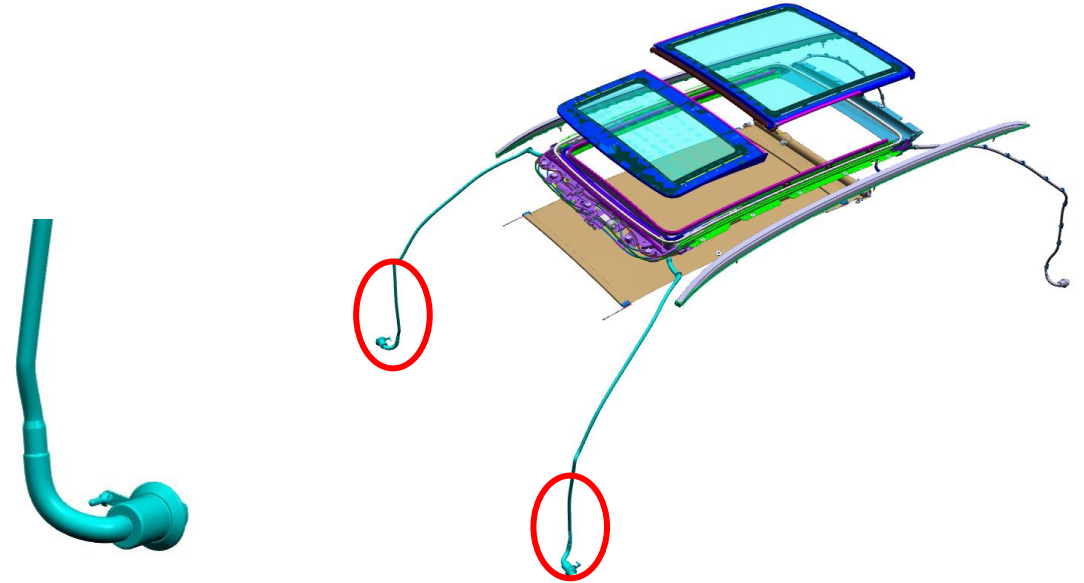
FRONT DRAIN TUBE TWISTED/KINKED

Situation: There is a water leak near the front or rear carpets. The drain tubes may be twisted. Remove A-pillar kick panels to check if front drain tube is twisted/kinked. Use borescope if needed.

!!This situation is one of the more common issues. Investigate thoroughly!!

twisted

kinked

Slightly kinked

Repair: Reposition hose to remove kink. If kink can't be removed, refer to B54 11 19 Attachment 1 for repair instructions.

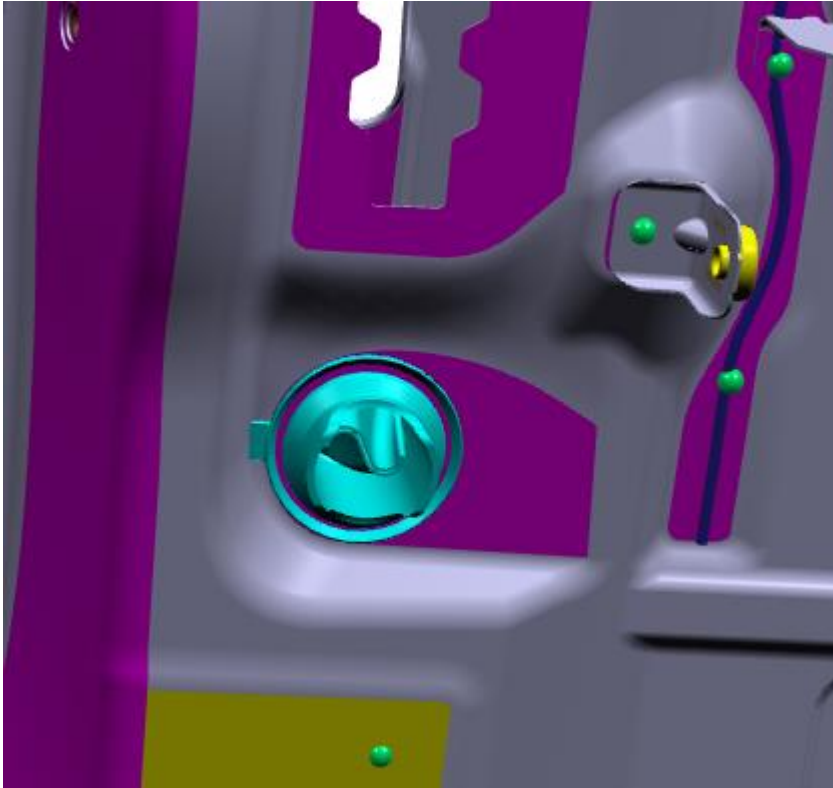
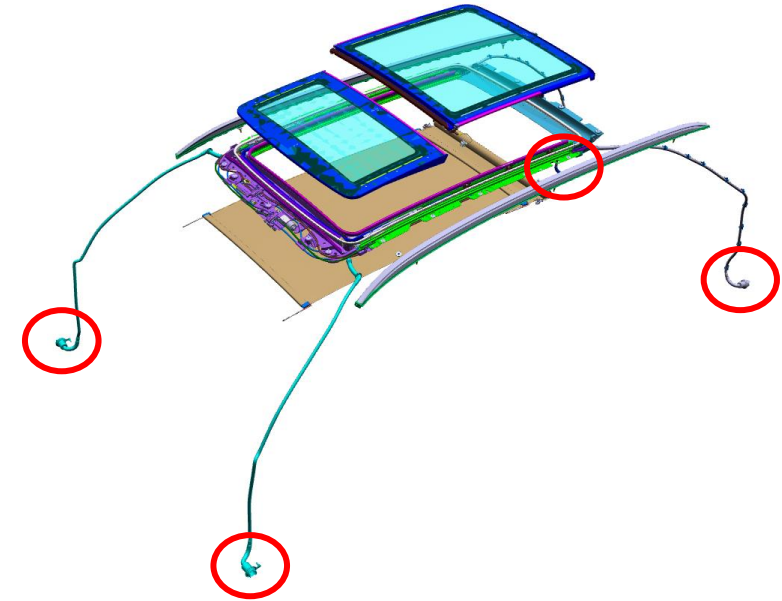
DRAIN TUBES NOT CONNECTED AT BOTTOM

Situation: There is a water leak near the trunk area or you have a water leak near the front carpets. The drain tubes may not be properly connected at the A-Pillar or D pillar at the bottom

Repair: Make sure that drain grommet is seated correctly in the A-Pillar. If not, correctly seat grommet.

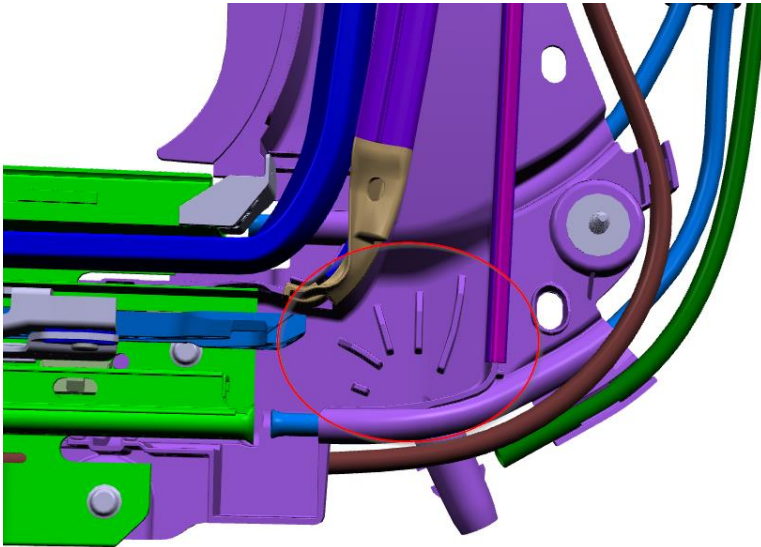
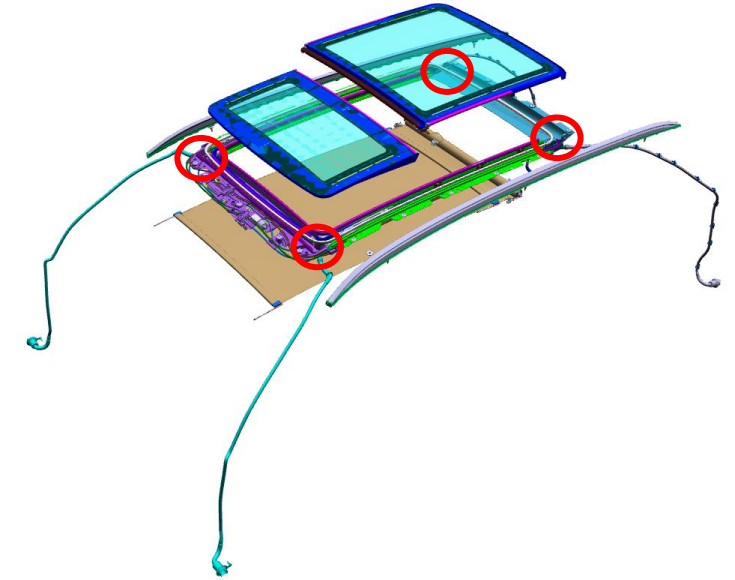
DRAIN TUBES CLOGGED (DIRT/DEBRIS)

Situation: There is a water leak onto the carpets. The drain tubes may be clogged.

Repair: Verify water flow through drain tube. Check for twist/kinks in drain hoses first. If no defect is found, gently blow air through drain tube to force debris to come out. Submit TSARA case for assistance if clog cannot be cleared.

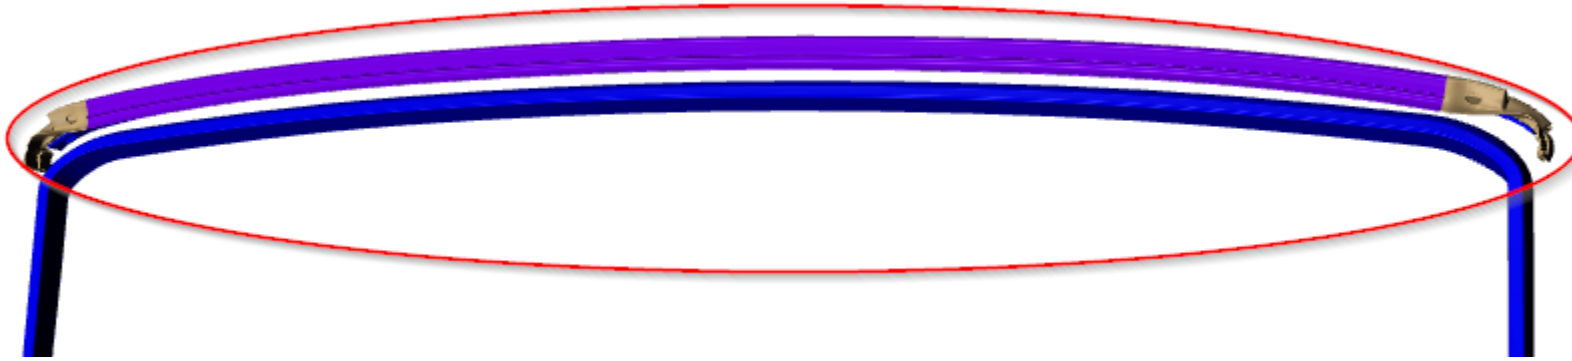
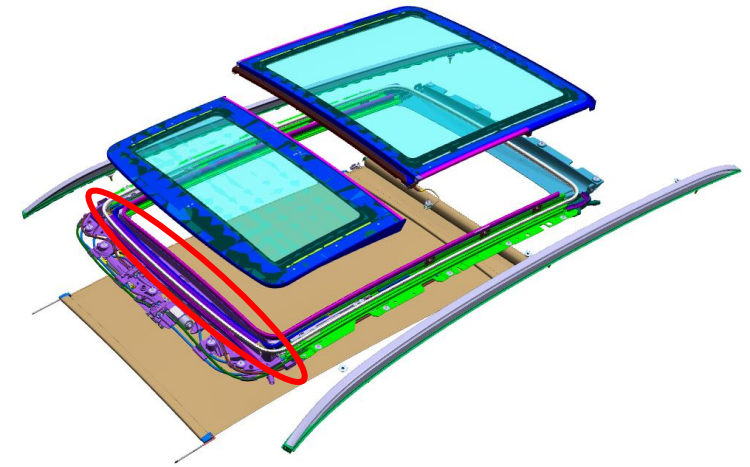
AERO ACOUSTIC SEAL NOT INSTALLED / STUCK

Solution: There is a water leak in the front. The aero-acoustic seal may be incorrectly installed or deformed.

Corners not seated correctly. Can lead to water ingress.

Repair: Check if the seal is properly seated and in good condition. If not, then reset or replace the aero-acoustic seal and replace the body seal according to the ISTA/AIR instructions REP 54 13 055.

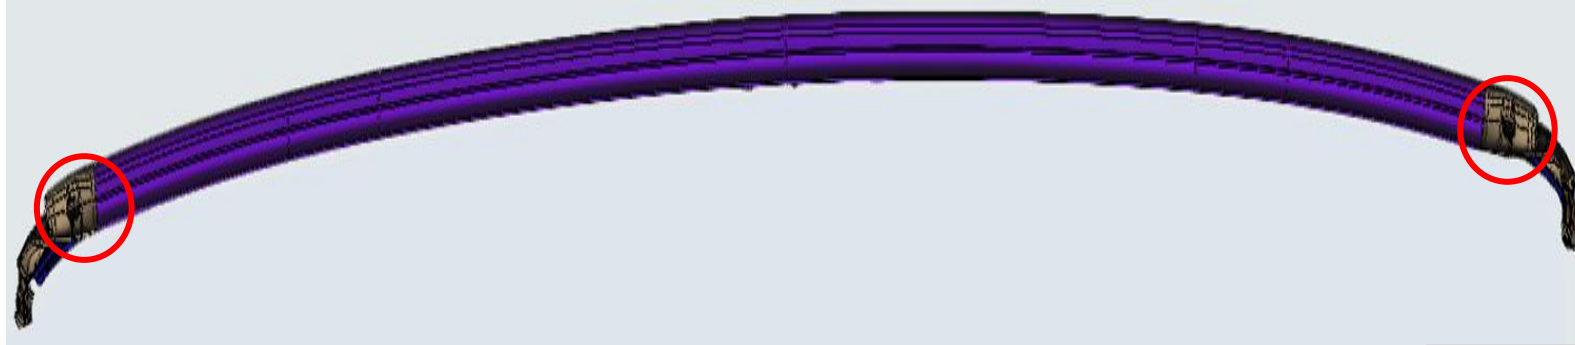
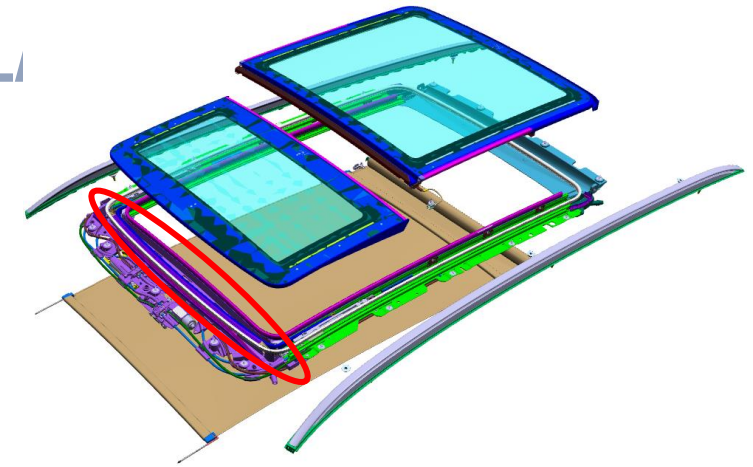
AERO ACOUSTIC SEAL VENT/ DRAIN HOLES BLOCKED/ FLASH

Solution: There is a water leak in the front. The aero-acoustic seal may have flash or blockage at the front vent/ drain holes.

Repair: Check if the seal is blocked at the front corners. If the holes are block by flash then replace the aero-acoustic seal.

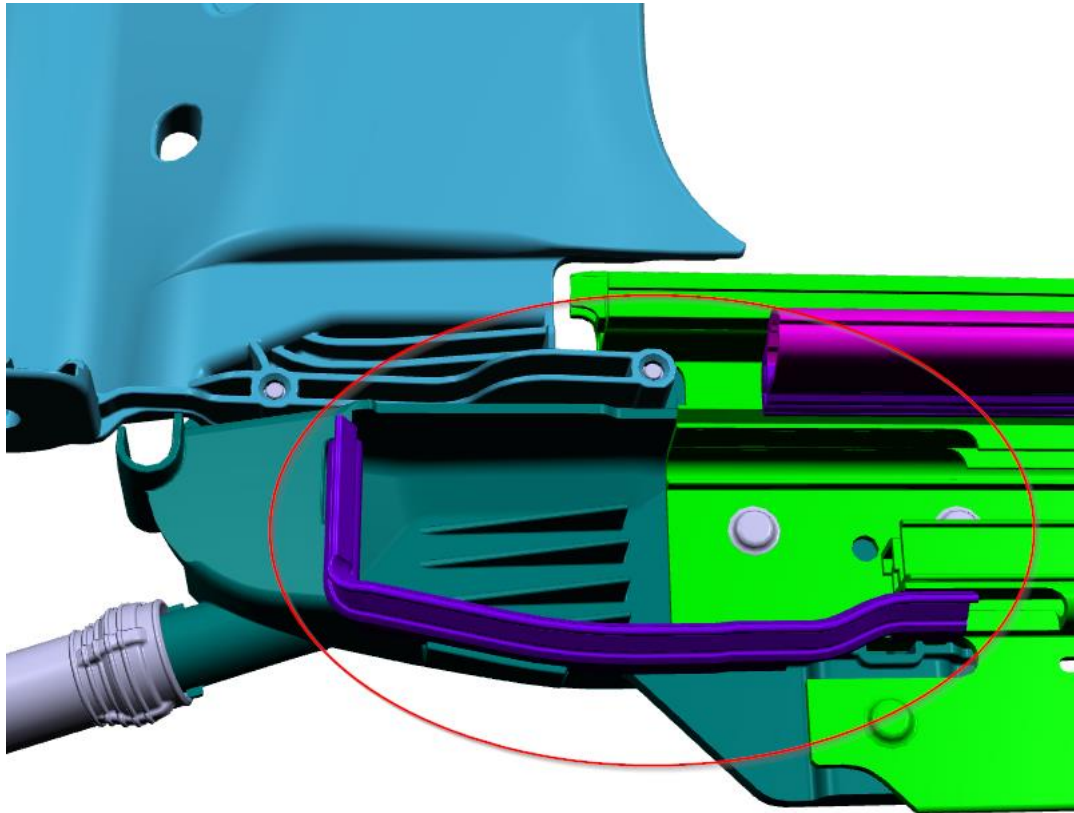
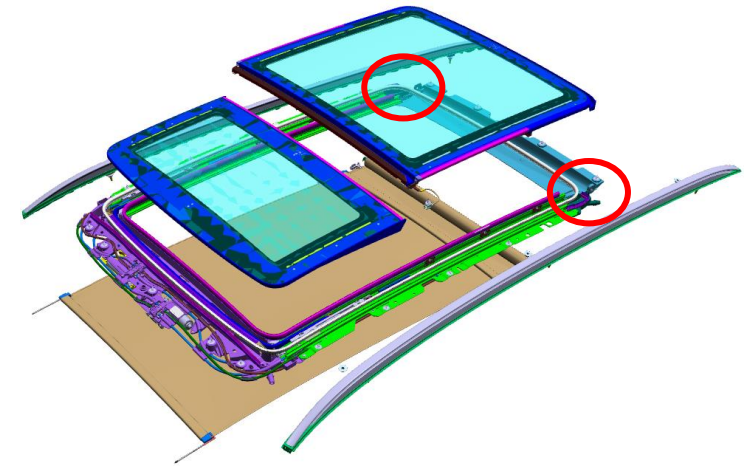
REAR BEAM DYKO SEAL NOT INSTALLED

Situation: There is water ingress in the trunk area. The rear beam seal may not be installed.

Repair: Check if seal is properly seated. Loosen bolts to lower the frame in order to properly inspect seal. If seal is completely missing then replace frame according to ISTA/AIR instructions REP 54 13 261.

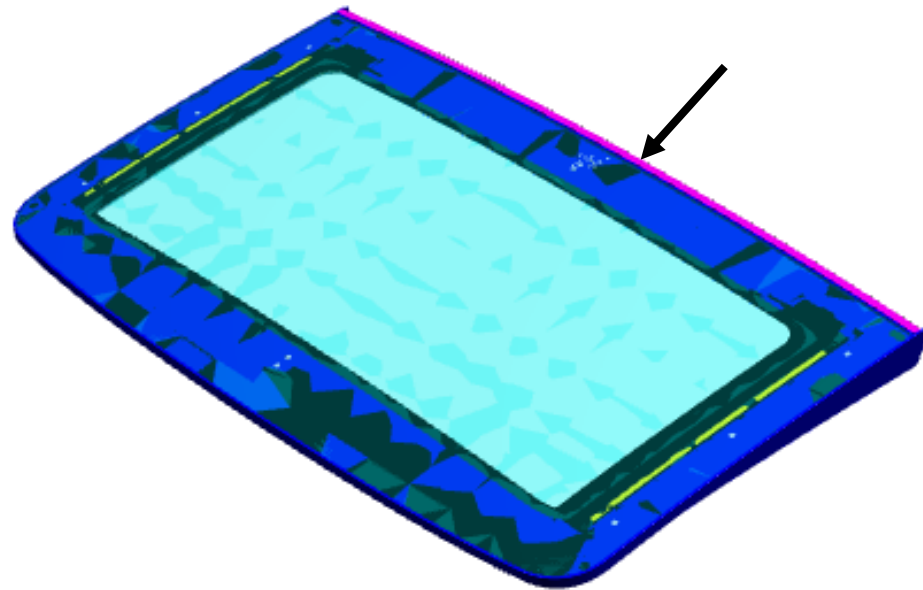
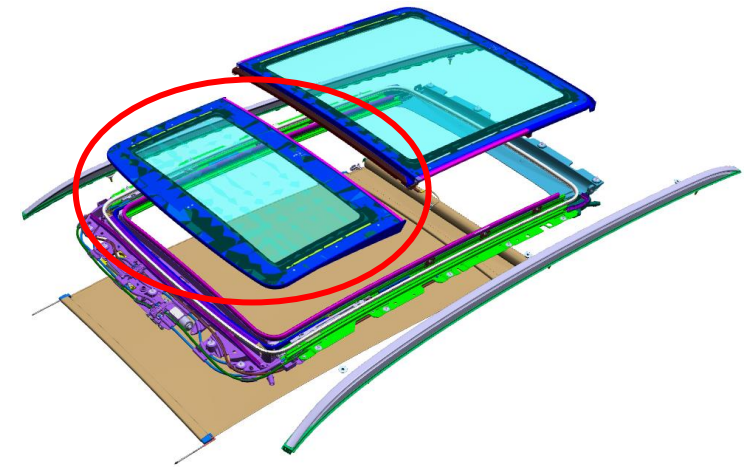
FRONT CENTER SEAL LOOSE/SHRINKING

Defect: separated

Defect: shrunk / gap

Situation: Wind noise heard at speeds of 30 Mph. A gap can be seen near the end of the seal on front glass.

Repair: Replace seal according to ISTA/AIR instructions REP 54 13 052. Refer to B54 04 21.

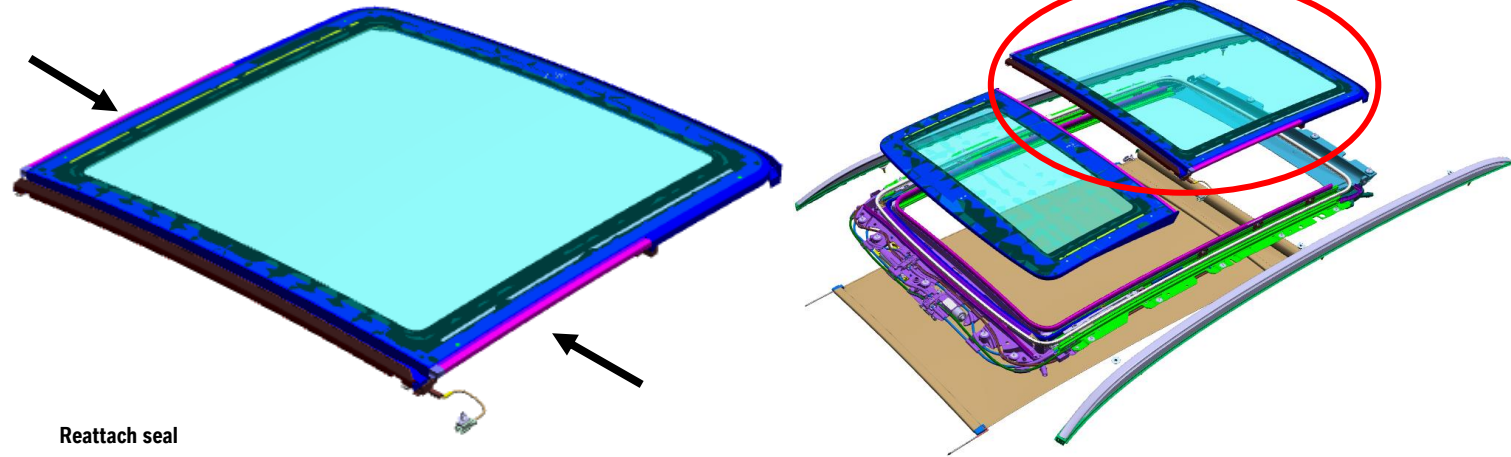
SIDE SEAL LOOSE/SHRINKING

If gap is greater than 0.5 mm. Ensure that the locking tab is present on the glass panel

Seal not engaged over the locking tab. Vent the glass and reattach.

Defect: gap

Defect: twist

Defect: loose

Situation: Heard on fast track (50kph). Run water on top of car and look for leak. Look for gap near end of the seal on front glass. Excess water enters through the sunroof seals. (see photos)

Fully formed knob

Missing knob

Reattach seal

Repair: Look for gap near the ends or twist in the seal(s). If found, replace seal according to ISTA/AIR instructions REP 54 13 050. If the knob or locking feature is missing on the rear glass panel replace the rear glass panel.

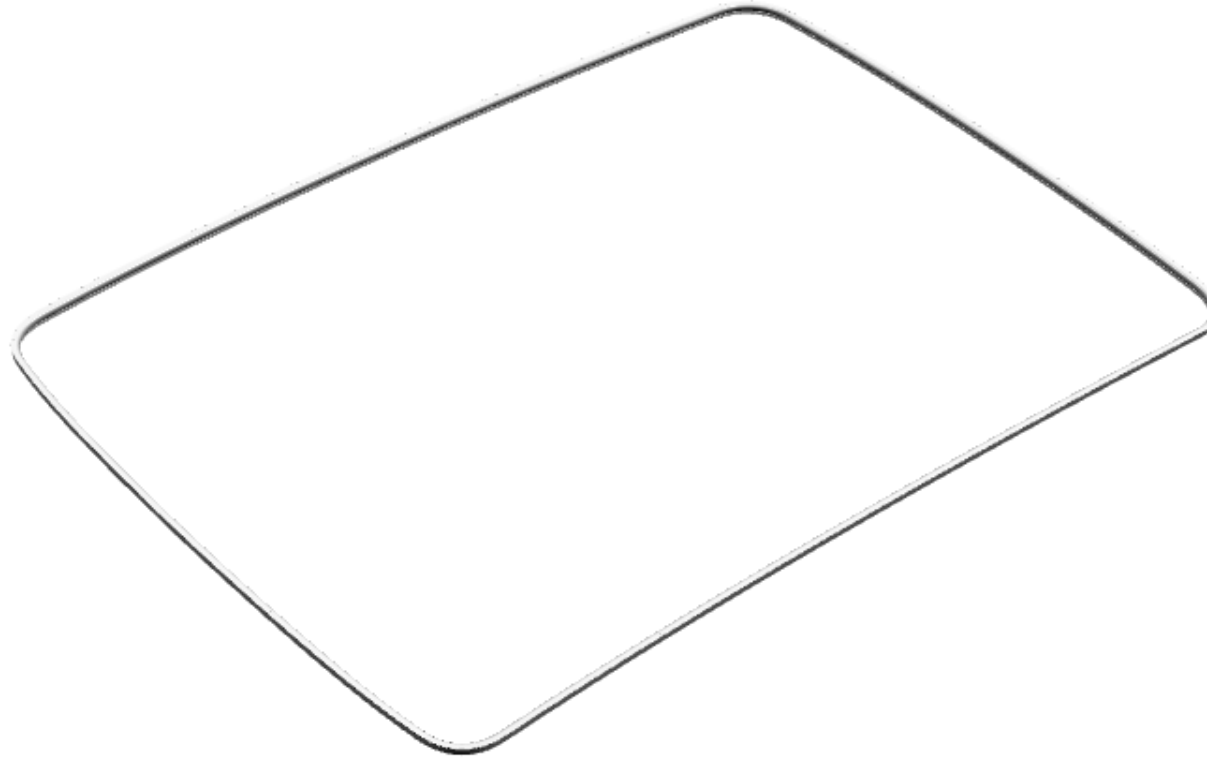
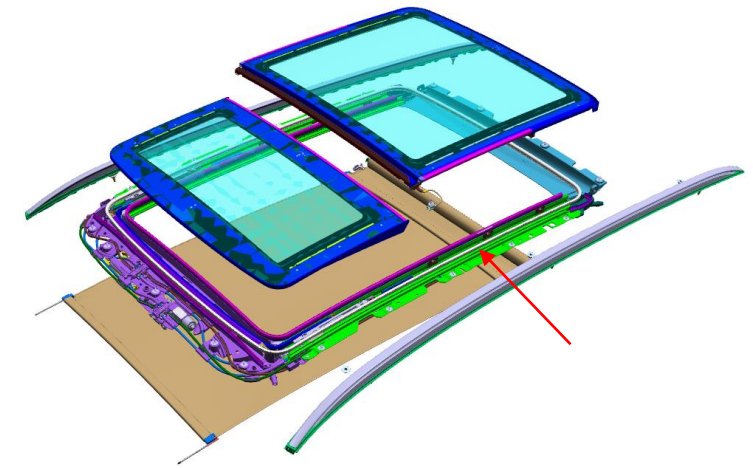
BODY SEAL NOT ATTACHED

Situation: The body seal may be detached or improperly installed.

example: gap/not flush

Repair: Check body seal to see if it is flush to vehicle. (no loose areas/wrinkles)

If damaged, replace body seal according to ISTA/AIR instructions REP 54 13 055.

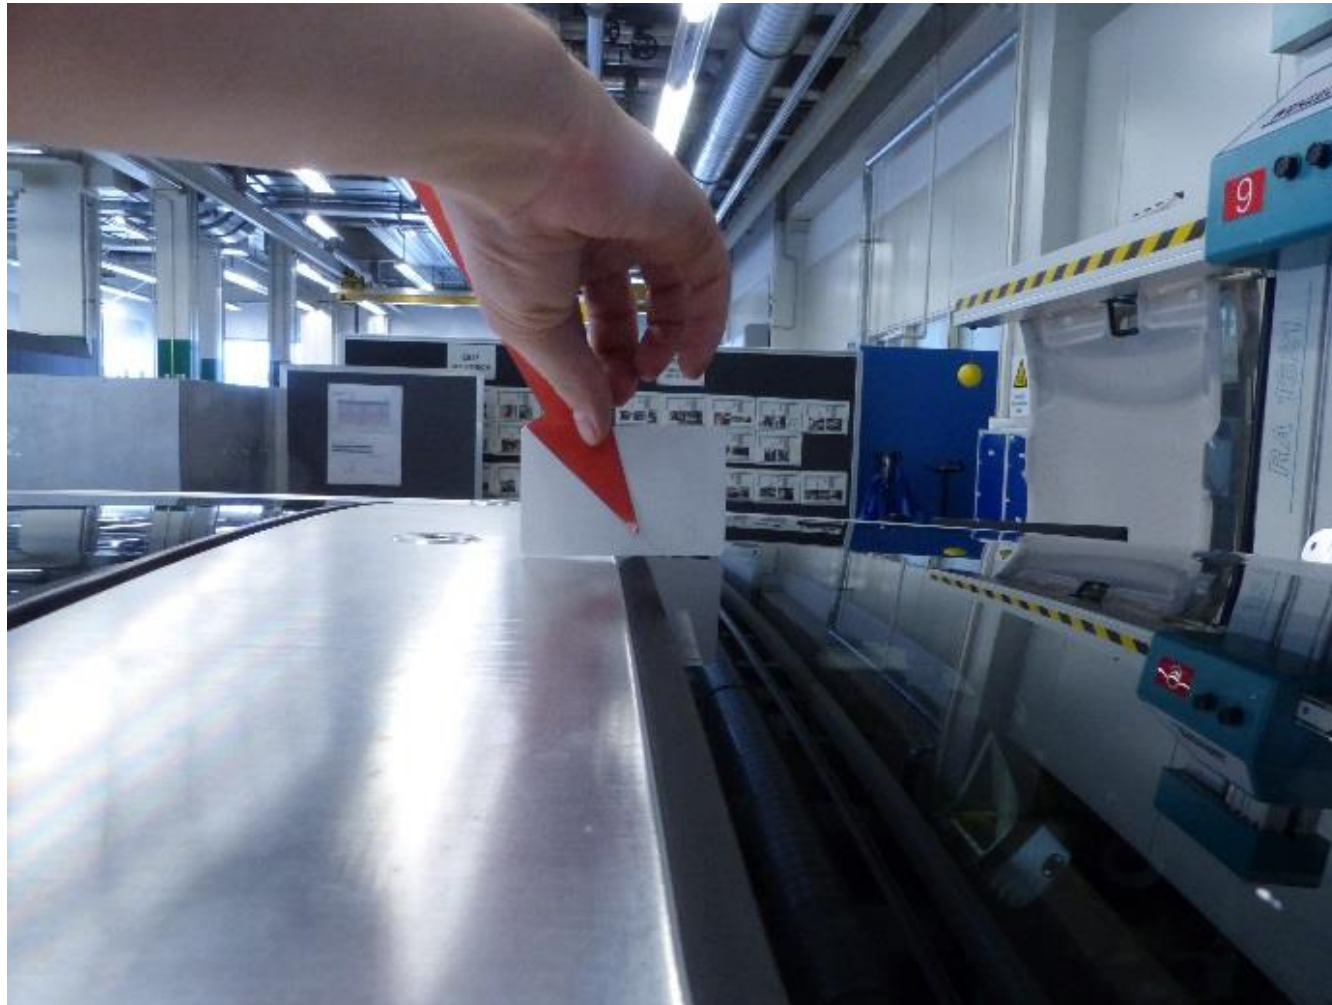
GLASS NOT FLUSH

Situation: Rushing wind noise is heard from center of the glass.

Repair: Tape can be used to isolate noise and find where glass is not flush.

Adjust both sunroof glass panels according to ISTA/AIR instructions REP 54 13 002.

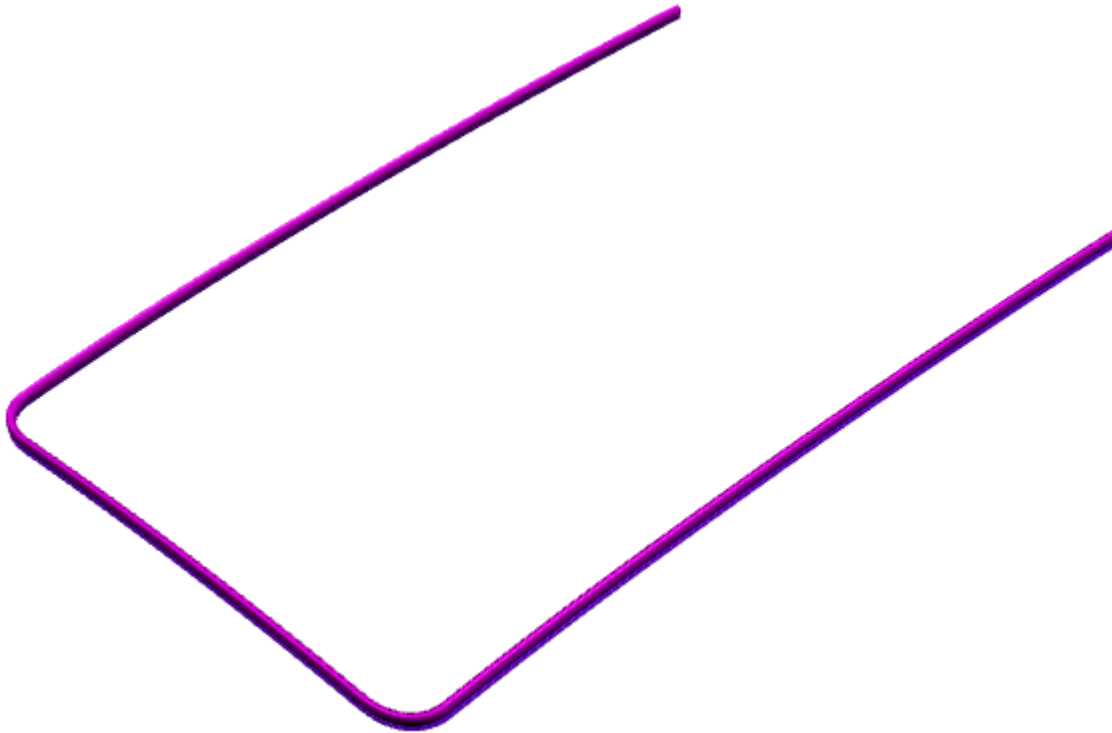
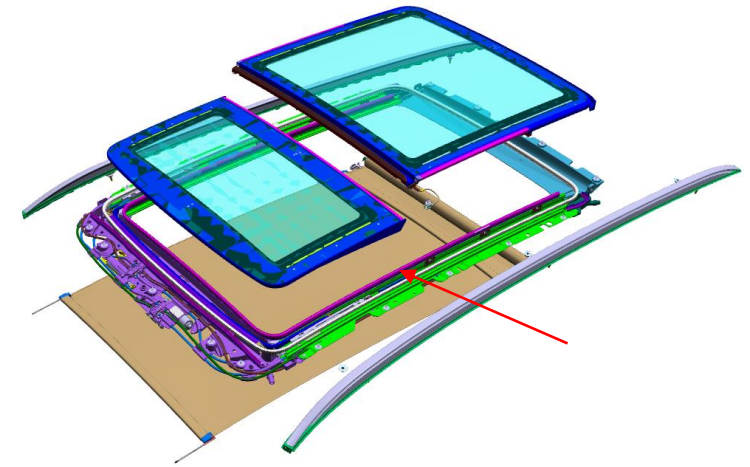
ACOUSTIC SEAL LOOSE

This seal will not cause a water leak into the vehicle and should not be replaced to solve a water leak on the pano roof.

Situation: Rattle or groaning noise heard while driving over rough road surfaces. Upward pressure on the glass will stop the noise. The cause is the interference between the sunroof glass and the acoustic seal mounted to the sunroof frame (not the roof perimeter seal).

Repair: Slightly lower the glass (within specification) to increase the pressure between the glass and the seal.
