This Service Information Bulletin (Revision 7) replaces SI B54 11 19 **dated January 2024**.

F95 (X5 M Sports Activity Vehicle)	F96 (X6 M Sports Activity Coupe)	F97 (X3 M Sports Activity Vehicle)	F98 (X4 M Sports Activity Coupe)
G01 (X3 Sports Activity Vehicle)	G02 (X4 Sports Activity Coupe)	X5 (Sports Activity Vehicle)	X6 (Sports Activity Coupe)
X7 (Sports Activity Vehicle)

This bulletin outlines known areas of possible water entry, operational noise, or wind noise for the vehicles listed above. It serves only as a diagnostic resource in troubleshooting complaints from the roof area.

SUNROOF DIAGNOSIS

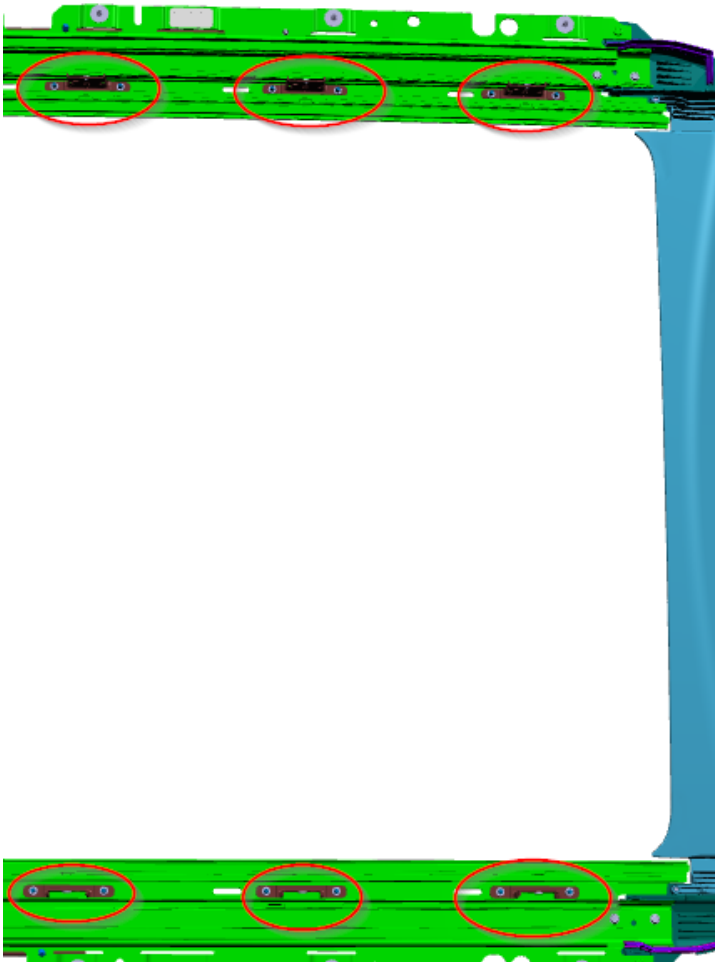
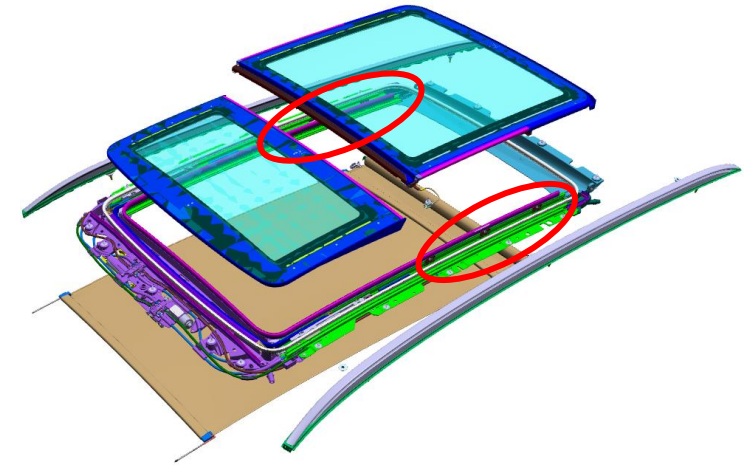
REAR GLASS BRACKET LOOSE

Situation: Metallic noise heard while driving over rough road surfaces.

Repair: Inspect bracket screws (**bracket to frame**, not glass to bracket). Check for any screws with thread lock interference. If excess thread lock is on the screws then replace screws. Tighten loose screw(s) to 6.1 Nm to fully seat. If the screws can't be tightened correctly, the frame would need replacement.

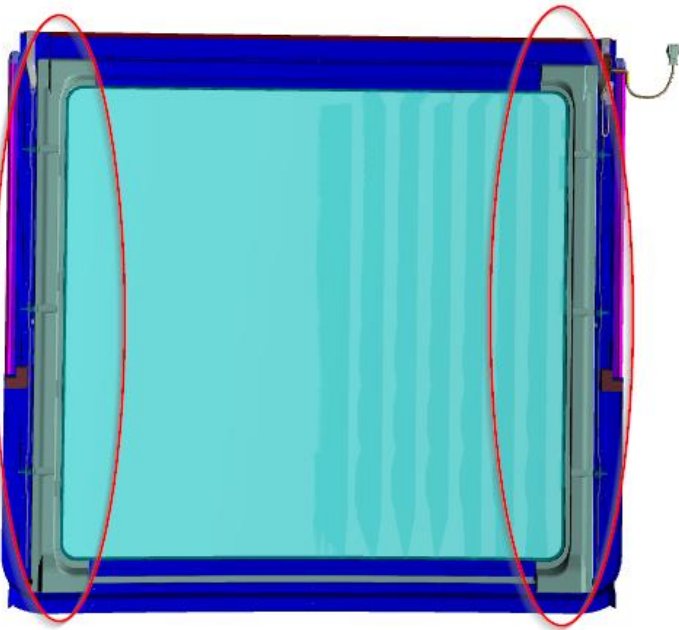
Situation: Rattle is heard from plastic cover tapping on glass panel (front or rear glass) when driving on rough road surfaces.

This situation only affects vehicles with SA407 (Panoramic Sky Lounge LED Roof)

Repair: Attempt to insulate with felt tape is visually appropriate. Replace glass panel according to ISTA/AIR instructions REP 54 13 250 if insulation is not possible.

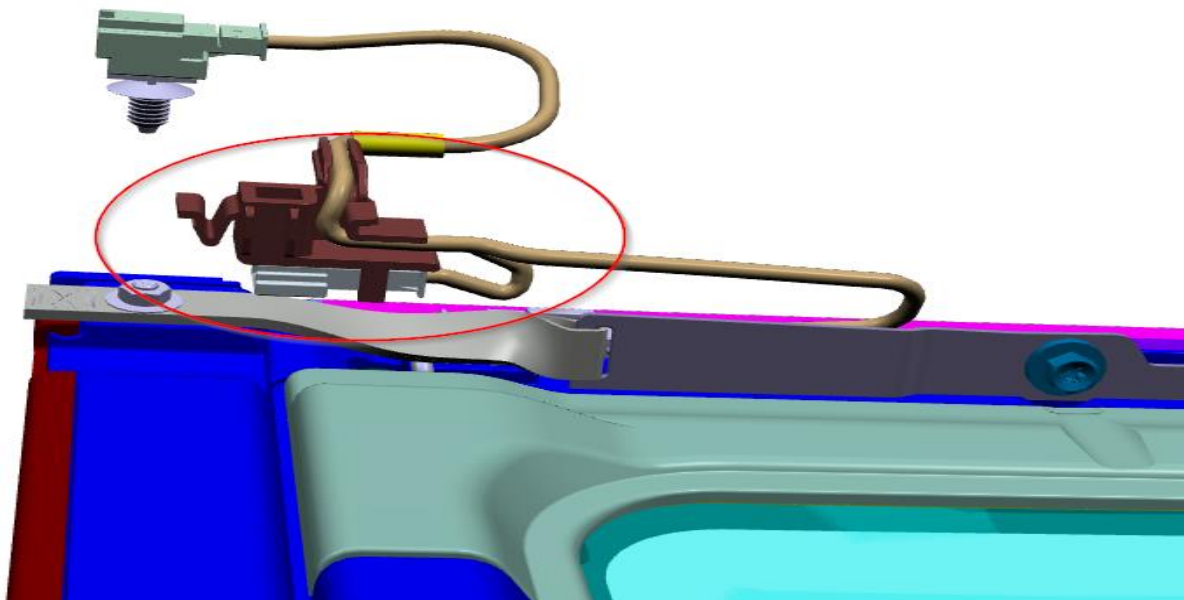
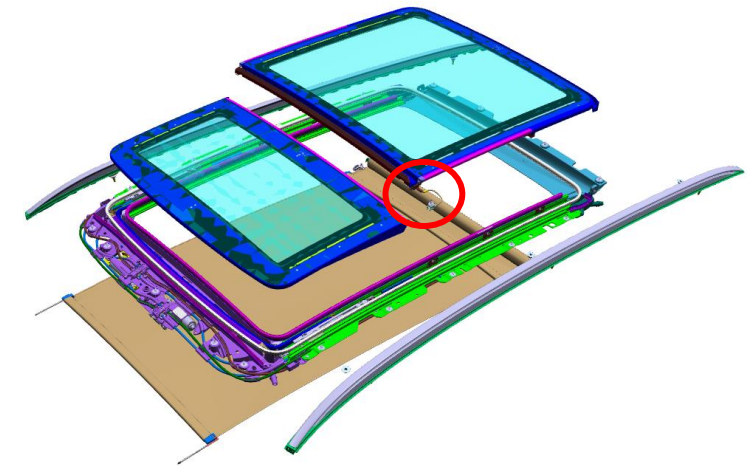
AMBIENT LIGHT CLIP LOOSE/NOT INSTALLED

Clip loose with prongs attached to connector

Clip attached to panel with a press fit rib on the back into a slot on the panel. Glass supplier glues the rib with cyanoacrylate glue.

Solution: A loose clip for the ambient light harness is tapping on the glass or contacting the sunroof mechanism. Only affects vehicle with SA407 (Panormaic Sky Lounge LED Roof).

Repair: Correctly install the harness clip.

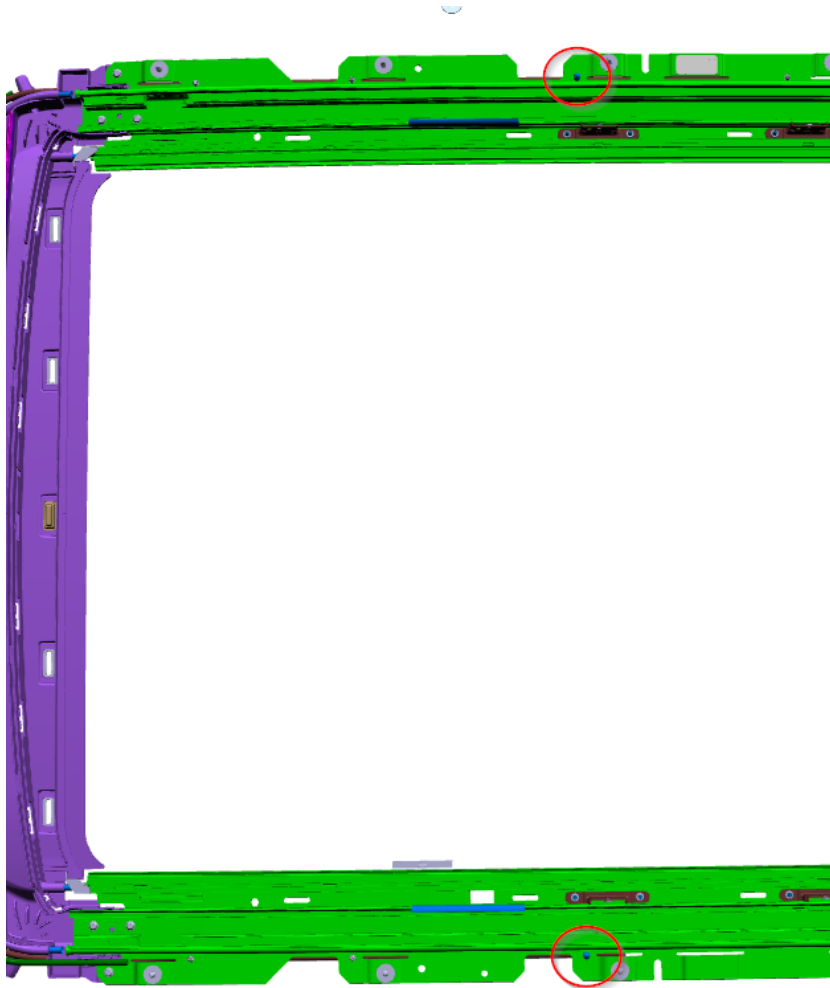
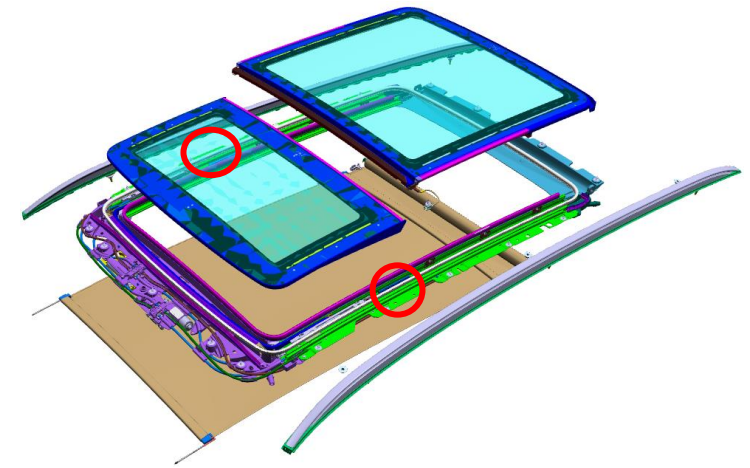
CABLE TUBE CLIP NOT INSTALLED

Identifier: If there is humming / crackling noise when opening of the sunshade. Or Plastic rattling while driving on bad track.

Repair: Engage/set clip correctly. If tube is damaged and noise persists then replace cassette according to rework instructions.

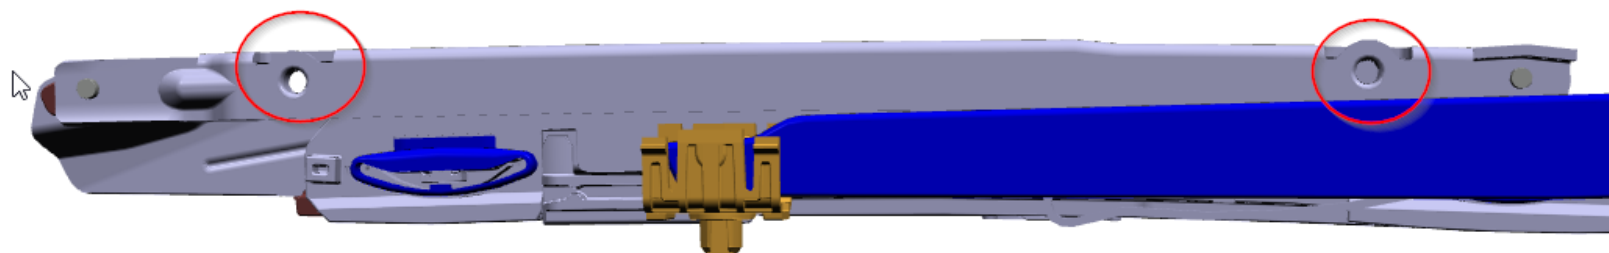
EXTRA SCREW

Situation: A metallic “rolling” noise is heard during acceleration/deceleration. An extra screw may have fallen into the track during production. The screw is not missing from any location.

Repair: Remove the extra screw. Additional repairs are not necessary, all other screws are correctly installed.

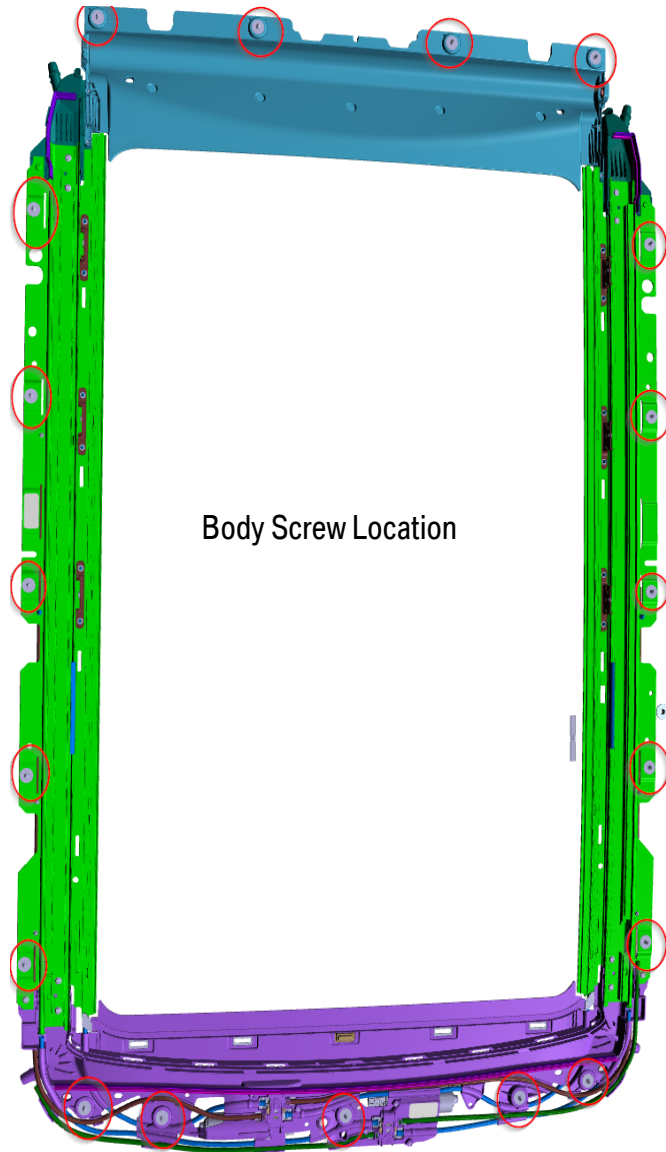
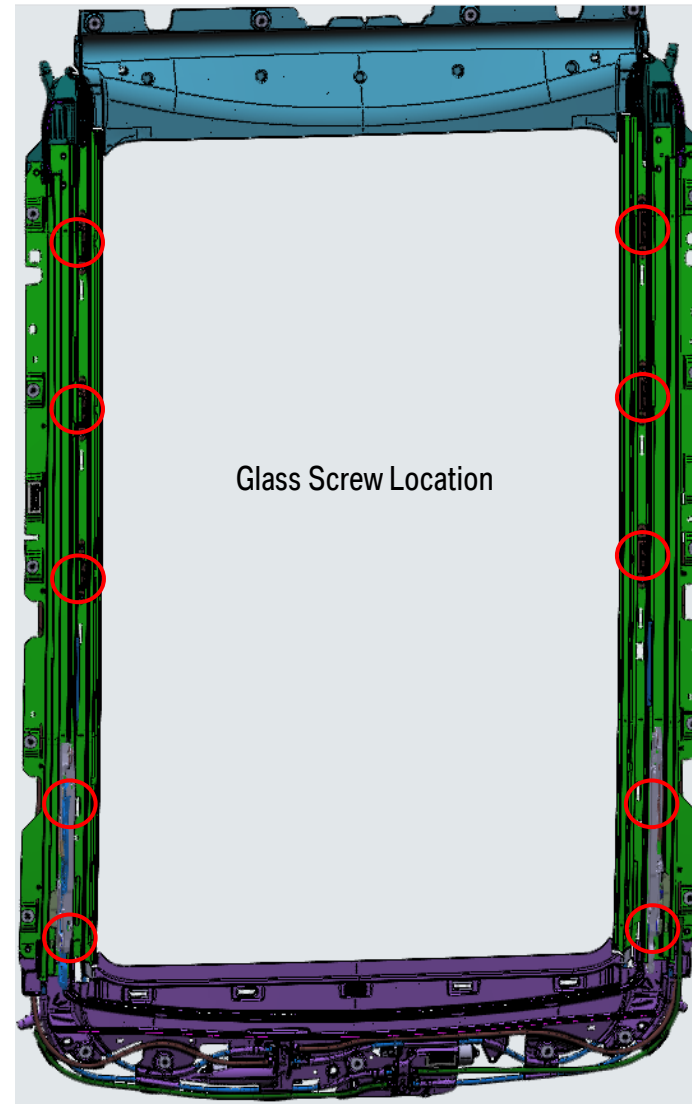
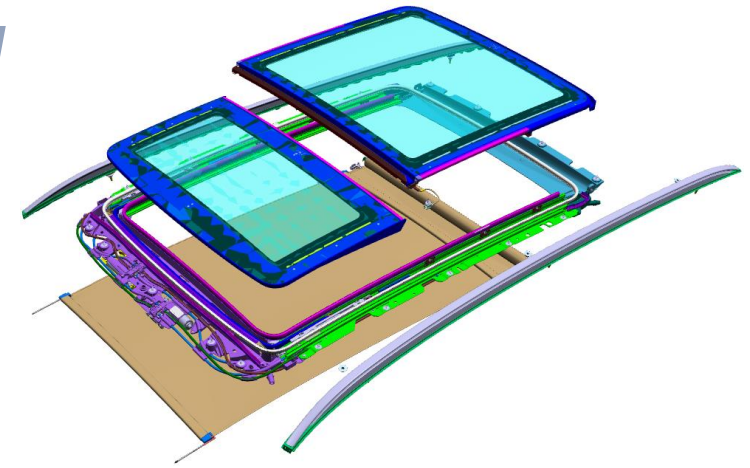
LOOSE FRAME TO BODY SCREW/ FRAME TO GLASS SCREW

Identifier: Rattling noise is heard from the roof area. One or more sunroof frame or glass screws may be loose.

Repair: Inspect screws for signs of cross-threading. Replace screws if damaged. Re-torque frame screws correctly according to ISTA/AIR repair instructions to 5.4 Nm. Re-torque glass panel screws to 4.5 Nm. Note: Ensure headliner clips are engaged and not broken.

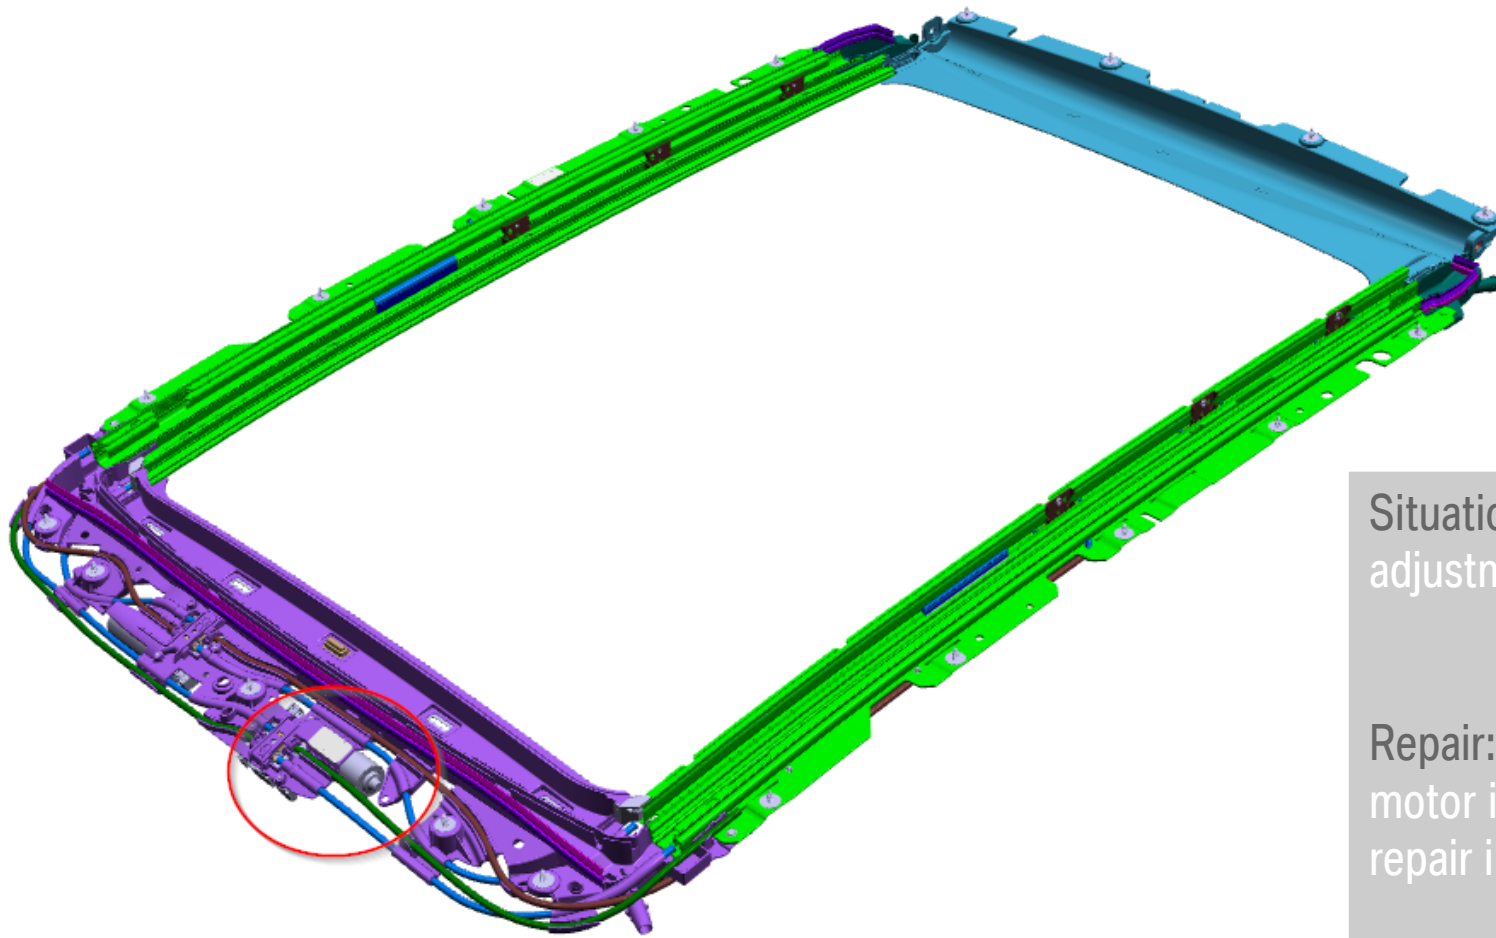
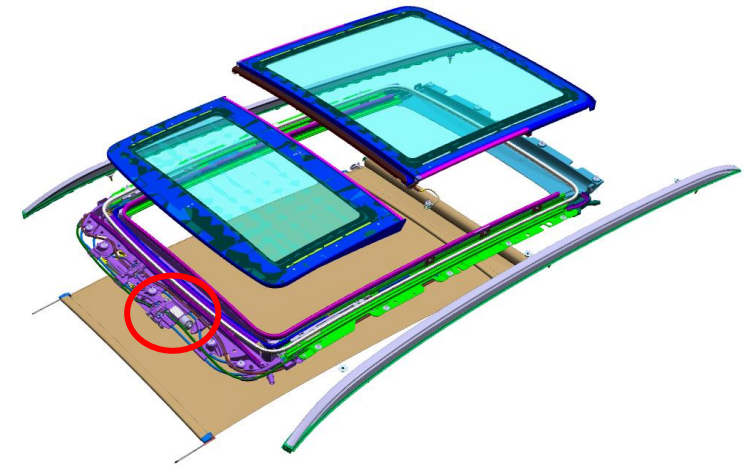
MOTOR NOISE

Situation: An oscillation noise is present from the adjustment motor when the shade or glass is moving.

Repair: Swap/replace the motor and retest. Replace the motor if found to be the cause according to ISTA/AIR repair instruction REP 67 61 580.

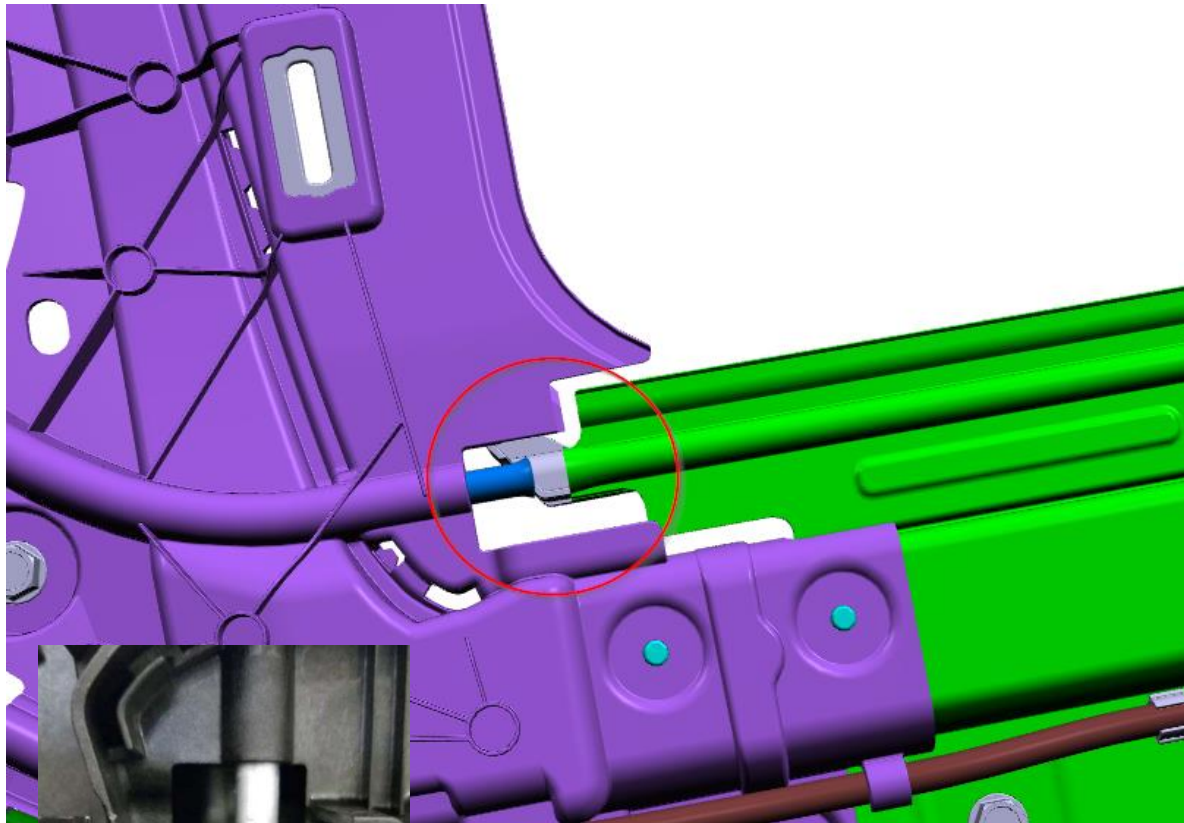
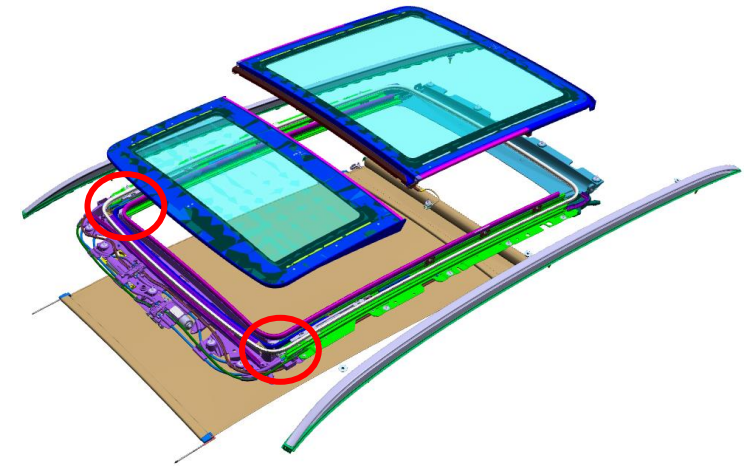
CABLE RATCHETING

Defect: misaligned or burr

Situation: A quiet oscillating/chattering noise is present when moving only the sunshade.

Repair: Inspect the sunroof frame for misalignment or a burr on the cable guide as shown. If damage is found, replace the frame according to ISTA/AIR instructions REP 54 13 261.

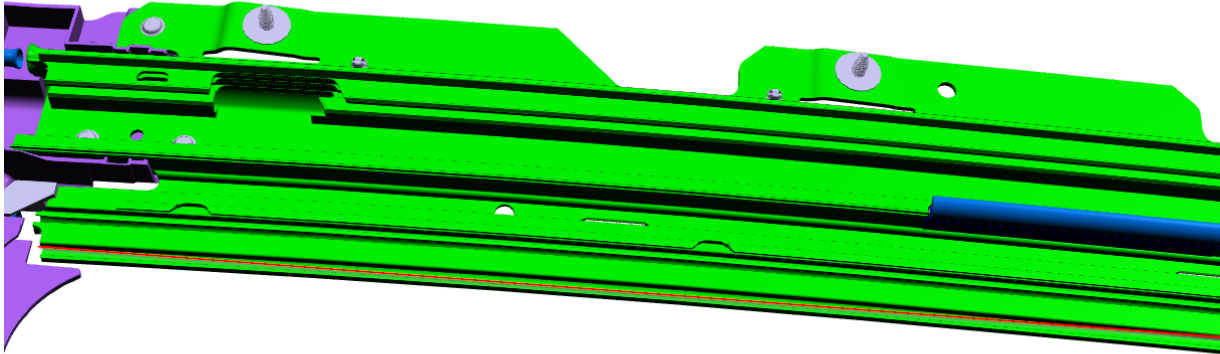
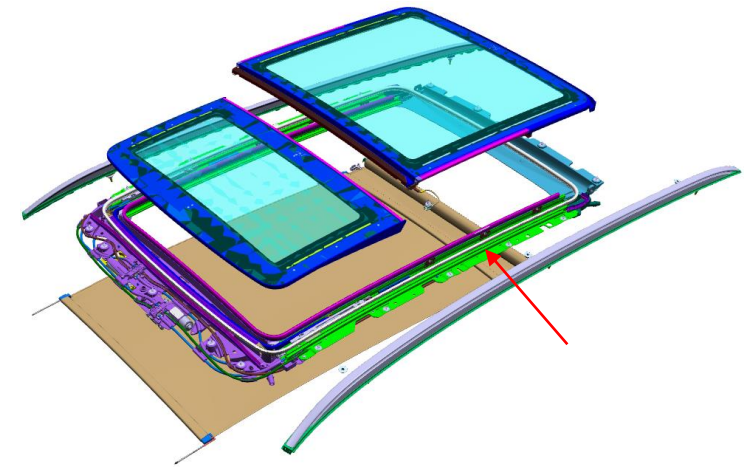
GUIDE RAIL NOT ENOUGH LUBRICATION

Situation: A squealing or chattering noise is heard when moving the sunshade. Typically on Alcantara (suede) equipped vehicles.

Repair: Clean and lubricate the sunroof guides. If noise persists then replace sunshade according to ISTA/AIR instructions REP 54 13 548.

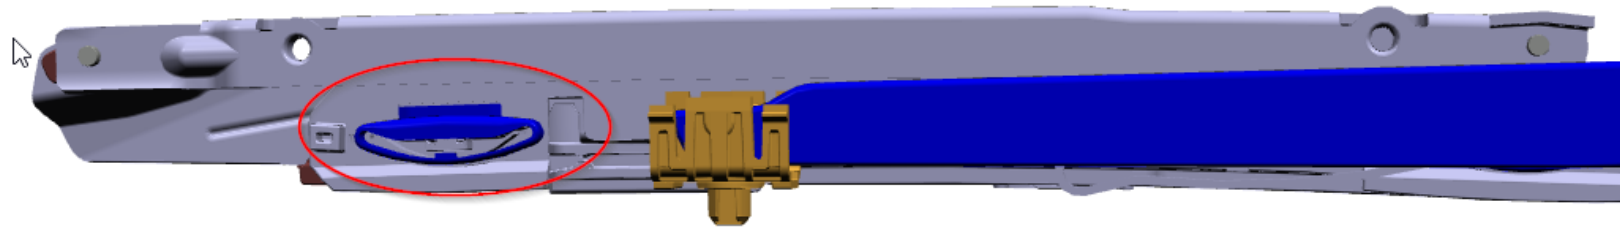
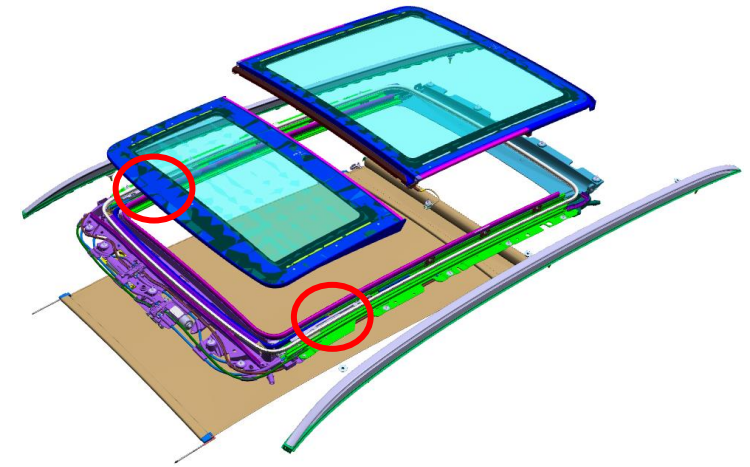
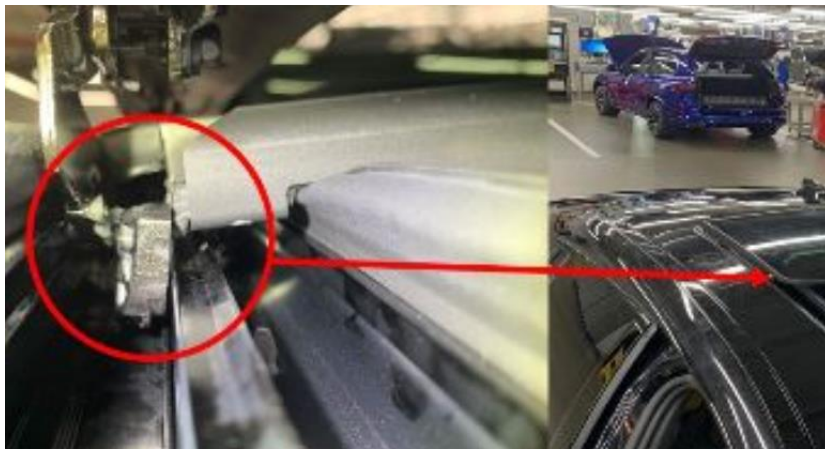
GUIDE SHOE NOT INSTALLED CORRECTLY

Blue slide shoe missing is the only root cause. Its actually yellow in color in the vehicle with two per rail slider. Causes a pop noise during glass close.

Situation: A rubbing/tapping noise heard when glass is moved.

Repair: Replace glass mechanism according to ISTA/AIR instructions REP 54 13 515.

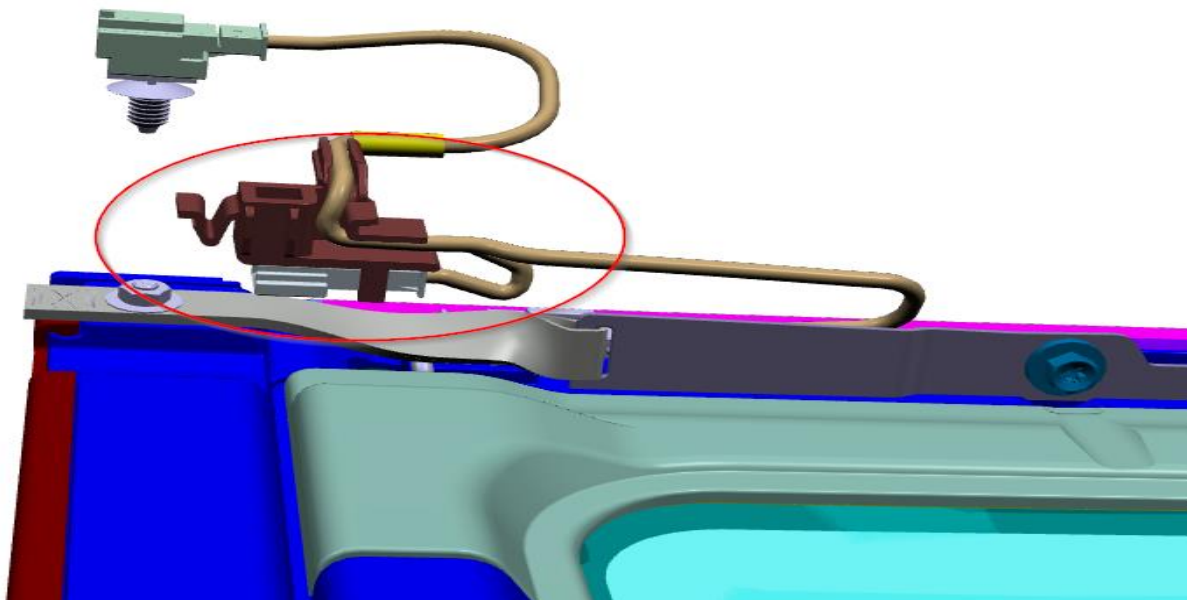
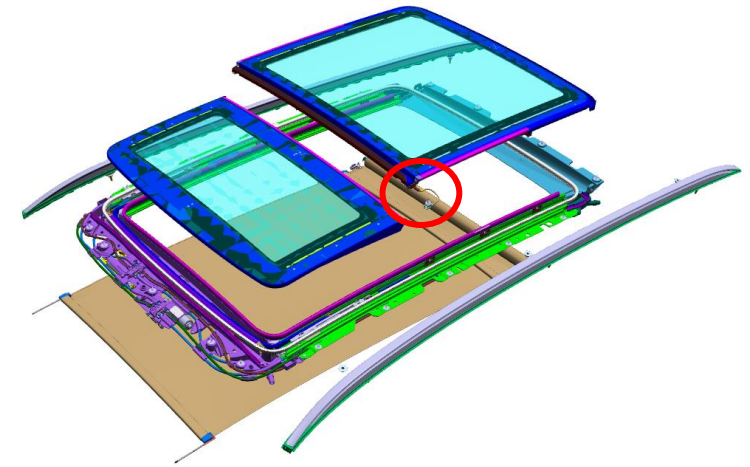
AMBIENT LIGHT CLIP LOOSE/NOT INSTALLED

Clip loose with prongs attached to connector

Clip attached to panel with a press fit rib on the back into a slot on the panel. Glass supplier glues the rib with cyanoacrylate glue.

Solution: A loose clip for the ambient light harness is tapping on the glass or contacting the sunroof mechanism. Only affects vehicle with SA407 (Panormaic Sky Lounge LED Roof).

Repair: Correctly install the harness clip.

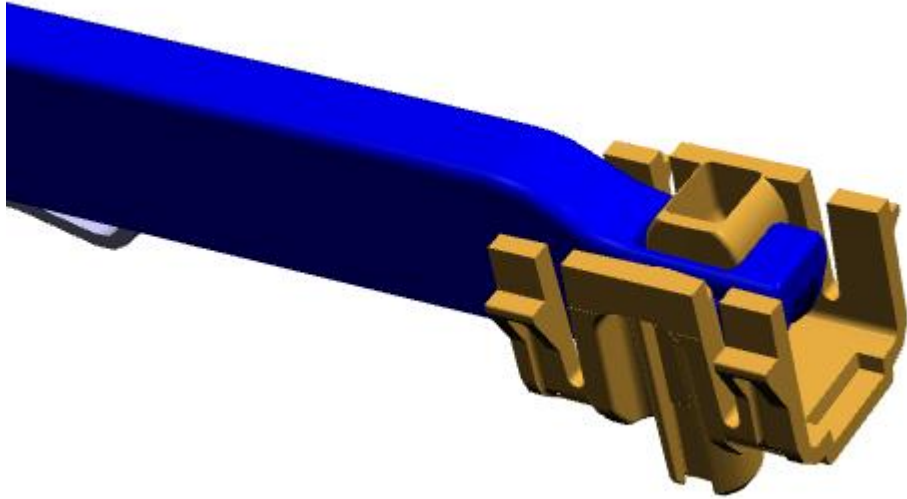
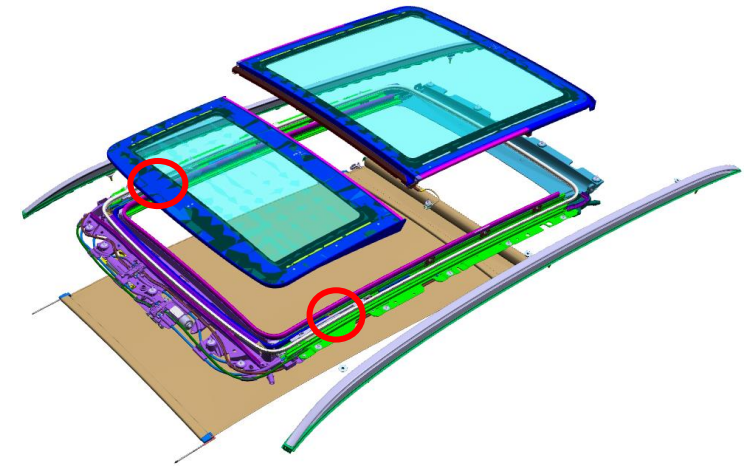
WIND DEFLECTOR PIVOT POINT LOOSE/BROKEN

Situation: A creaking noise is present while the wind deflector raises/lowers. Sunroof may reverse due to anti-trap when closing.

Repair: Replace pivot point and wind deflector according to ISTA/AIR instructions REP 54 13 090

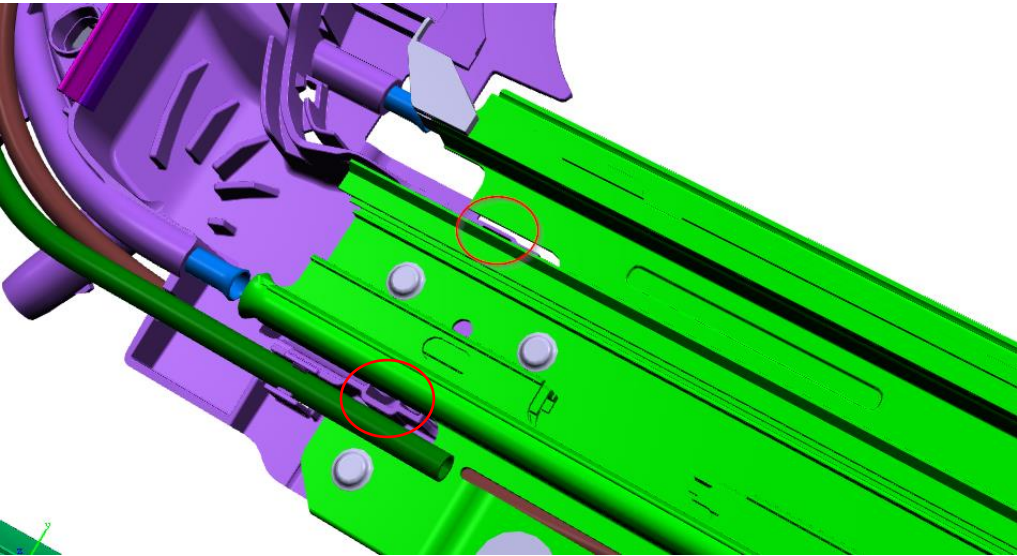
WIND DEFLECTOR EXCESS BUTYL

Picture of NOK (Before adjustment)

Picture of OK (After adjustment)

Situation: A popping noise is heard when the wind deflector raises/lowers.

Repair: Remove excess butyl to allow the wind deflector to move freely.

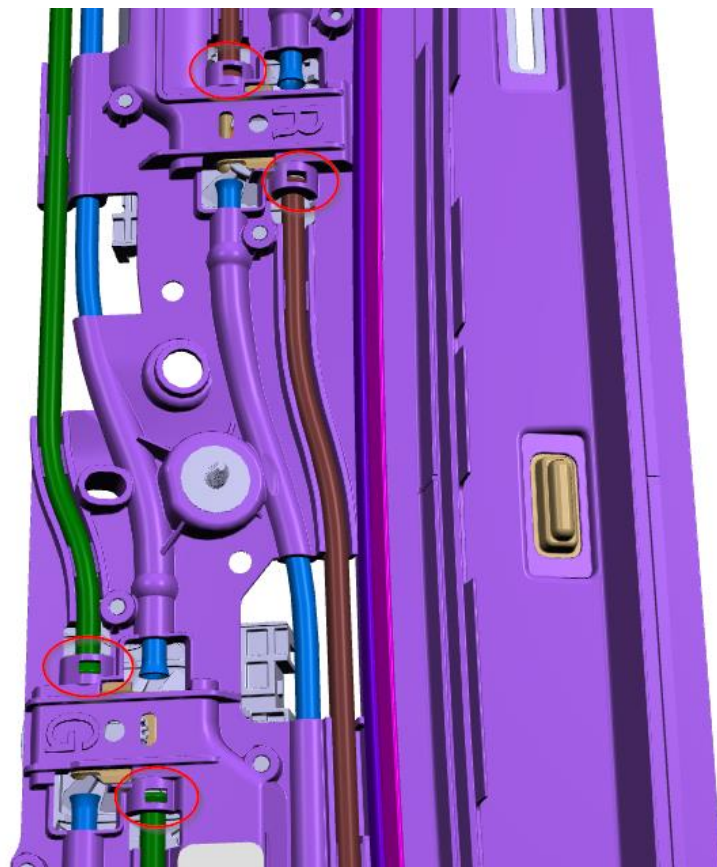
RELIEF CABLE TUBE NOT INSTALLED/ LOCKED IN

Bead not visible in window

Situation: A humming/ crackling noise is present when the opening of the sunshade or the glass.

Repair: Replace frame according to ISTA/AIR instructions REP 54 13 261.

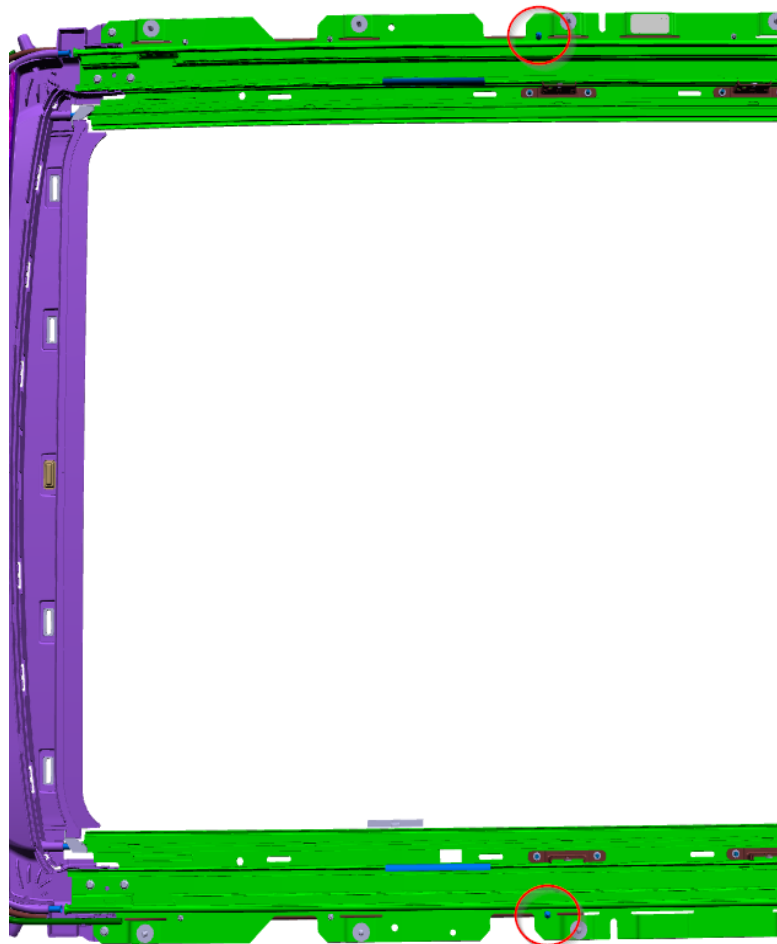
CABLE TUBE CLIP NOT INSTALLED

Identifier: If there is humming / crackling noise when opening of the sunshade. Or Plastic rattling while driving on bad track.

Repair: Engage/set clip correctly. If tube is damaged and noise persists then replace cassette according to rework instructions.

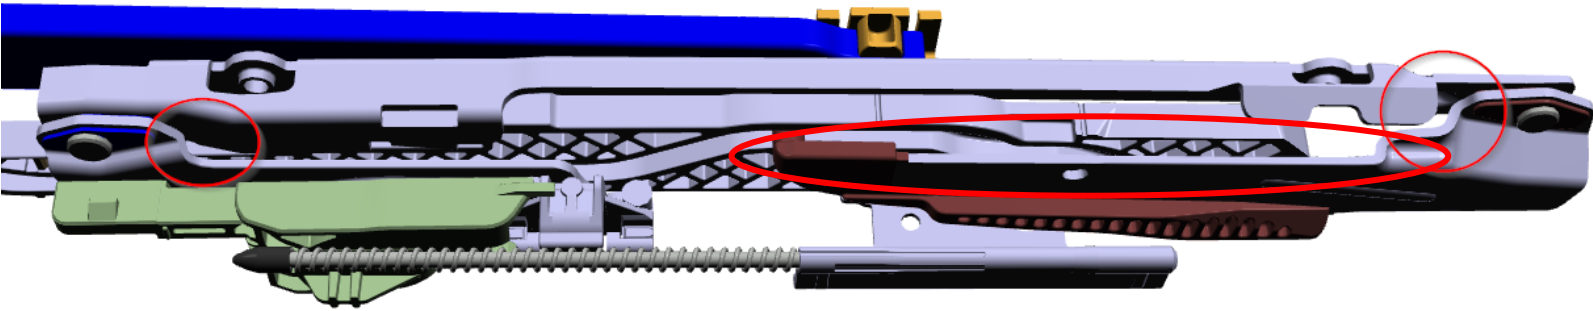
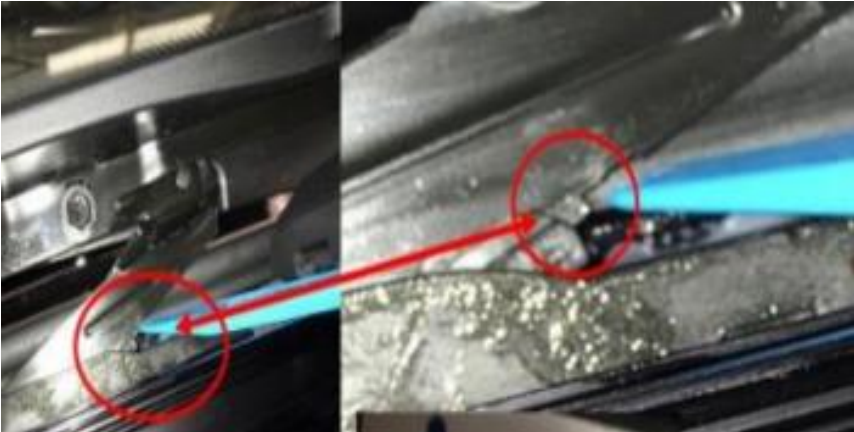
MECH ARM BURR

Scratching noise when glass is moving to full open position or early in close motion from a burr dragging along the rear glass seal or body seal. In addition to removing the burr from the mechanism, seals should be checked for degradation from the burr.

Situation: A clicking sound is present when the glass is opened to vent.

Repair: Inspect the pivot area for a burr and remove it if found. If the burr can't be found or it can't be repaired, replace the sunroof mechanisms according to ISTA/AIR instructions REP 54 13 515.
