SIB 61 20 24

DELIVERY STOP: INTERACTION BAR

E-Series	Model Description	Production Date
G70	7 Series Sedan	November 10, 2022 – March 28, 2023

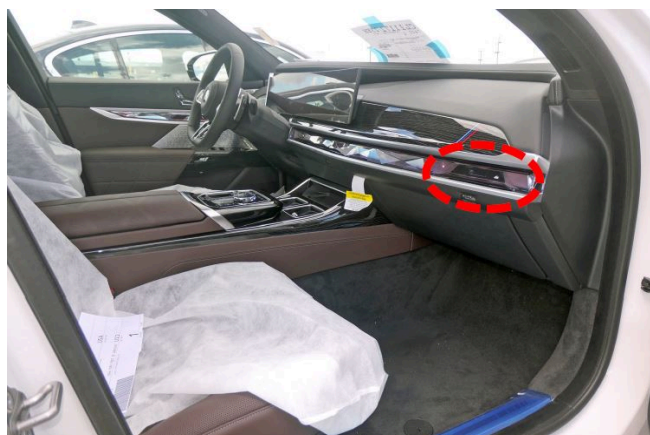
In the event of a voltage drop, comfort functions of the BMW interaction bar may fail and not respond.

Software error in the BMW interaction bar.

This can lead to a failure of the air vent functions on the passenger side of the bar (circled).

Replace the BMW interaction bar.

Replace the BMW interaction bar following the repair instructions listed in ISTA/AIR 61 31 147.
