## SIM 31 01 24 DIAGNOSING FRONT AXLE ISSUES

## SIB 31 01 24 DIAGNOSING FRONT AXLE ISSUES

2024-09-24

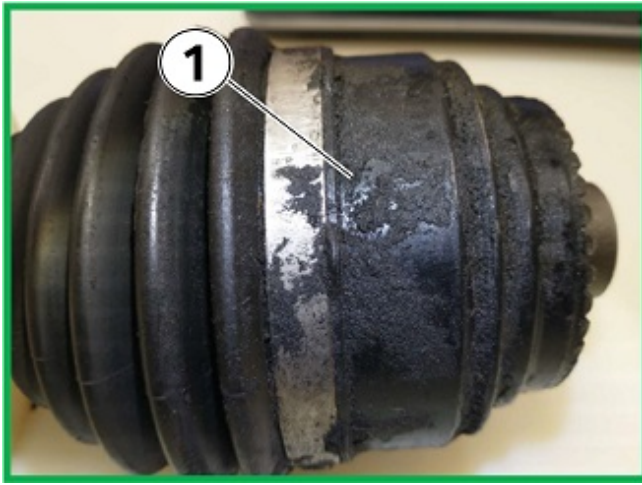
**A. The following are examples of good axles/boots. Do not replace.**

Example of dirt/contamination from outside influence (1).

**Surface contamination and/or grease build-up is normal. Do not replace the CV boot (inner) or axle half-shaft (outer).**

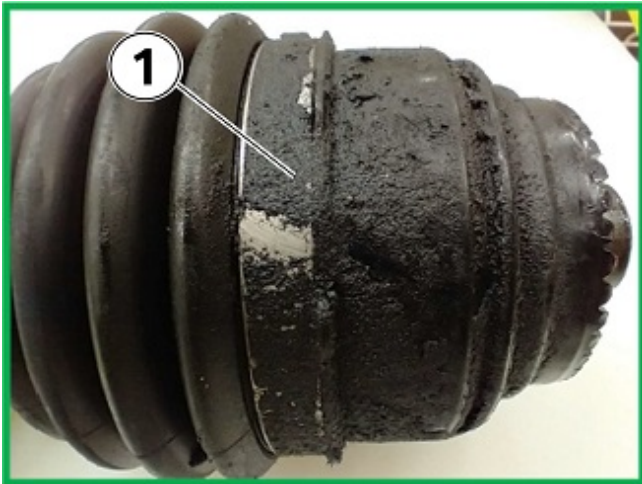
Example of dirt/contamination from outside influence (1).

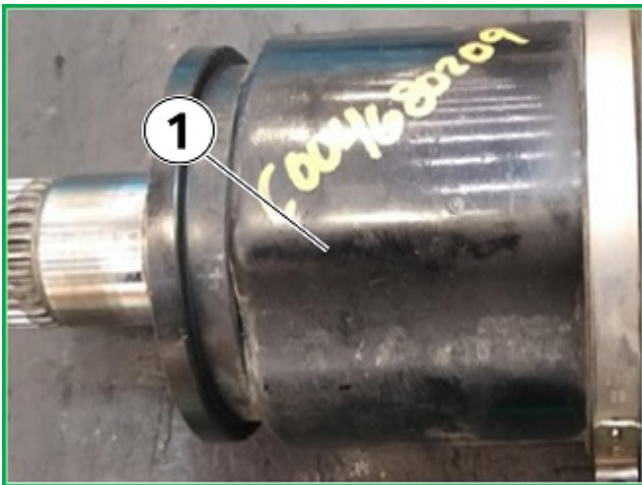
Example of dirt/contamination from outside influence (1).

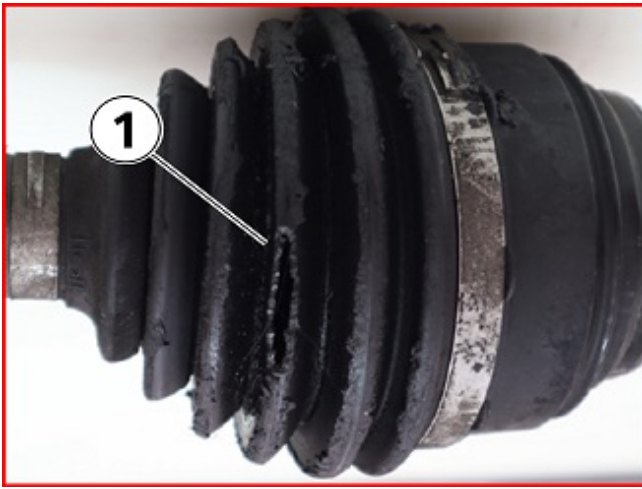
Tear in the boot (1).

**B. The following are examples of torn and/or leaking CV boots that require the necessary corresponding repair to be performed (CV boot/bellows repair kit installation or axle/output shaft replacement)**

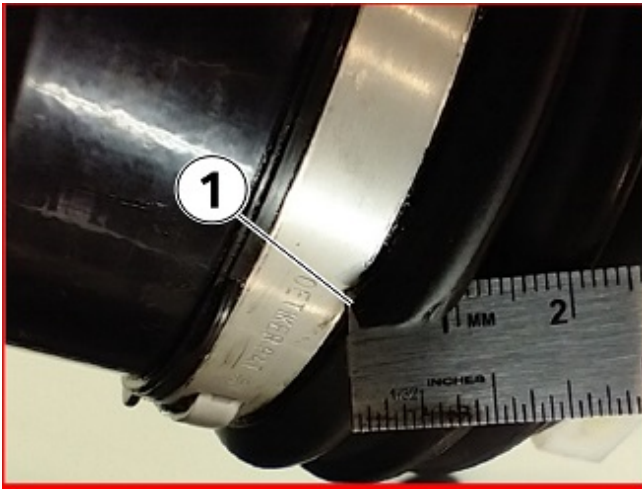
Tear or cut in the boot (1).

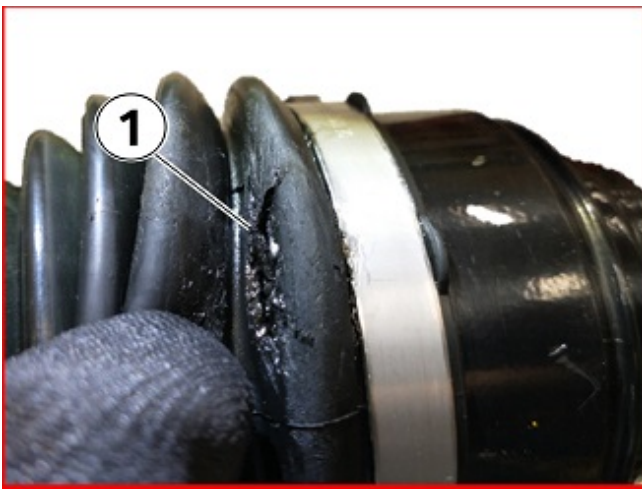
Tear or cut in the boot (1).

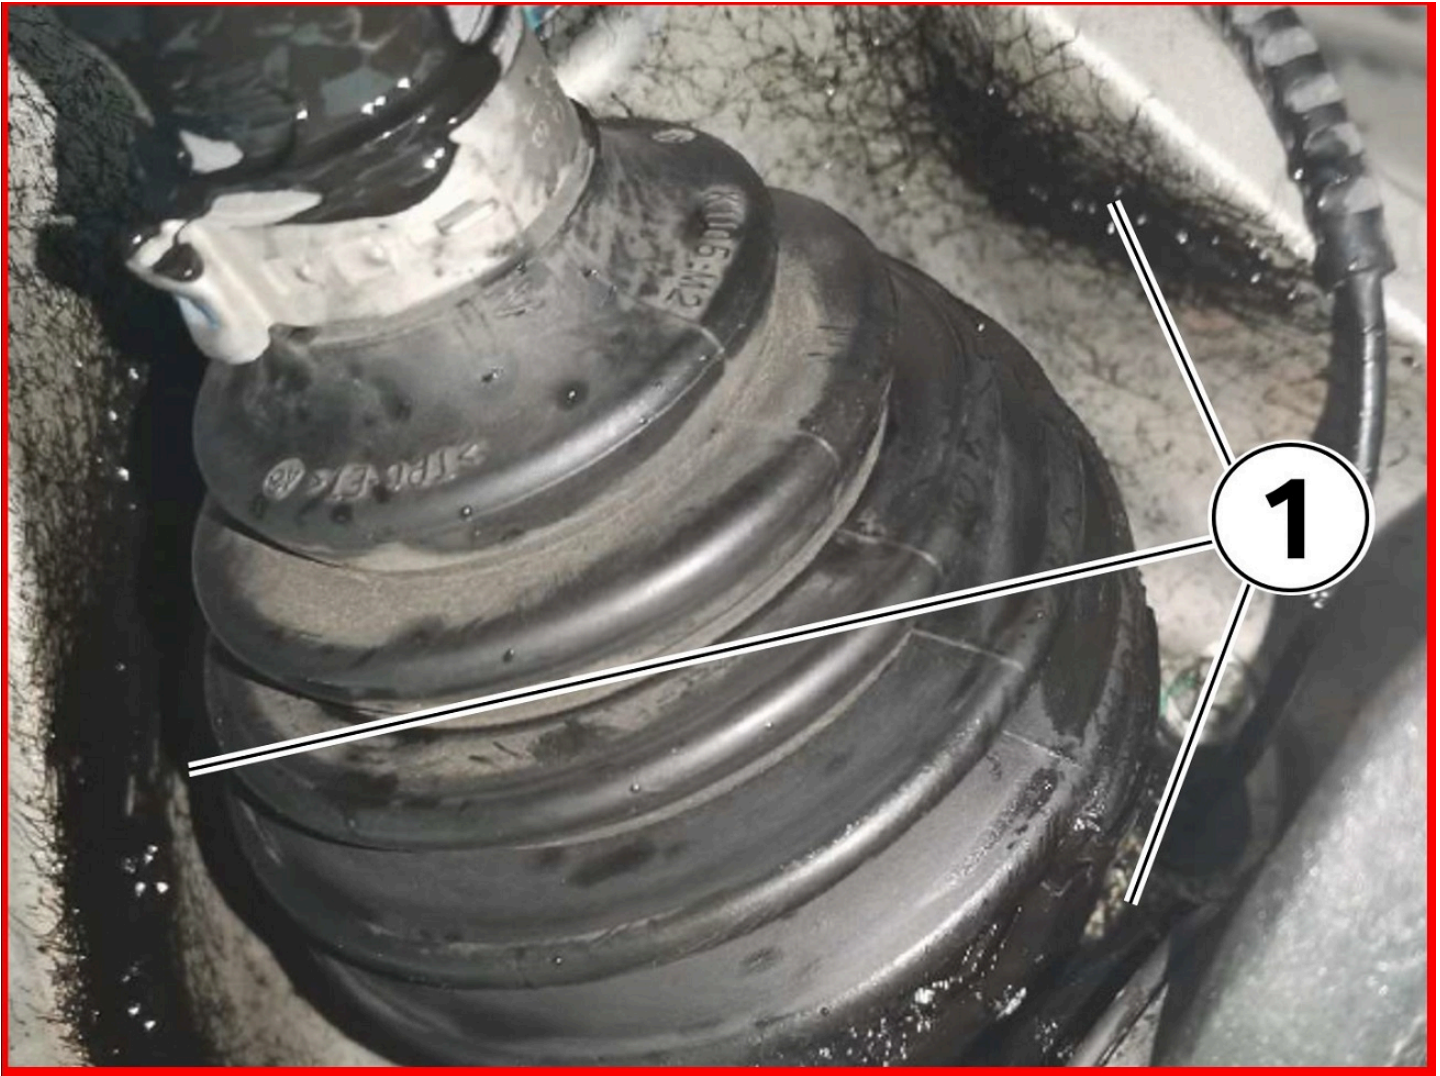
The below example is a boot that is dispersing grease around the outer carrier (1).
