MAS004328 RU 24-29

# Rapid Update 739 Grecale - Upper Tailgate Spoiler Check

DATE: September 17, 2024

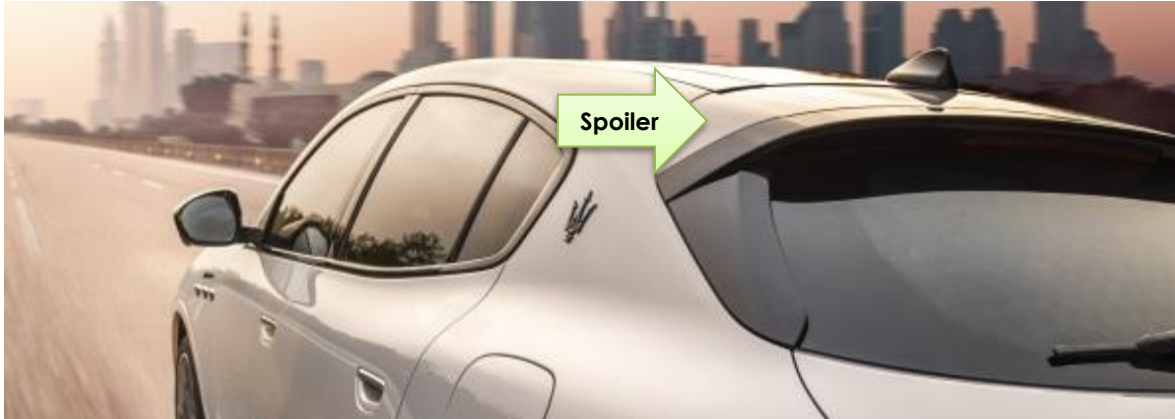
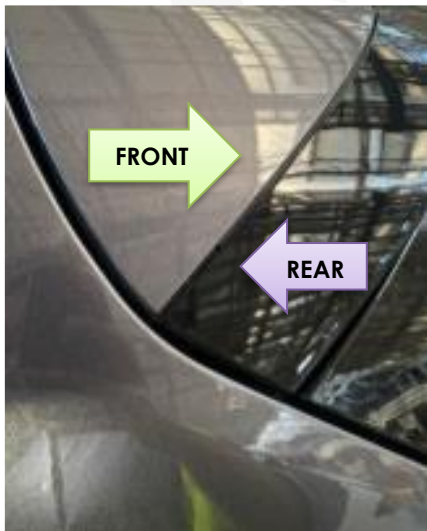
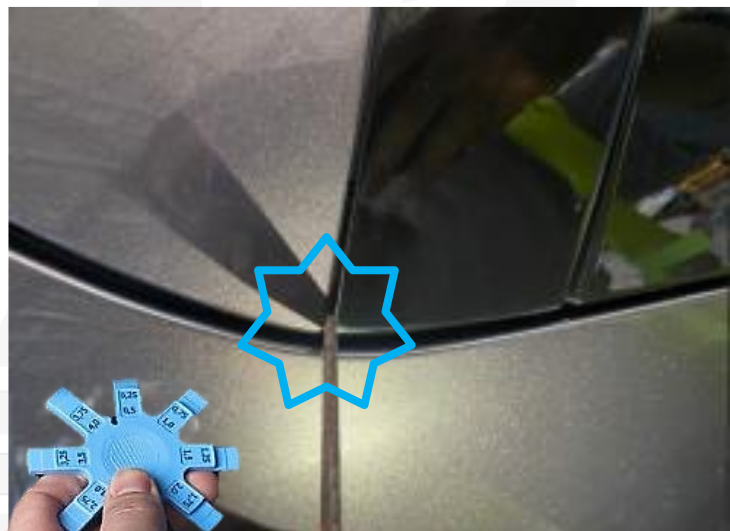
1. Always check ModisCS+ to see if the vehicle is involved in this action and if it has not been previously performed.
2. The spoiler consists of two parts: a front piece matching the car's color and a black rear piece. Check both sides of the spoiler, using a 3.5 mm thickness gauge to verify the gap between the front (example: gray or white) and rear (black) components.

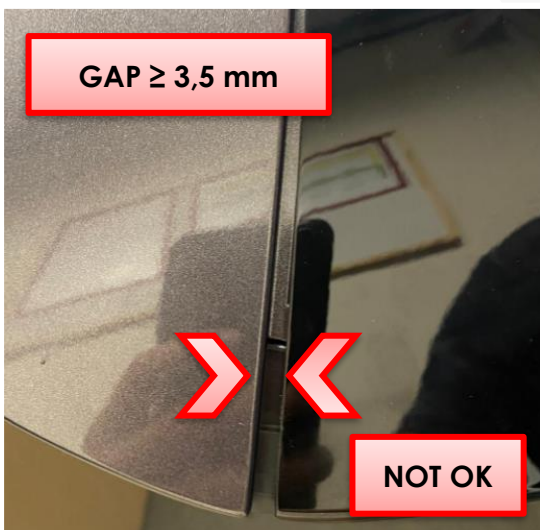
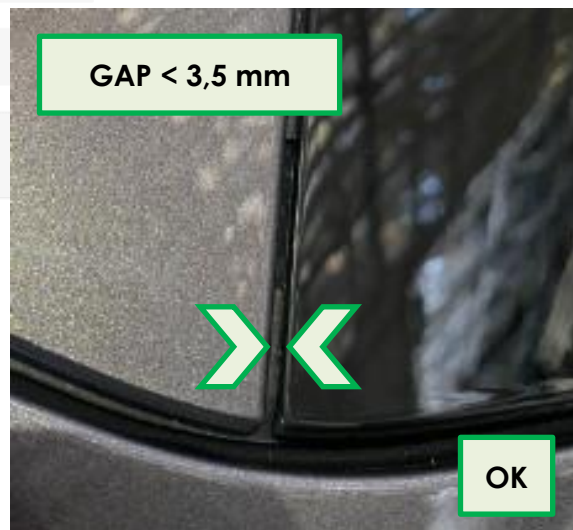
3. Measure the gap between the two components. **If the gap exceeds 3.5 mm**, the component is NOT compliant and must be replaced according to the instructions in the workshop manual.
  - **9.15.188 UPPER REAR DOOR SPOILER**      **Removal-Refitting or Replacement**

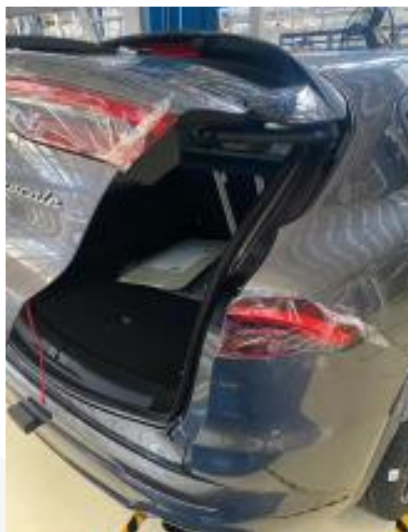
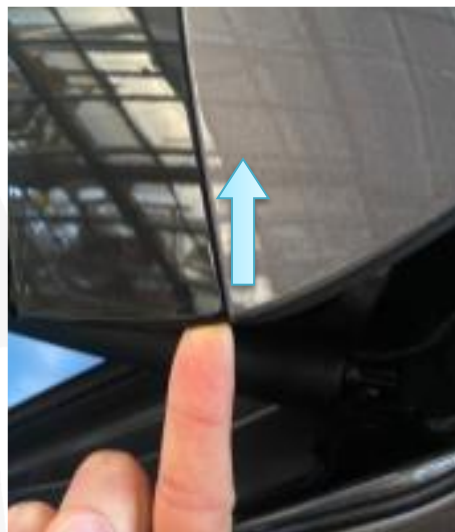
4. **If the gap is less than 3.5 mm**, the component is acceptable, and you may proceed with the inspection.
5. Open the vehicle's rear door and check the spoiler by applying upward pressure with your finger on the end of the rear (black) part of the spoiler.

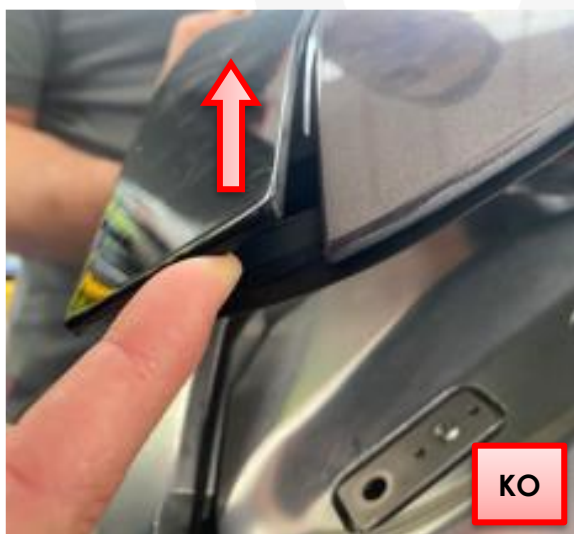
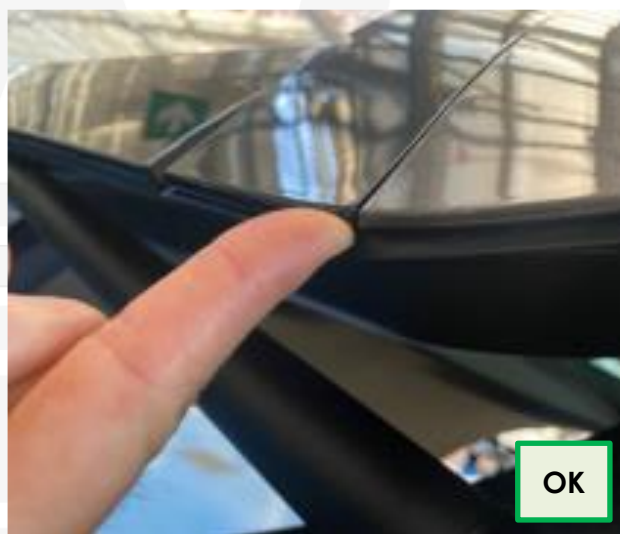
7. **If lifting** occurs, the **component is NOT OK (non-compliant)** and it is necessary to replace it, following the instructions contained in the workshop manual = **9.15.188 UPPER REAR DOOR SPOILER Removal-Refitting or Replacement**.

8. After the repairs, restore any components removed by following the procedure in reverse order.
9. Procedure complete.
