# McLaren Artura HVAC TXV Block Inspection and Troubleshooting Guide

**Topic:** Troubleshooting guide supporting diagnosis of potential leaks from the HVAC TXV block

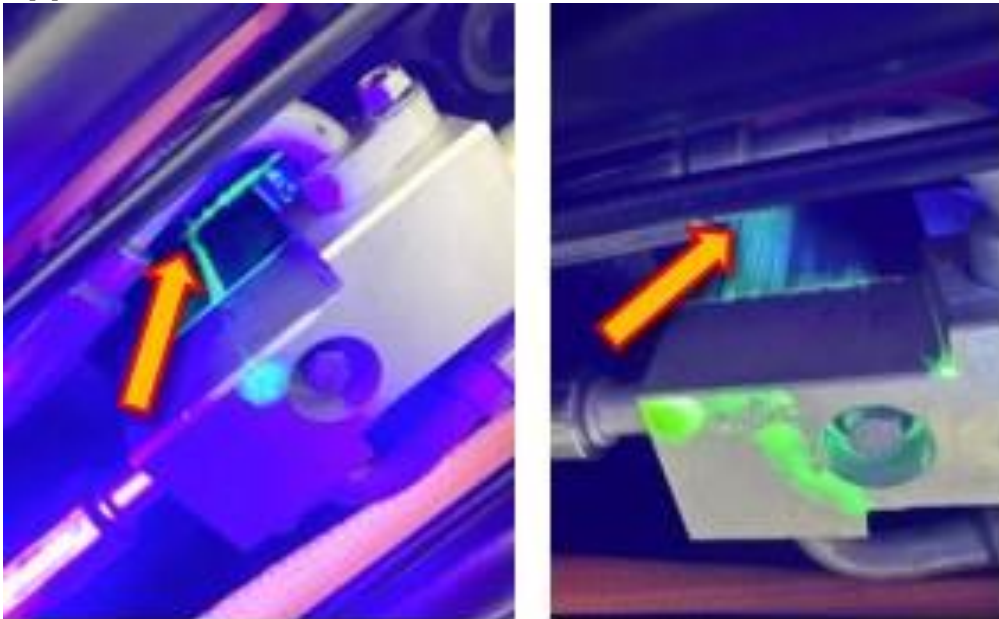
**Upper TXV leak** - Leaking from above the TXV between HVAC and TXV interface.

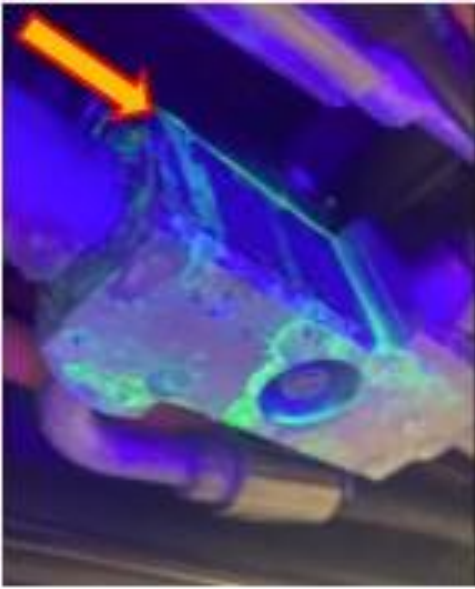
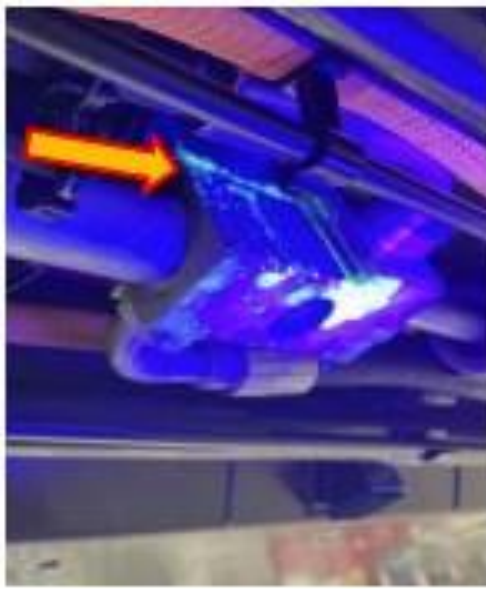
**Lower TXV/Block Interface Leak** - Leaking from in between TXV and pipe block.

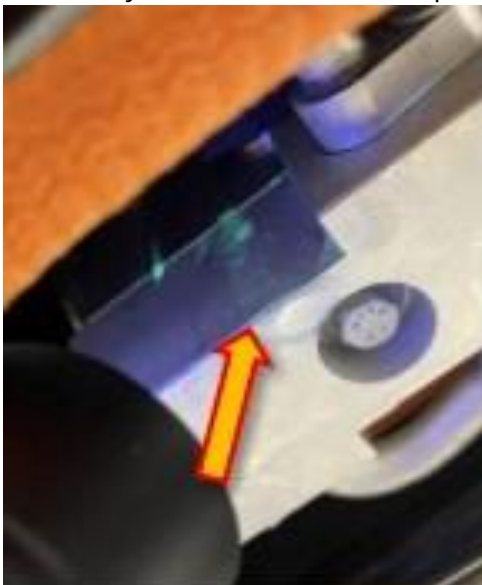
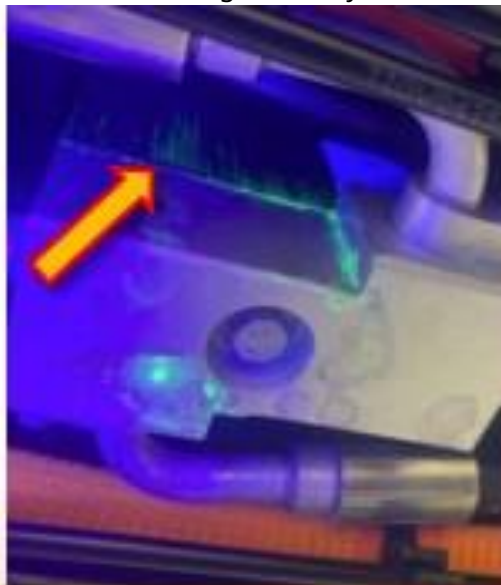
**Residual Dye Marks / Not Cleaned** - Faint residual marks, smudges, or condensate water carrying residual dye into channels. Due to poor cleanliness during assembly or after rework.

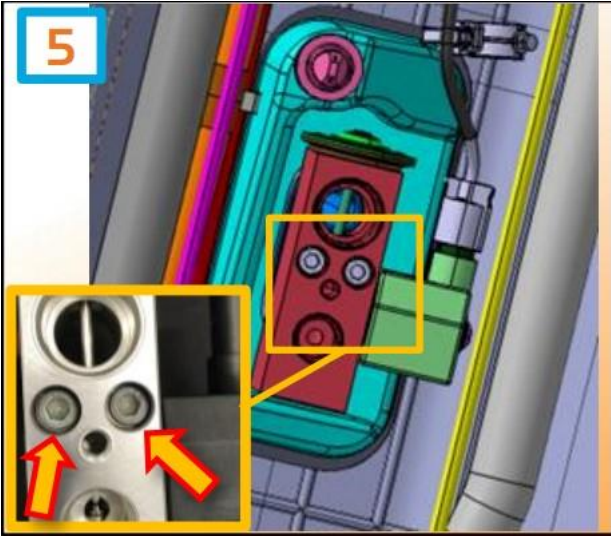
**Care point:** If bolts do not torque up to the nominal value, then it suggests an issue with the HVAC distribution box inserts. If the inserts are not present, please submit a Technical Request and await further guidance.

5. Prior to removal, check TXV bolts torque value of 6Nm is achieved

If the inserts are present, replacement of the HVAC distribution box will be required with part number **16LA709CP** or newer. Please submit a Technical Request for parts release purposes.

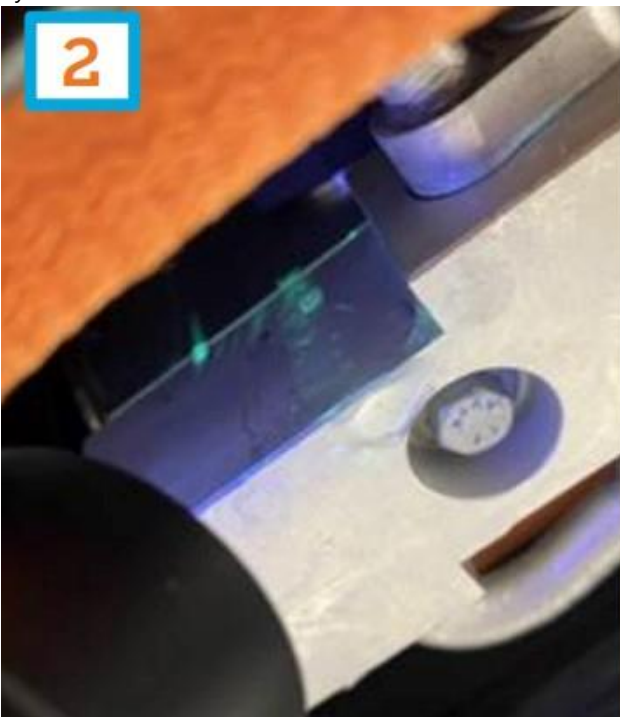
2. If faint marks, smudges or witness lines are visible, this suggests condensate water could have carried residual dye down the TXVblock

Thoroughly clean the block assembly and surrounding areas with solvent cleaner. Inspect again with UV light to ensure no residual dye is left

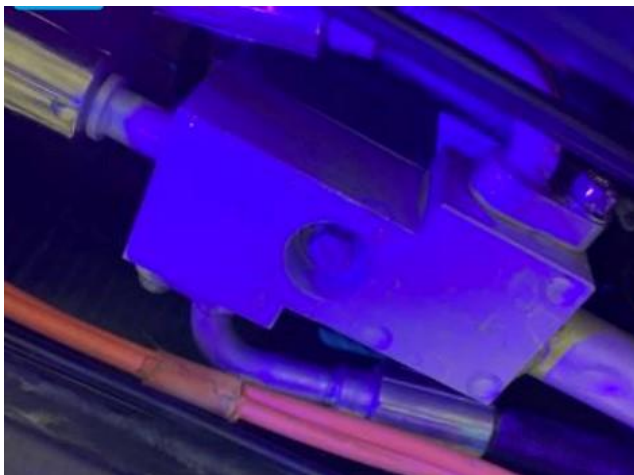
**Care point:** Expected refrigerant loss rate due to system porosity = 35grams per year. If gas recovered equates to expected amount then it further suggests residual marks only

3. De-gas system noting refrigerant/oil recovered. Nominal Gas fill = 650grams  $\pm$  10grams (R1234YF)

4. Replenish system with refrigerant and run the vehicle A/C on Quick Cool for 30 mins. Inspect for any reoccurring dye with UVtorch. If after 30 mins no dye is visible, no further action is required
