McLaren P1 & Speedtail HAD Shaft Seal Leaks

Location: Powertrain

Topic: McLaren P1 & Speedtail HDA Shaft Seal Leaks

Condition: Fluid leak present on input shaft seal and motor shaft seal

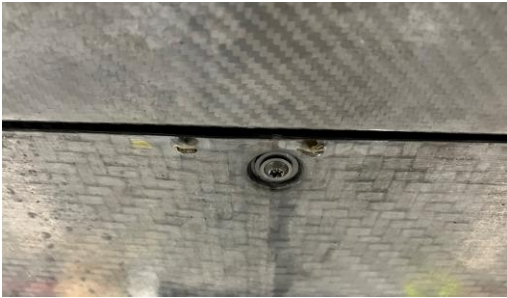
A leak from the HDA seals can manifest itself at the rear floor underneath the vehicle.

Image 1 Clutch fluid present at the rear floor of the vehicle

If this condition is identified during inspection, follow the procedure below to confirm if the leak requires rectification:

1. Remove rear floor and the transmission NVH cover
2. Clean the area removing all the oil present on the floors, NVH cover and any internal surface visible within the transmission
