<b>REFERENCE:</b>	<b>TSB:</b> 14-008-24 <b>GROUP:</b> 18 - Vehicle Performance	<b>Date:</b>	September 24, 2024	<b>REVISION:</b>	—
<b>VEHICLES AFFECTED:</b>	<p>2019 - 2022 (DJ) RAM 2500 Pickup                  2019 - 2022 (D2) RAM 3500 Pickup                  2019 - 2022 (DD) RAM 3500 Cab Chassis                  2019 - 2022 (DP) RAM 4500/5500 Cab Chassis                  This bulletin applies to vehicles equipped with the 6.7L I6 Cummins Turbo Diesel engine (Sales Codes ETL and ETN) or a 6.7L I6 Cummins HO Turbo Diesel engine (Sales Code ETM).</p>	<b>MARKET APPLICABILITY:</b>			
		<input checked="" type="checkbox"/> NA		<input type="checkbox"/> MEA	
		<input type="checkbox"/> SA		<input type="checkbox"/> IAP	
		<input type="checkbox"/> EE		<input type="checkbox"/> CH	
<b>CUSTOMER SYMPTOM:</b>	<p>Customers must experience a Malfunction Indicator Lamp (MIL) illumination and the vehicle must exhibit/set the following Diagnostic Trouble Code (DTC):</p> <ul style="list-style-type: none"> <li>• P203E-00 - Reductant Level Sensor 1 Circuit Intermittent-Erratic.</li> </ul> <p>Customers may also experience one or more of the following:</p> <ul style="list-style-type: none"> <li>• Repeated fr

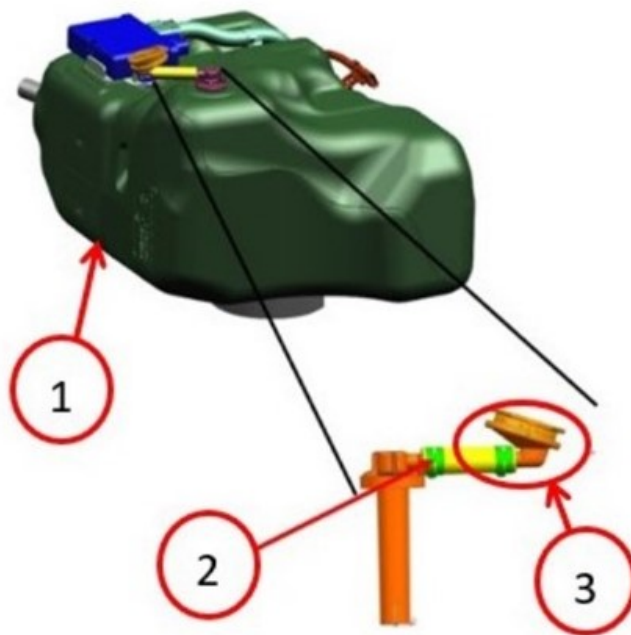
**Fig. 1**  
DEF Tank Assembly

- 1 - DEF Tank
- 2 - Hose Clamp
- 3 - GVV

2. Loosen the hose clamp on the Grade Vent Valve (GVV) hose from the DEF tank [Fig. 1](#).
