REFERENCE:	TSB: 03-009-24 GROUP: 03 - Differential and Driveline	Date:	September 27, 2024	REVISION:	—
VEHICLES AFFECTED:	2024 (J6) Jeep Wrangler This bulletin applies to vehicles built on or before May 25, 2024 (MDH 0525XX) equipped with the Dana M220 Wide Full Floating RR Axle (Sales Code DRN).			MARKET APPLICABILITY:	
				<input type="checkbox"/> NA	<input type="checkbox"/> MEA
				<input type="checkbox"/> SA	<input checked="" type="checkbox"/> IAP
				<input type="checkbox"/> EE	<input type="checkbox"/> CH
CUSTOMER SYMPTOM:	Customers may experience the following: <ul style="list-style-type: none"> An intermittent grinding, screeching, rubbing noise coming from the right hand side of vehicle on the rear axle. 				
CAUSE:	Lack of lubrication

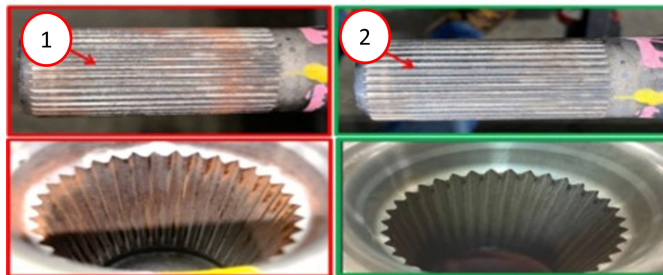
Fig. 1
Axle Shaft Splines/Hub Splines

1 - Axle Shaft/Hub Splines Prior To Cleaning
2 - Axle Shaft/Hub Splines After Cleaning

4. Remove the axle shaft from the hub.
5. Using brake cleaner and a wire brush, clean both the interface of the shaft splines and hub splines to remove any of the "fretting/corrosion" seen on those splines [Fig. 1](#).

NOTE: After cleaning the interface use forced air to remove any remaining debris on interface.

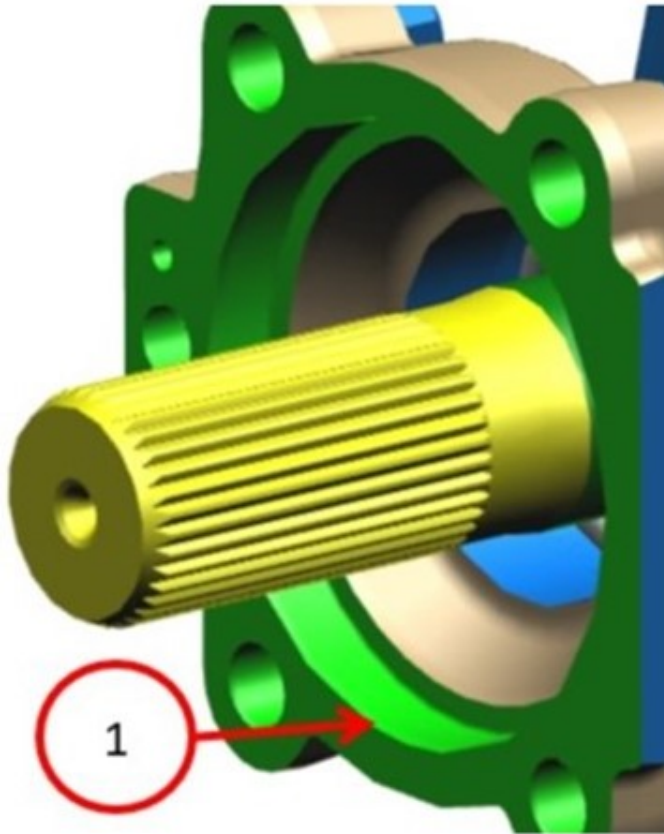
Fig. 3
Tube Flange Diameter To Lubricate

1 - Area To Apply Lubricant To The Tube Flange Surface

- Lubricate the tube flange inside diameter with 75-85W sump lube as this aids in O-ring guidance [Fig. 3](#).
