**Technical Service Bulletin (TSB)**  
**Crank Gear Flange Dislocation**

<b>REFERENCE:</b>	<b>TSB:</b> 09-014-24 REV. A <b>GROUP:</b> 09 - Engine	<b>Date:</b>	September 27, 2024	<b>REVISION:</b>	09-014-24
<b>VEHICLES AFFECTED:</b>	<b>2023 - 2024 (H6) Jeep Meridian</b> <b>2023 - 2024 (M6) Jeep Compass</b> This bulletin applies to the following vehicles built on or after February 02, 2023 (MDH 0202XX) on or before February 24, 2024 (MDH 0224XX) equipped with a 2.0L I4 Turbo Diesel Engine With/ESS (Sales Code EBS).	<b>MARKET APPLICABILITY:</b>			
		<input type="checkbox"/> NA <input type="checkbox"/> MEA <input type="checkbox"/> SA <input checked="" type="checkbox"/> IAP <input type="checkbox"/> EE <input type="checkbox"/> CH			
<b>CUSTOMER SYMPTOM:</b>	<b>Customers may experience one or more of the following:</b> <ul style="list-style-type: none"> <li>• Vehicle does not start due to crank gear flanged dislocated.</li> <li>• Abnormal noise from the engine compartment.</li> <li>• Noise from the timing cover area.</li> </ul>

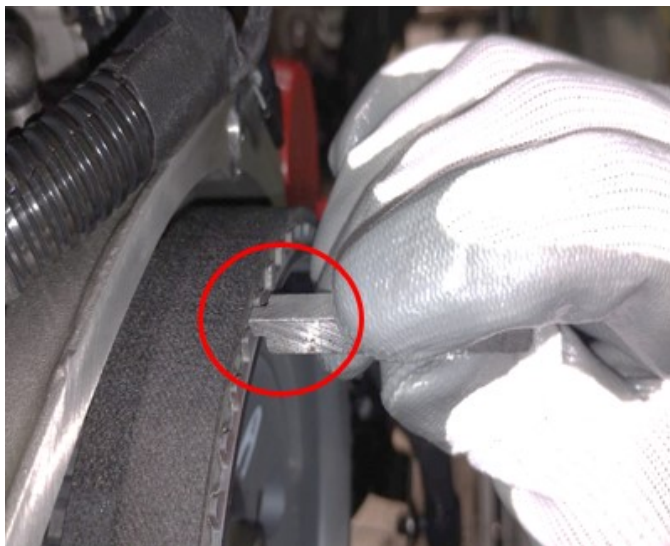
**Fig. 7**

8. Is the gap between the cam gear face and the belt face more than 3 mm (0.1 in.) [Fig. 7](#)?

- YES >>> Proceed to [Step 9](#).
- NO >>> Proceed to [Step 13](#).

9. Remove and reinstall the timing belt. Refer to the detailed service procedures available in DealerCONNECT/Service Library under: Service Info> 09 - Engine / Valve Timing / Belt, Timing / Removal and Installation.

10. Rotate the engine 360 degrees and recheck the belt position gap from the cam gear face to the belt face using a Vernier Caliper [Fig. 6](#).
11. Is the gap between the cam gear face and the belt face still more than 3 mm (0.1 in.) [Fig. 7](#)?

- YES >>> \*\*Proceed to [Step 12](#)\*\*.
  - NO >>> Proceed to [Step 13](#).
12. \*\*Replace the tensioner bracket assembly. Refer to the detailed service procedures available in DealerCONNECT/Service Library under: Service Info> 09 - Engine / Valve Timing / Tensioner, Engine Timing / Removal and Installation\*\*.
