## Technical product information

<b>Topic</b>	Driver / Passenger door(s) creak on close - All models (front and / or rear)
<b>Market area</b>	Australia E04 Bentley rest Asia and Australia (6E04),China 796 VW Import Comp. Ltd (Vico), Beijing (6796),Germany E02 Bentley rest Europe (6E02),Japan E03 Bentley Japan (6E03),Korea, (South) E08 Bentley South Korea (6E08),United Arab Emirates E06 Bentley Middle East and Africa (6E06),United Kingdom E01 Bentley UK (6E01),United States E05 Bentley USA and rest America (6E05)
<b>Brand</b>	Bentley
<b>Transaction No.</b>	2071525/3
<b>Level</b>	EH
<b>Status</b>	Approval
<b>Release date</b>

Driver / Passenger door(s) creak on close - All models (front and / or rear)

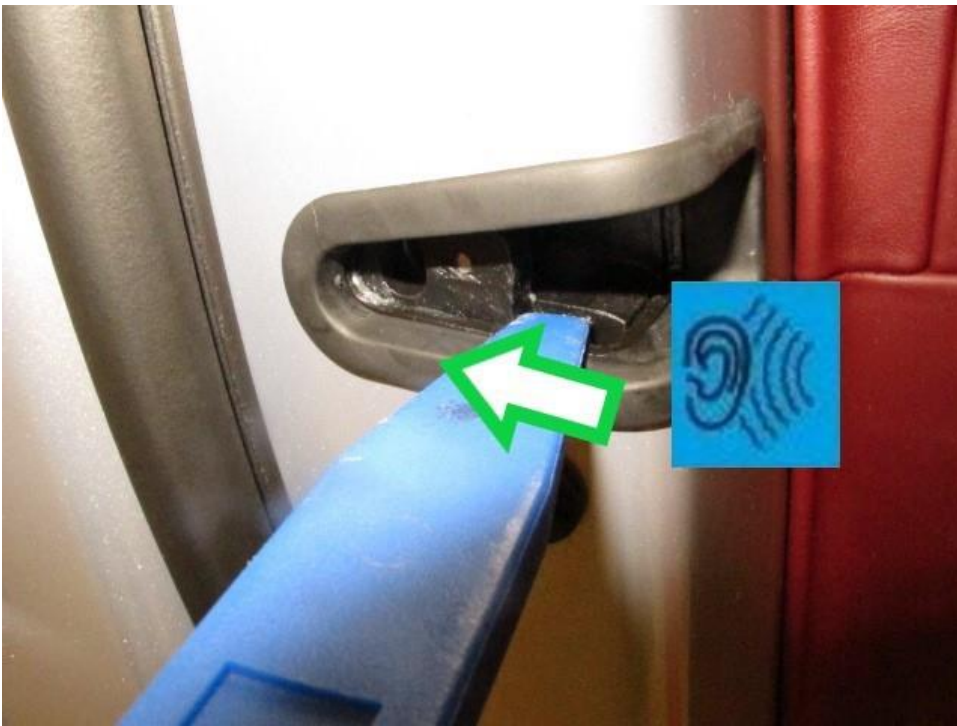
**With the door open - Does the latch creak during the power close operation?**

2) Referring to Figure 1 - With the door open - Use a suitable non metallic tool - Close the latch

3) In the event the door latch is creaking as described in Step 2 - Refer to Rep.Gr 57 or Rep.Gr 58 and replace the applicable power close door latch motor cable as described within the onward instructions

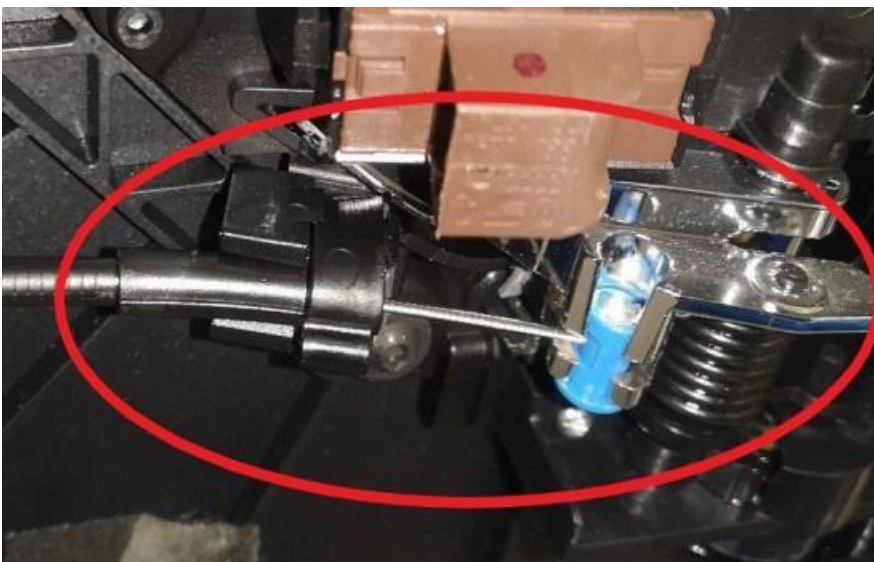
**CAUTION:** Referring to Figure 2 (New Continental GT, New Continental GTC and New Flying Spur) and Figure 3 (Bentayga) extra care must be taken when removing and refitting the door trim and bowden cable. Should any issues be evident or damage caused within the highlighted area shown (depending on model) the operative must raise a DISS query and await feedback before conducting any further work

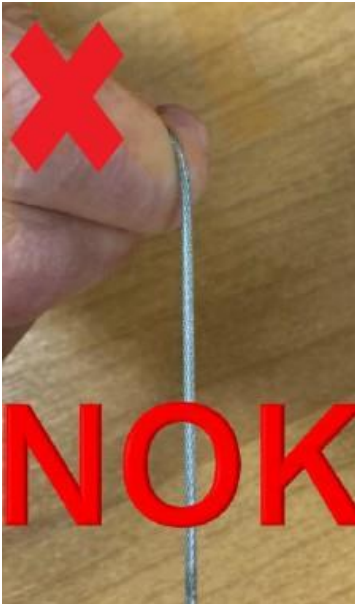
**⚠ CAUTION**  
Do not grip / hold the cable as shown in Figure 6 as the cable can be easily damaged/bent (this is imperative when fitting the new replacement cable)

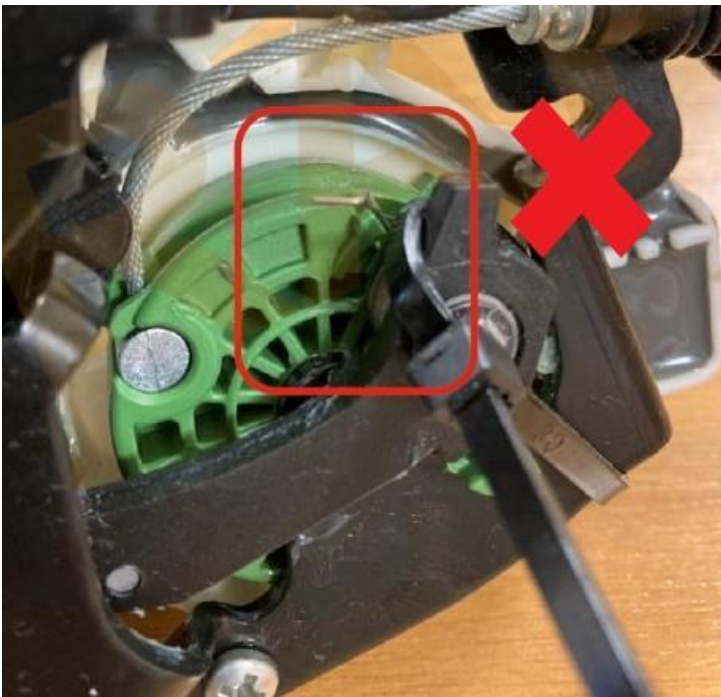
Figure 10

Take care when fitting the cable tie as the spool tensioning spring can be partially dislodged (Figure 10) or completely dislodged (Figure 11) in this scenario the spring should be relocated back to its original home position (refer back to Figure 9)

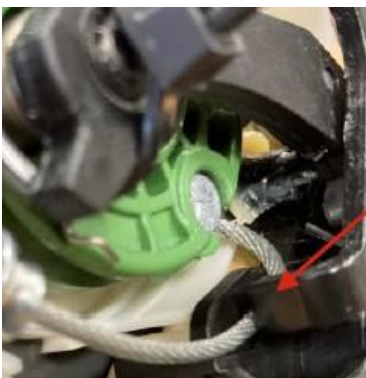
Figure 14

<p><b>⚠ CAUTION</b></p>
<p>The cable can be easily bent / damaged during fitment into the spool, the cable could also be easily trapped under the bracket</p> <p>– Figures 14 shows an example of the cable trapped/damaged during fitment</p>
