Technical product information

Topic	Engine intermittently fails to start/DIP pop up 'Engine start system: fault'
Market area	Bentley: worldwide (2WBE),China 723 Volkswagen (Anhui) Automotive CO (6723),China 796 VW Import Comp. Ltd (Vico), Beijing (6796)
Brand	Bentley
Transaction No.	2061362/5
Level	EH
Status	Approval
Release date

Continental GT/GTC and Flying Spur

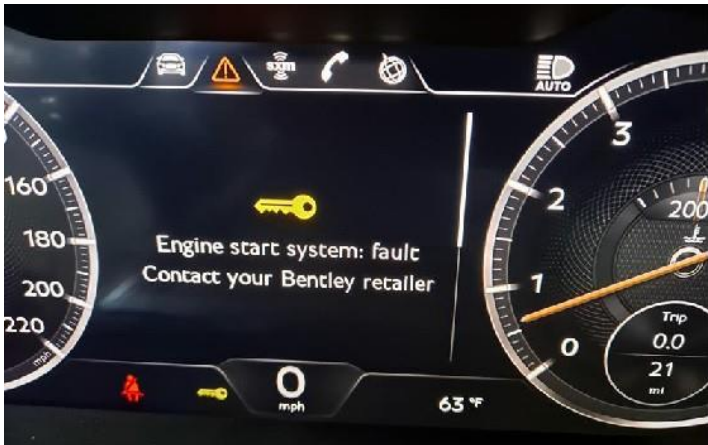
Customer unable to intermittently start the engine with the start button

Or

Engine starts but customer gets a pop up error within the Drivers Information Panel (DIP)

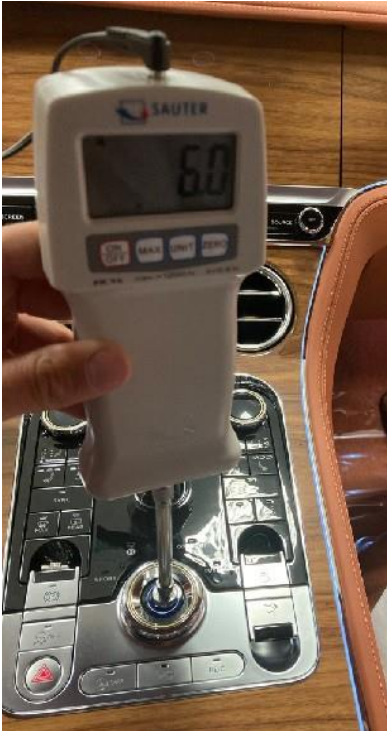
Figure 2

Note: Electrical tape not shown in image for clarity purposes only, please ensure tape is applied

3) Using the workshop tool WT10354 (Force gauge) and selected adaptor highlighted below (Figure 1), slowly press down on the Access/start

authorization button centrally (Figure 2) and record the force (N) which each contact point 1 to 3 changes from 'Not operated' to 'operated'
