# Technical product information

<b>Topic</b>	Front and/or rear internal door trim panel - Poor retention between the trim panel and door
<b>Market area</b>	Bentley: worldwide (2WBE),China 796 VW Import Comp. Ltd (Vico), Beijing (6796)
<b>Brand</b>	Bentley
<b>Transaction No.</b>	2074995/1
<b>Level</b>	EH
<b>Status</b>	Approval
<b>Release date</b>

## Continental GT/C and Flying Spur

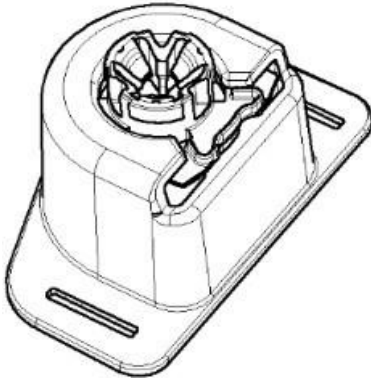
Figure 1

Front and/or rear internal door trim panel - Poor retention between the door trim panel trim clips and door panel tucker studs

The door trim panel is retained to the door panel tucker studs with trim clips (Figure 1)

3) Abrade all tucker studs using 3M Scotchbrite (or similar)

**Tip:** Ensure the whole tucker stud front to rear is abraded - Then wipe clean

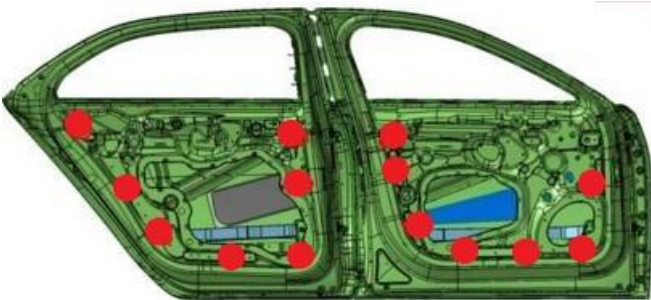
The door trim clips fit / secure onto the door panel tucker studs, the tucker studs are located as shown in Figures 2 and 3 (Depending on model)

The presence of coatings in some cases can affect the retention of the door trim panel

- Flying Spur (front and rear doors) - Figure 2

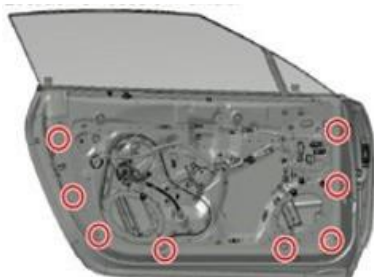
Figure 3

- Continental GT/C (Figure 3)
